# FLYING

January/February 2003

# 2002 Mishap Review

## FY02: A SOBERING YEAR A SUMMARY OF USAF FLIGHT MISHAPS IN FY02

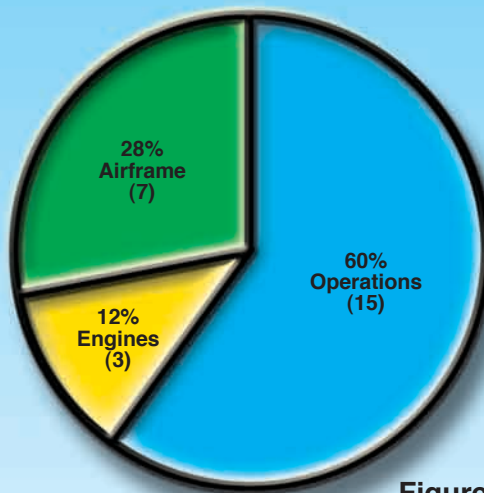
**Figure 2**

Now let's take a look at how engines stacked up against other causes of destroyed aircraft. Figure 2 tells us that engines made up the smallest category resulting in destroyed aircraft this year. Again, this is good news for the engine community, at least relative to the airframe and ops side of things.

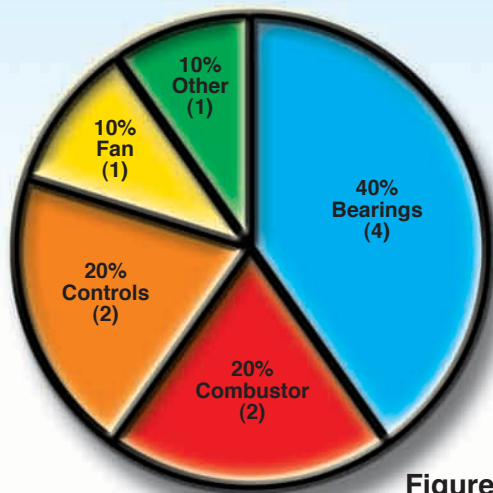
**Figure 3**

**FY02 Engine-Related Class A Mishaps by Engine Section**

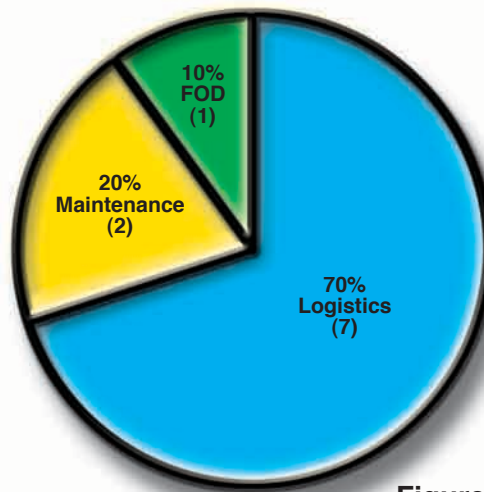
**Figure 4**

Figure 4 presents us with an overview of this past year's mishap factors. Even a quick glance reveals that the majority of engine-related mishaps fall under "Logistics." Of these seven logistics-related mishaps, three were known failure modes with either corrective mea-

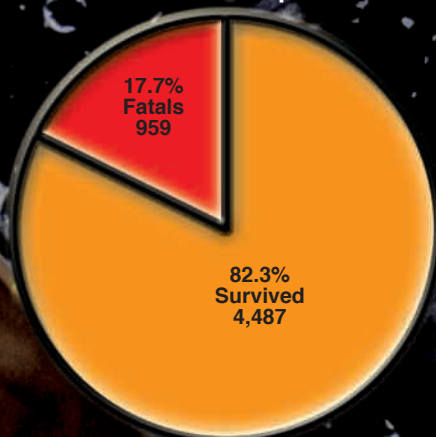
**Figure 1**

Since the introduction of the ejection seat in U S Air Force aircraft in 1949, there have been 5446 ejection attempts (through 30 Sep 02). The survival rate for this period is 82.3 percent (see Figure 1). Improvements in ejection seat technology have improved the survival rate to over 91 percent and reduced injuries during the ejection sequence.
