Flying Safety

HEADQUARTERS UNITED STATES AIR FORCE • RESTRICTED

AUGUST 1948

Volume 4 No. 8

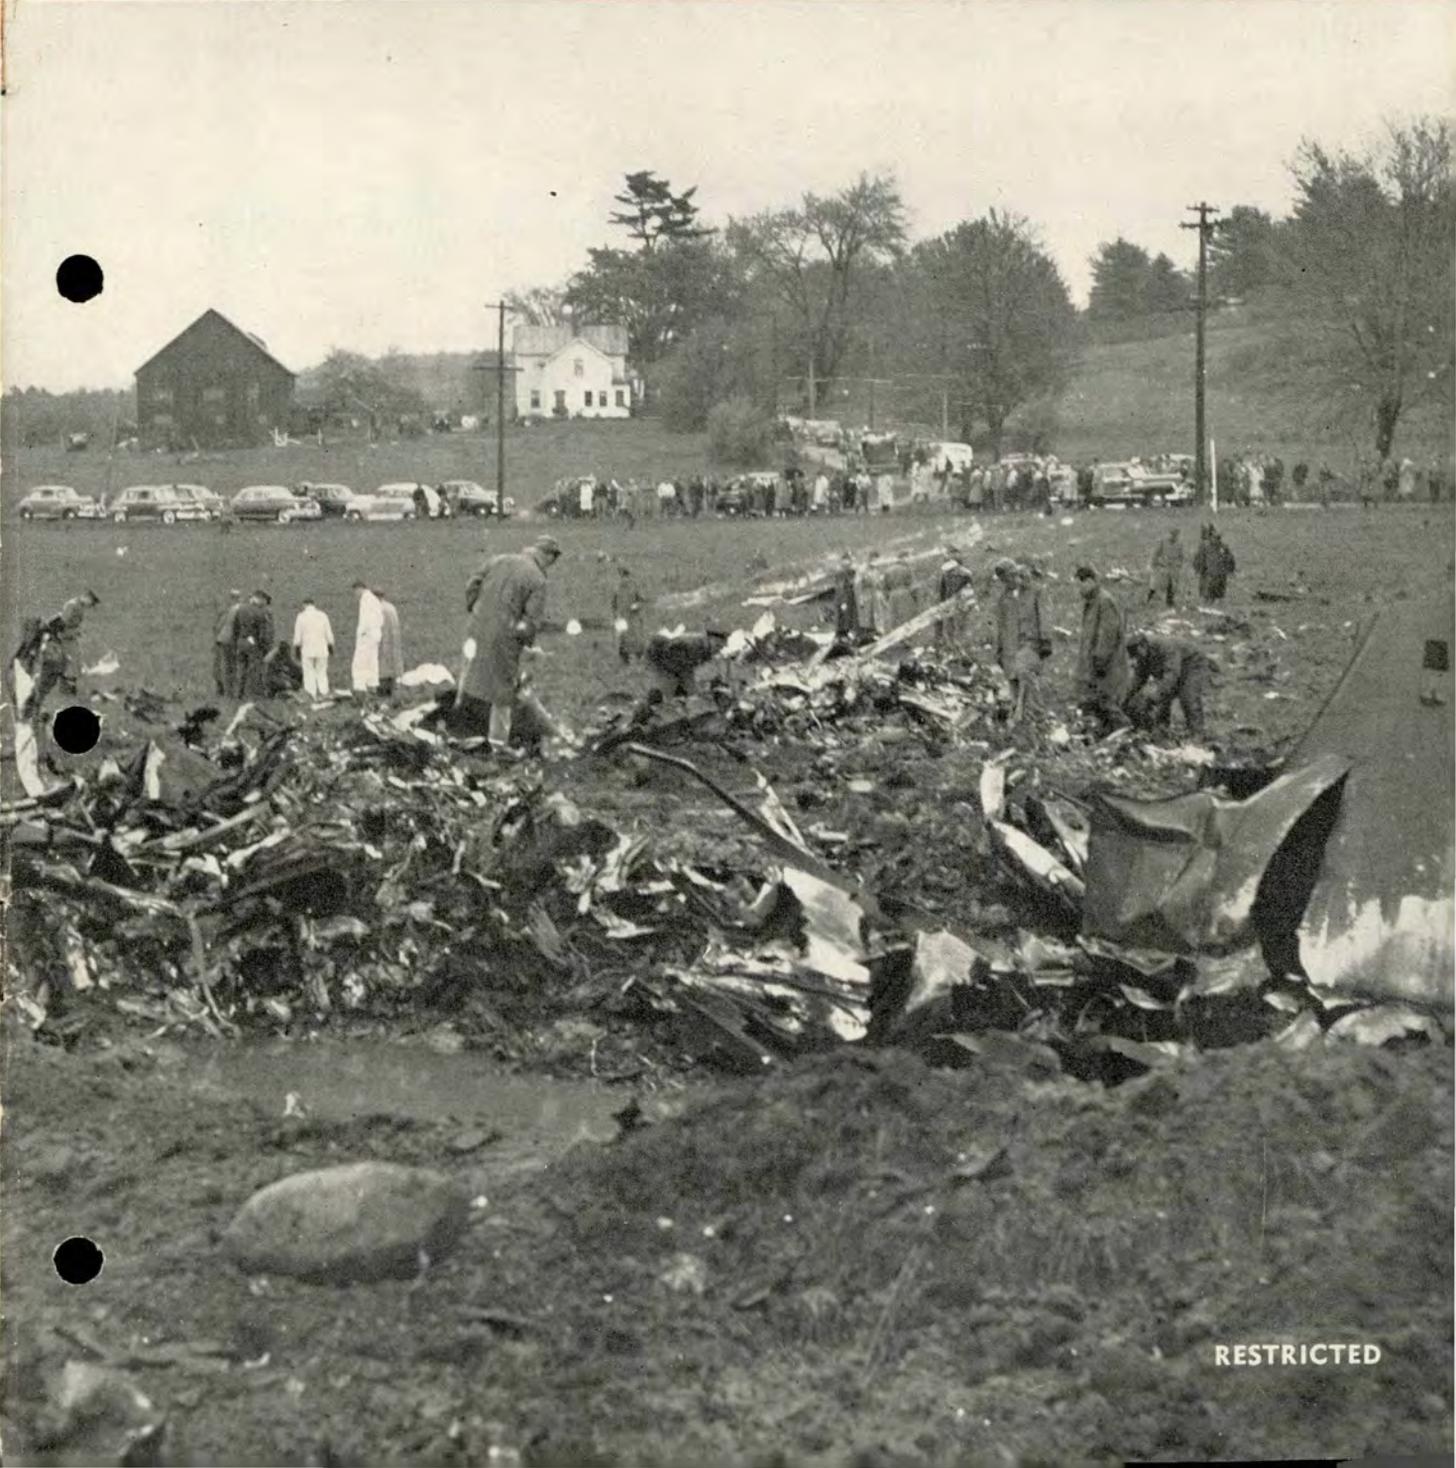
A C-54 with an instructor pilot, pilot, and crew chief was cleared IFR for a local flight during which the pilot was to receive a base instrument check. When the assigned altitude was reached, the pilot reported his position to approach control. This was the last radio contact. Later, witnesses saw the plane dive through a low overcast into the ground at an angle greater than 80°. The plane exploded upon impact and fire followed. The three persons aboard were killed.

Due to the complete wreckage of the plane, it was impossible to determine the cause of the accident. It was recommended that the following portions of instrument practice or check flight be restricted to VFR conditions: 1. Maneuvers that require the caging of gyro instruments. 2. Simulated emergencies such as engine failure. 3. Turns steeper than standard rate. 4. Usual attitudes, slow flight or approach to stalls.

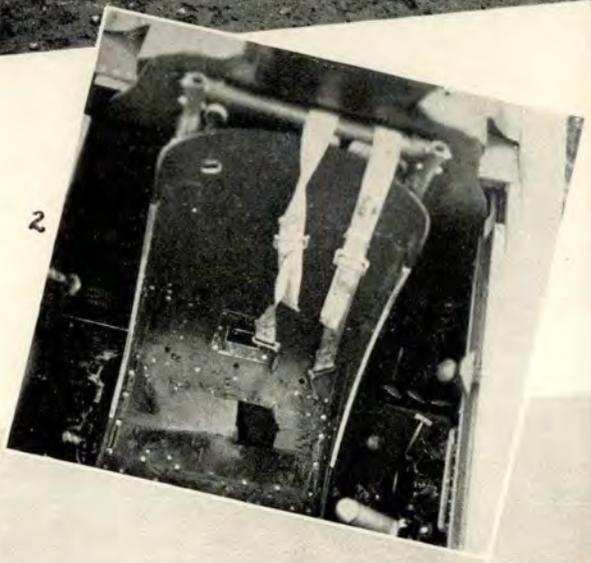
2

(2) This picture of the pilot's seat indicates the failure of the seat caused by impact of crash landing of the P-47. It wasn't the direct cause of the accident but is related to it and should be included for possible safety study and recommendation.

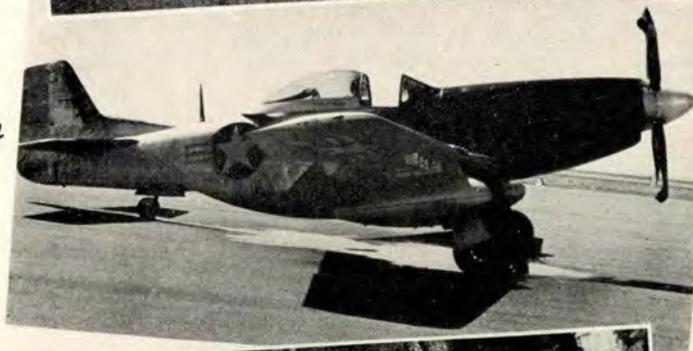
(4 & 5) Picture No. 4 shows why the pilot ground-looped on landing—note oil covering the fuselage and windshield. Also included is a photograph showing the failure of the dual drive and reduction gear housing in the P-51 engine which resulted in the oil leak.

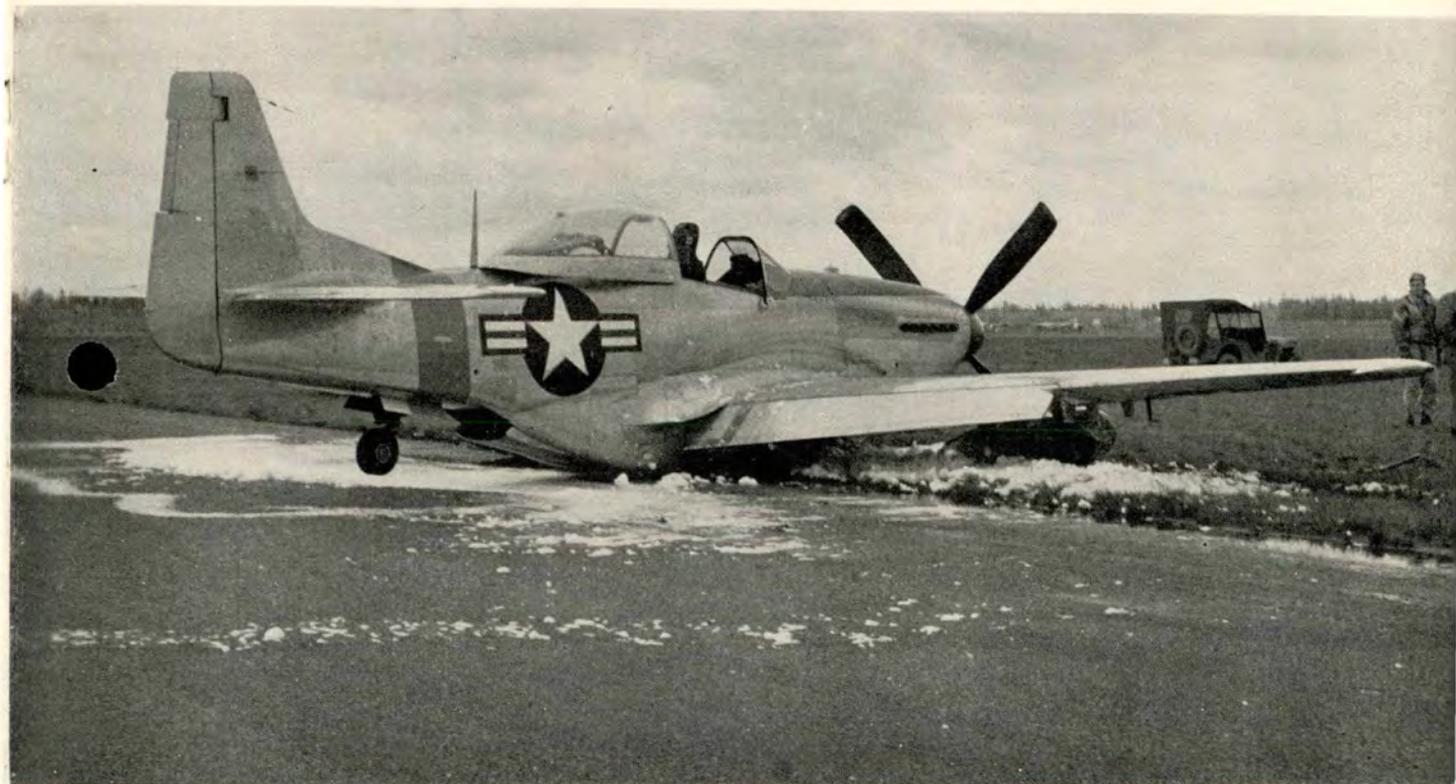
WHILE TURNING on the final approach, the pilot of this F-51D lowered wheels and full flaps. Airspeed dropped off to 145 mph indicated. Just prior to touchdown, the red landing gear warning light indicated momentarily that the gear was not down and locked. The pilot proceeded to land—wheels up. He stated that he thought his wheels were down and locked since the red warning light had gone out, but later remembered adding throttle just before his roundout. He stated that he didn't remember seeing the green light. Advancing the throttle beyond 20" HG normally will cause the red light to go out. Subsequent investigation led to the conclusion that the pilot had not placed the gear in the full down position. The P-51 received major damage. WHY?
