FLYING SAFETY

Volume 5 No. 2

February 1949

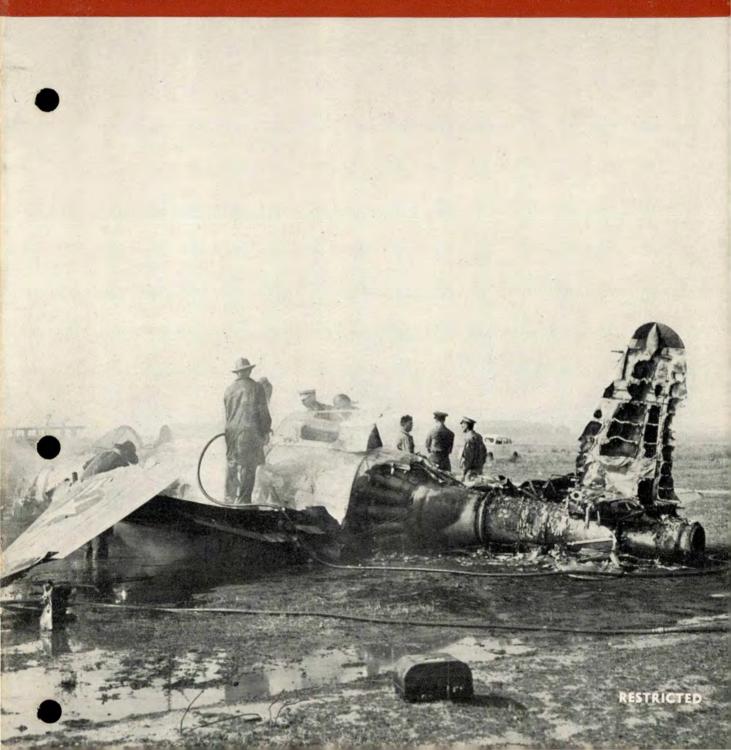
THE COVER PICTURE

Even with a visibility restriction of $1\frac{1}{2}$ to 2 miles in haze, the pilot of the burned F-80 on the cover flew a larger pattern than usual. He reduced power to about 50% rpm on peel-off and when he saw he was undershooting the runway on final it was too late to develop enough thrust going from 50% to 100% power. Consequently, the F-80 stalled and hit 2,000 feet short of the runway. The pilot escaped with minor injuries.

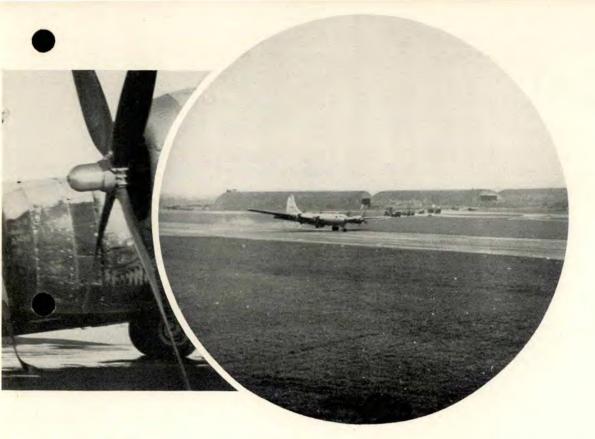
down. The nose gear and left landing gear were not down and locked at this time, but just prior to touchdown the safe to land light came on for the *left* gear. There was also a strong odor of electrical fire in the cockpit.

Now to get to the causes of all his troubles. The Form 1A had carried a write-up two months previous saying: "left gear fails to retract all the way." A successful retraction test was made a few days later. However, two subsequent flights were made with the same write-up as before. During the 24 days prior to this accident, repeated entries indicating malfunction of the landing gear system had been entered in the AF Form 1A.

In this case, it took the failure of the No. 4 engine (internal failure and nose reduction gear failure), a solenoid relay failing in the left landing gear, and nosewheel retracting motor burning up to really mess up the situation. But often it doesn't take anything more than the initial failure to follow up a report on the Form 1A to cause serious damage and fatalities. Failure to follow through on a Form 1A write-up is a short cut to disaster.

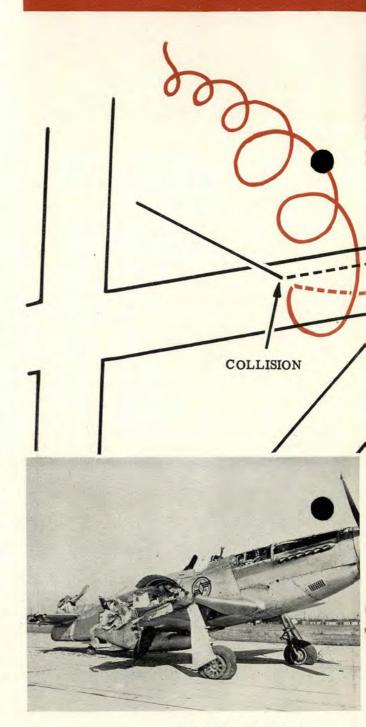
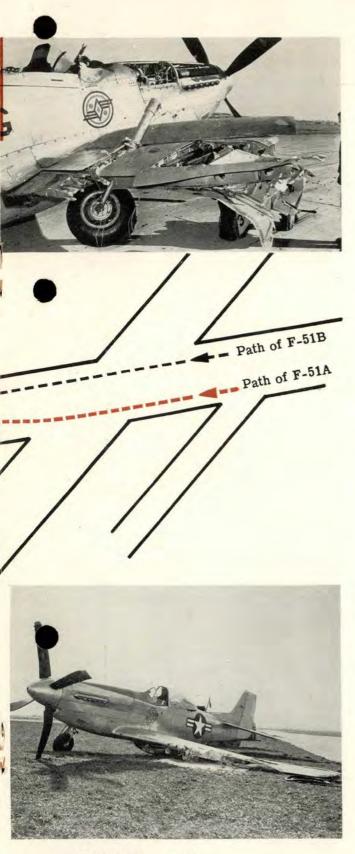
RUNAWAY MUSTANG

tang but its erratic orbits at about 20 to 30 mph precluded the possibility of anyone's getting into the cockpit. The F-51 continued wheeling for approximately 20 minutes during which a State Trooper had the area cleared of personnel and began to shoot at the tires of the plane. He fired five rounds from a .38 caliber service revolver and six rounds from a 12-gage shotgun before he was successful in deflating both tires and slowing the plane down. Then personnel climbed onto the aircraft and cut power and switches.

Tracking back to the reason for collision, it was found that close formation takeoffs were not permitted at this field because of the narrow (100 feet) runways. In formations a minimum interval of 10 seconds was to be maintained for takeoff of individual airplanes. The wingman was unable to see the lead plane at any time before the collision because of the proximity of the two aircraft on the narrow runway. Also, the flight leader, for some reason, didn't use full power for takeoff and allowed his plane to drift to the right side of the runway which his wingman was using.

Local regulations at this base are being revised so that aircraft without two-way radios will not be permitted to take off. Planes at this base will not be cleared for formation takeoffs, but each will be held by the tower until the preceding aircraft has cleared the runway. It was also recommended that crash helmets be provided and worn by all pilots flying fighters.

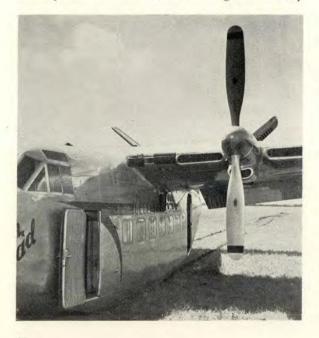
The keel tracks plainly show that the bottom of the airplane itself did not touch the ground at any

time, although the soil was extremely soft due to recent rains and was incapable of supporting an automobile.

The bottoms of the keels are covered with stainless steel and project three inches below the bottom of the airplane. Their unit pressure on the soil is slightly greater than the pressure on the sole of the shoe of a heavy man.

The Twin-Quad's belly keels were designed as a safety feature so that a pilot in trouble could land on almost any flat surface without significant damage to the airplane. The short landing run of 615 feet on wet, soft ground at an airport with a density altitude of 3,000 feet at the time of landing indicates that the keels met their safety design requirements.

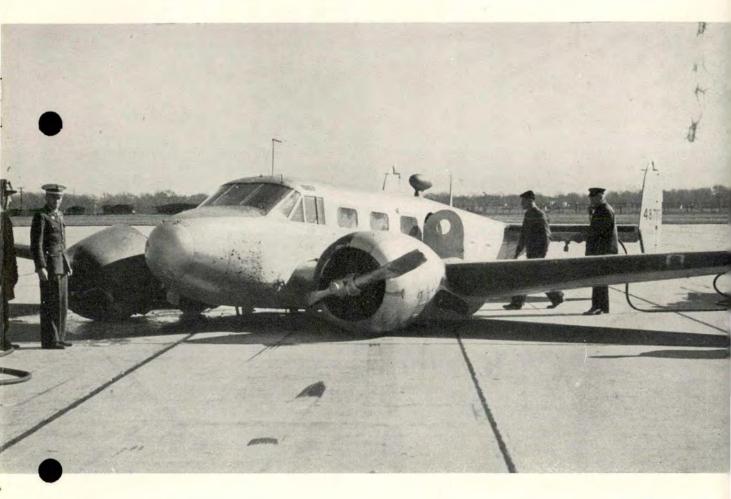
THE PILOT OF THIS C-45 was cleared to make a GCA approach while flying under the hood. His copilot was acting as safety observer.

While making the approach as directed by GCA, the pilot was advised by the final controller that he was below the glide path approximately $1\frac{1}{2}$ miles from touchdown. The pilot made corrections; the C-45 came over the fence and hit the ground approximately 40 feet beyond the fence and 900 feet short of the runway.
