A E R O S P A C E

SAFETY

UNITED STATES AIR FORCE

SEPTEMBER 1965

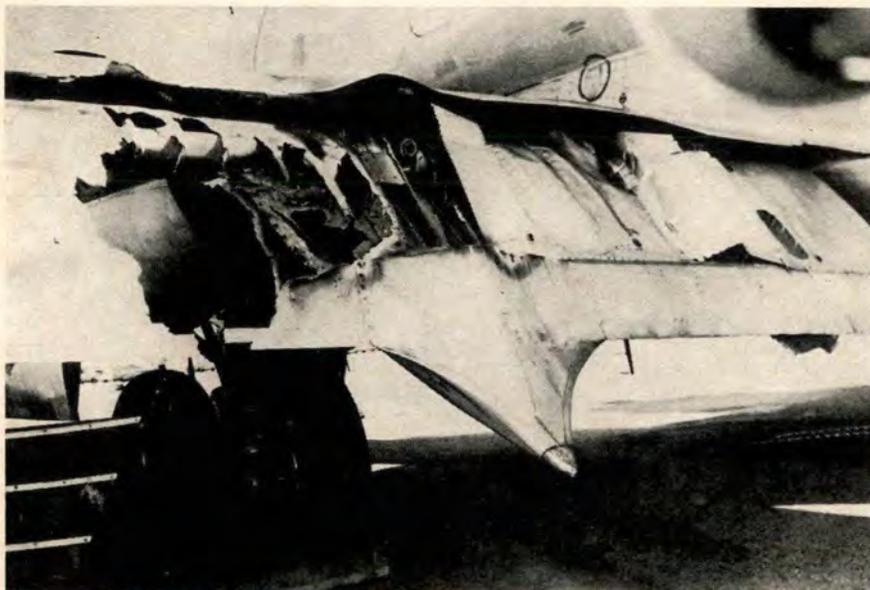
Another case, last August, involved a C-97 which caught fire as the result of a lightning strike. The aircraft was cruising at 17,000 feet over the Rockies when the strike occurred. There was an explosion, and flames appeared near the Nr 2 engine. The engine was shut down but the fire, fed by a leaking fuel line, was extinguished only by diving the aircraft at maximum allowable speed. Although the left flap was nearly destroyed by fire, a suc-

Lightning started Nr 2 engine fire that endangered this C-97 while cruising at 17,000 feet. Increased airflow, during dive, finally extinguished flames that caused great damage to left flap.

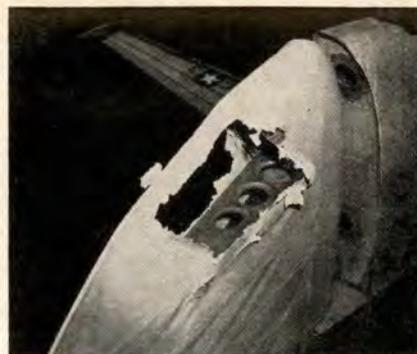
Note damaged rudder of C-124. Aircraft was struck while flying below 10,000 feet.

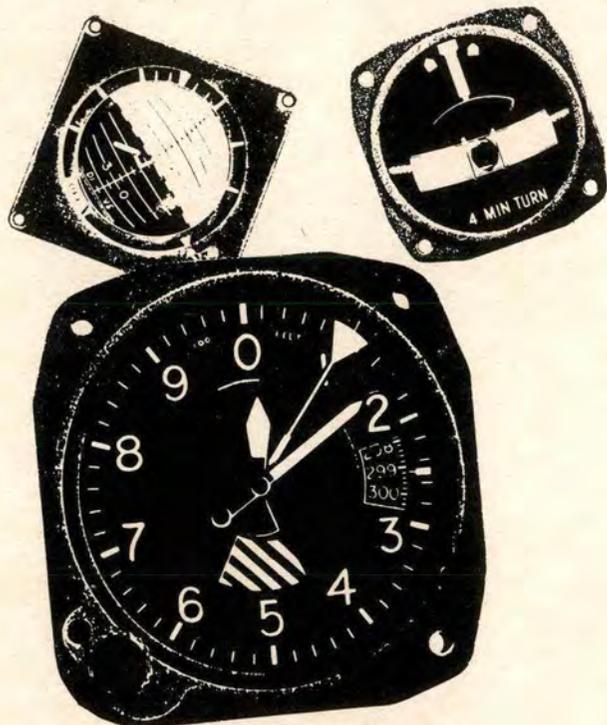
LOOSE PARTS IN CASE

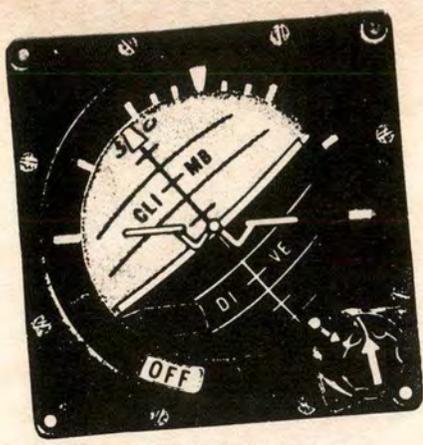
PITCH OSCILLATIONS

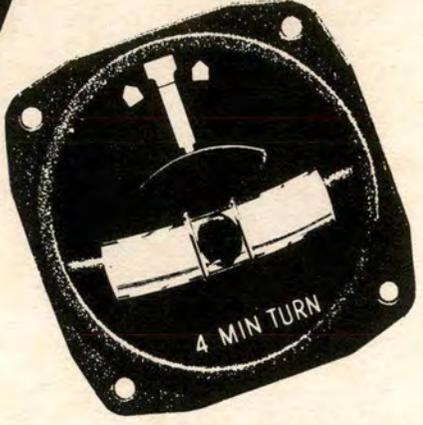
FAILED BENCH CHECK

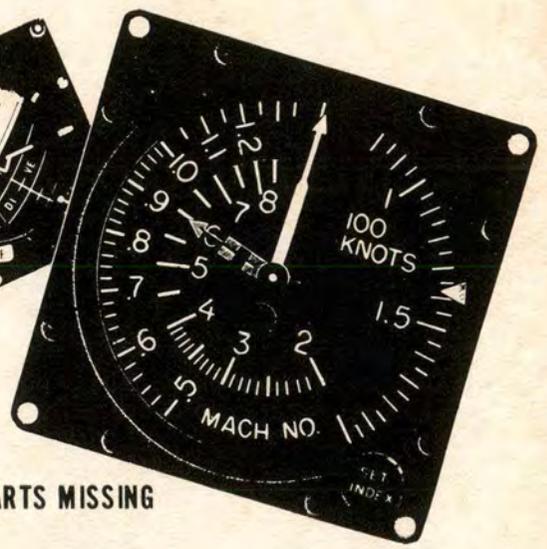
PARTS MISSING

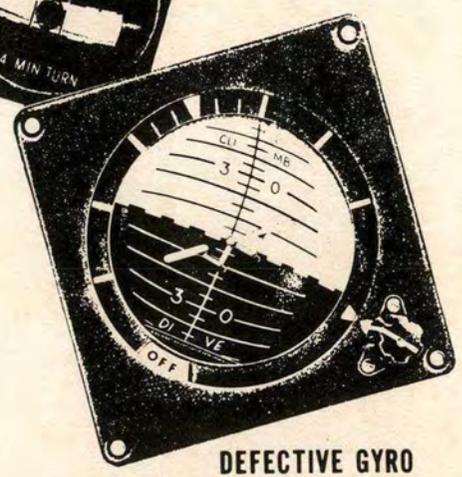
DEFECTIVE GYRO

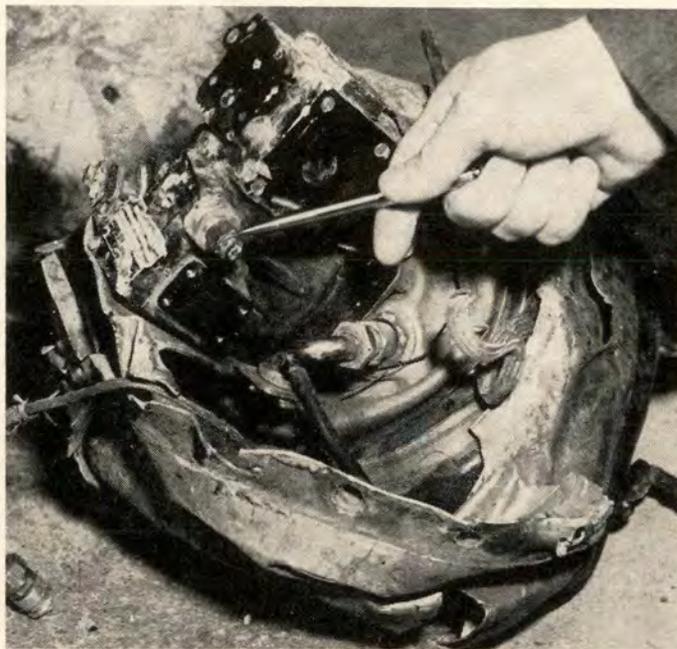
Get-home-itis and impatience, finally a do-it-yourself mod job to get engine started ended pilot's career. Investigator points to jerry-rigging repair job.

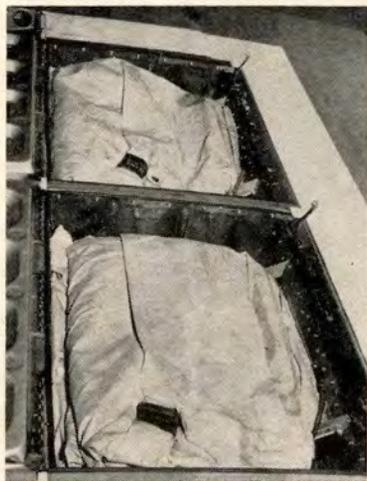
How about the CO₂ cylinder? Three reports were received in 1964 informing us of partial raft inflations during landing, taxi and takeoff. Entrapped gas does not expand at sea level. The aircraft on which these incidents occurred had flown several missions since installation of rafts, another fact which rules out gas entrapment. After receiving these reports, altitude tests were conducted on both makes of cylinder-valve assemblies in an attempt to find a leak path. Although neither assembly malfunctioned during the course of the test, a detailed inspection of one make of valve revealed possible leak paths through and around the poppet. Some slight grooving of the rubber could be seen. Continued high altitude use would, without doubt, increase this grooving until the poppet would not seat and a leak would develop. In addition, minute metal chips were discovered on the valve seat, compounding the grooving problem. To overcome this problem we suggest inspecting the cylinders and valve assemblies more often, and more thoroughly. There should be a maximum of three years between detailed valve inspections. Cylinder weight checks, discharge cable length checks and valve cam safety wire integrity inspections must be accomplished frequently. In our opinion, the existing collapsible cable housing should

Rafts installed in wing trailing edge compartment. Unvented gas pressures can build up enough to cause door to pop open, loss of raft.

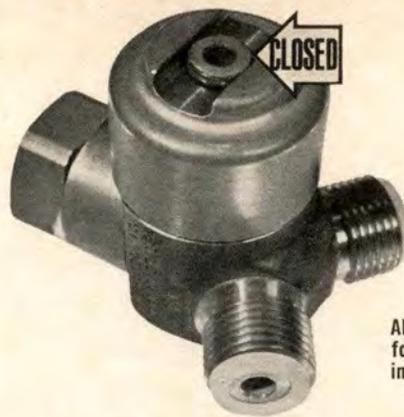
Above, modified vent manifold (life raft compartment) in closed venting position.

The manifold utilizes an O-ring detent to hold the vent plunger open. Unless the installing document is carefully studied, and the internal configuration of the vent understood, it is impossible to externally determine if the vent is open or closed. Try it, hand someone a vent manifold and the part number 717 tool. Chances are that the person will pull the plunger out and announce that he has it in the venting position which, of course, is wrong. To overcome this problem, we modified the unit used on our test article. The change consisted of machining a slot three eighths of an inch wide and a tenth of an inch deep in the removable cap of the manifold. The exposed portion of the vent plunger was painted insignia red around the periphery. This provides an exposed red warning when the vent is closed and, when properly open, the technician sees only the flush, brass end of the plunger (note illustration). This is a cheap, effective change that can easily be accomplished on all your units.

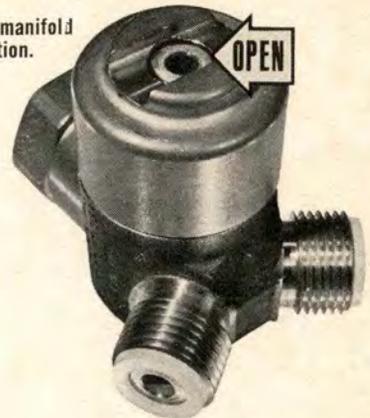
Right, modified vent manifold in open venting position.
