A E R O S P A C E

SAFETY

AUGUST 1966

AFRP 62-1 VOLUME 22 NUMBER 8

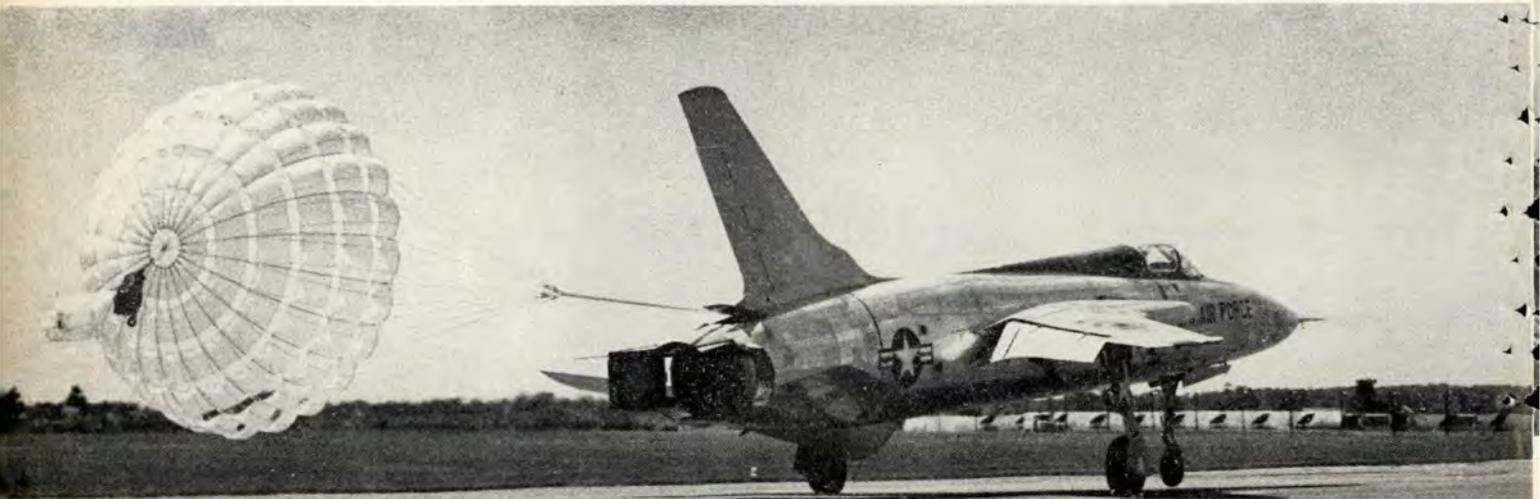
Successful landing with drag chute doing its job. When it doesn't, the pilot may face the barrier, or a trip off the end.

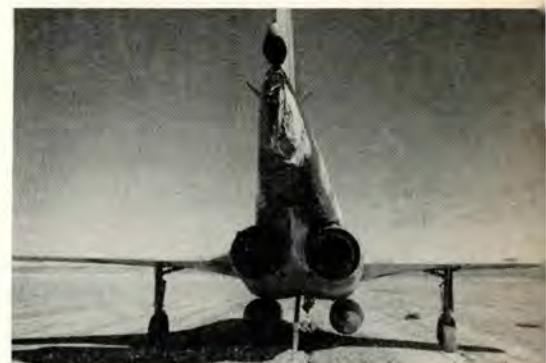
What happens when a drag chute fails? This F-101 missed the barrier, went off the end during test at Edwards. Not many bases have lake beds for overrun.

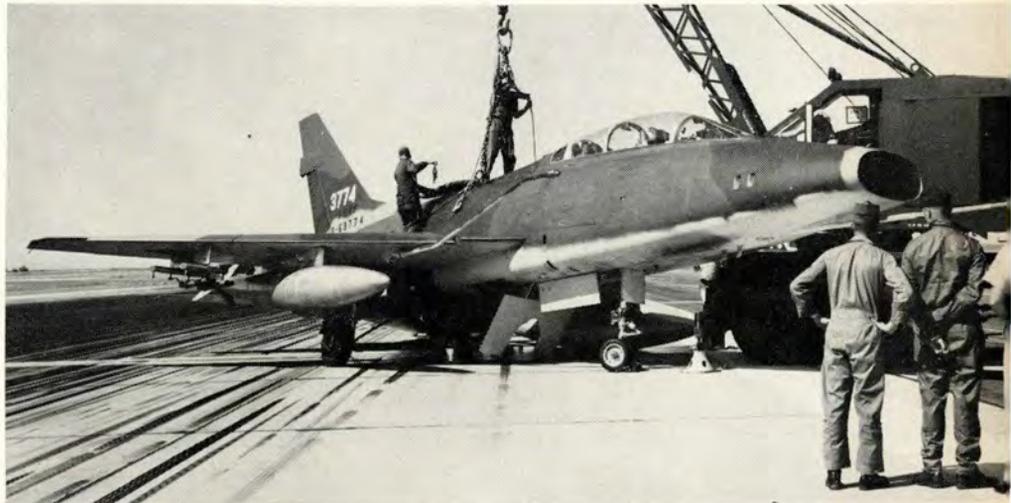
Right, cushions and an airbag under the left wing prevent further damage to aircraft. →

as cushions and prevented the left wing tip and speed brakes from touching the ground. The aircraft was raised with a crane, left gear extended, safetied, and towed off the runway. The cause was determined to be a missing bolt.

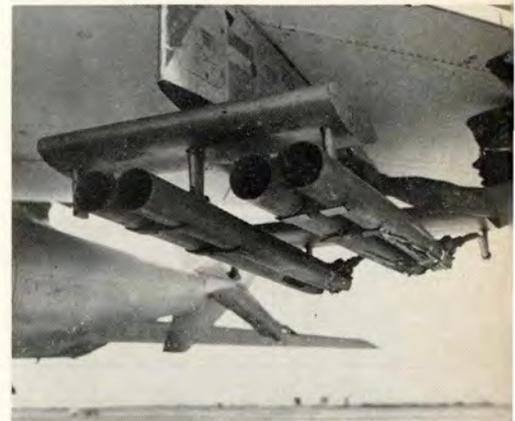
Above picture shows amount of angle off from center of runway. The maintenance people first hooked onto the aircraft very carefully in order to lift it high enough to get a jack under the left wing. Most of this turning took place just prior to aircraft's coming to complete stop after the wing dropped to the ground. Right, close-up of the MA-2 launcher rail shows the small amount of damage to the outboard tubes. →

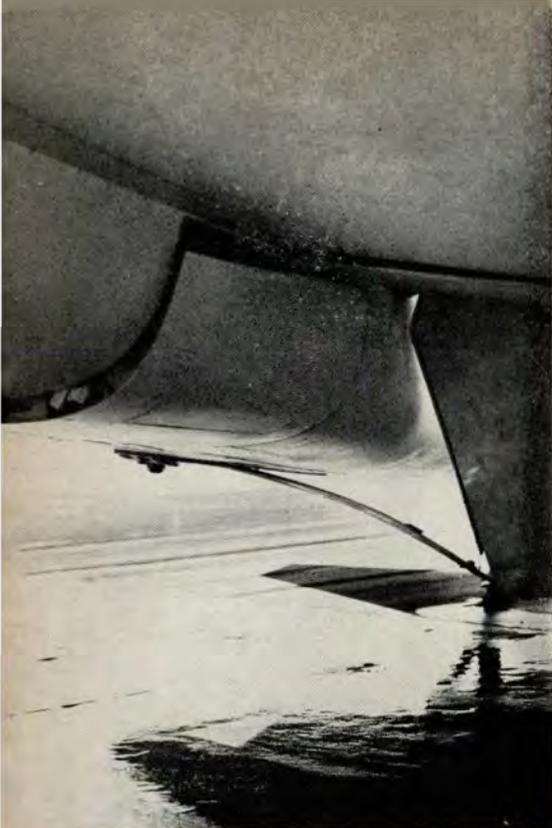
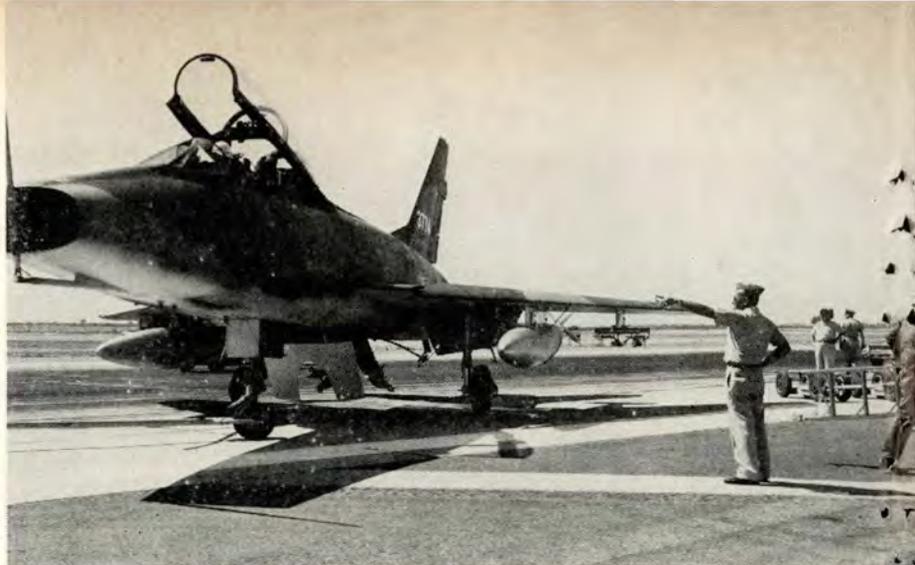
▲ Reclamation officer directs aircraft be towed off the runway approximately 45 minutes after the landing. Estimated repair time was 20 direct manhours. The left tank had to be replaced, the left rocket launcher replaced, and a small amount of sheet metal repair to the tail hookup locking bracket fitting area.

◆ Photo of the left wing shows position of the gear as it was in flight. Note the left flap is full down and unscathed. Fluid on the ground is water from the fire trucks that washed away fuel to prevent fire hazard.

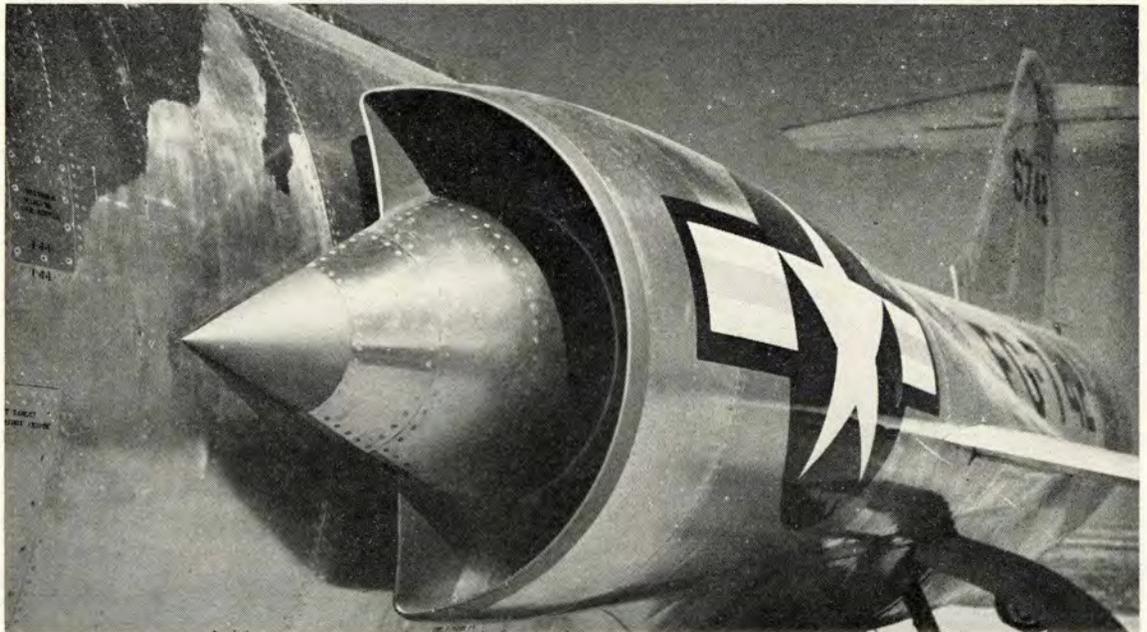
Distortion of pressure profile at engine inlet from FOD, extreme maneuvers may cause engine to stall.

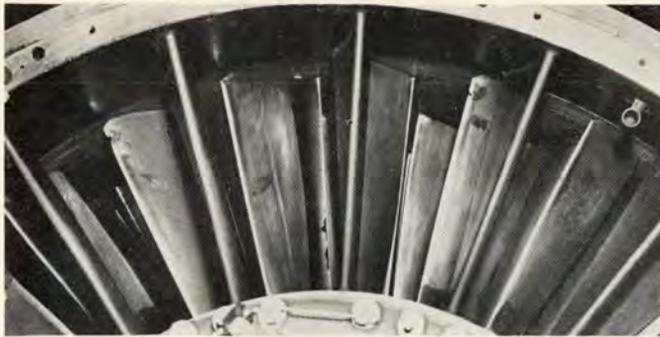
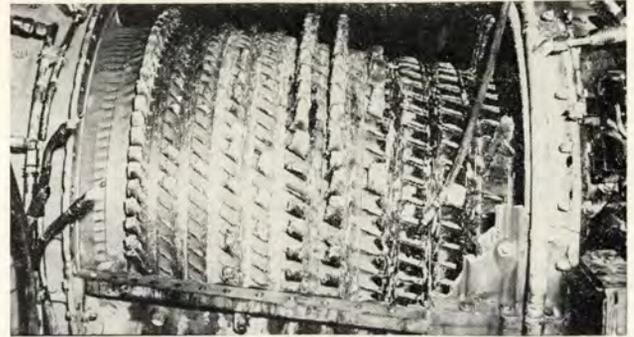
FOD is often the villain causing engine to stall.
