UNITED STATES AIR FORCE

January/February 2002

2001 MISHAP REVIEW

FLYING *Safety*

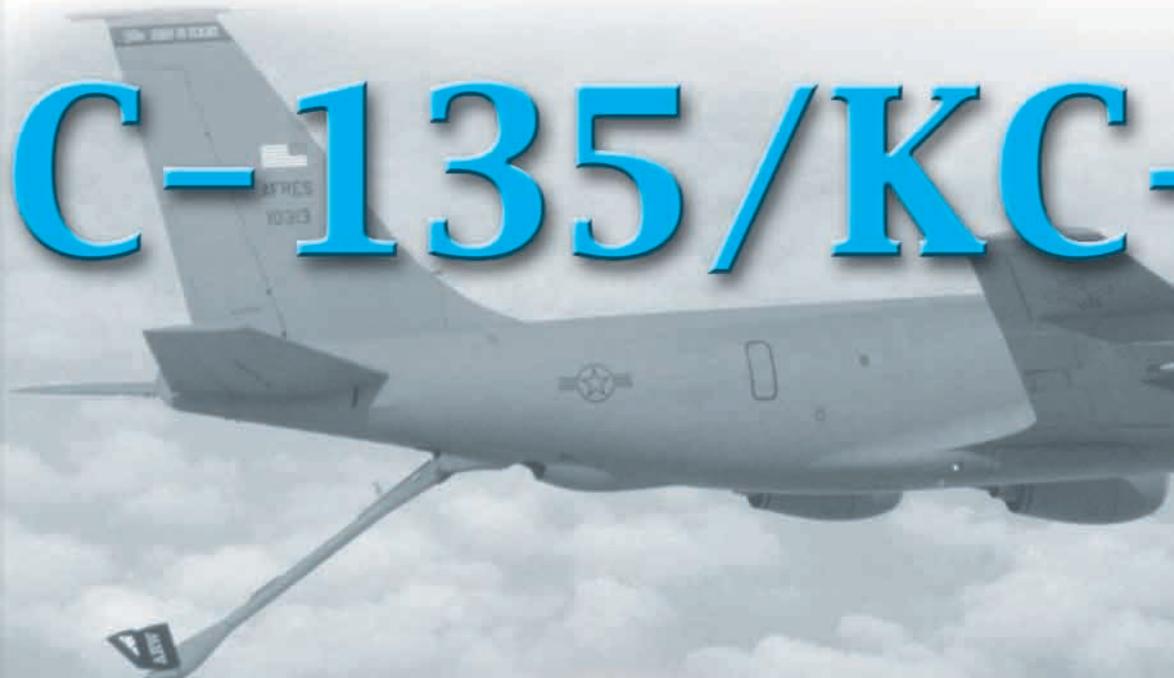
The sine wave broke off the receiver's refueling probe and caused failure of the drogue basket coupling.

- During a Tornado air refueling using the Multi-Point Refueling System, slack developed in the refueling hose. The reel system didn't take it up in a timely manner and a sine wave developed. The sine wave broke off the receiver's refueling probe and caused failure of the drogue basket coupling,

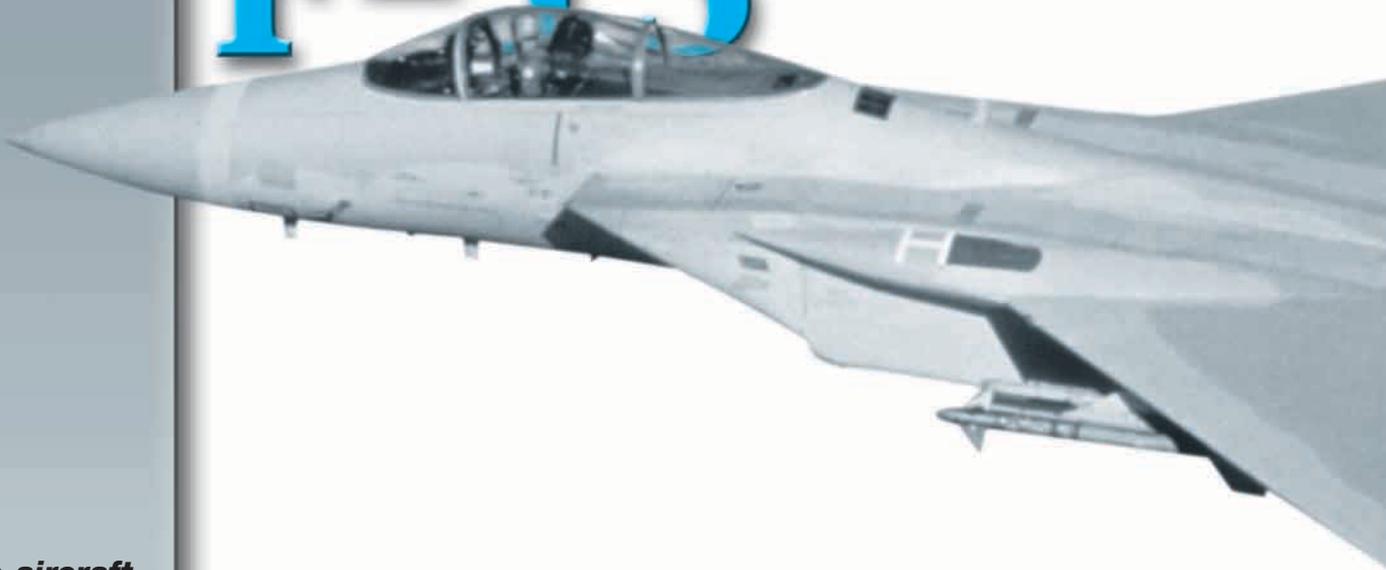
**The aircraft
impacted
17 ducks
at an alti-
tude of 650
feet AGL
and a
speed of
450 knots.**

Mishap 2: An F-15E based at Seymour Johnson AFB was conducting a night, local, Surface Attack Training (SAT-3) mission. The aircraft impacted 17 Lesser Scaup (basically ducks averaging 1.75 lbs. each) at an altitude of 650 feet AGL

and a speed of 450 knots. The right hand engine catastrophically failed and caught fire. The left engine was damaged, as were the right conformal tank, left ramp, navigation pod, targeting pod, left side of the canopy bow and panels 47L and 155L. The crew managed to fly the aircraft back to Seymour Johnson using the damaged left engine, while the right engine continued to burn. The aircraft landed safely and neither crewmember sustained injuries.

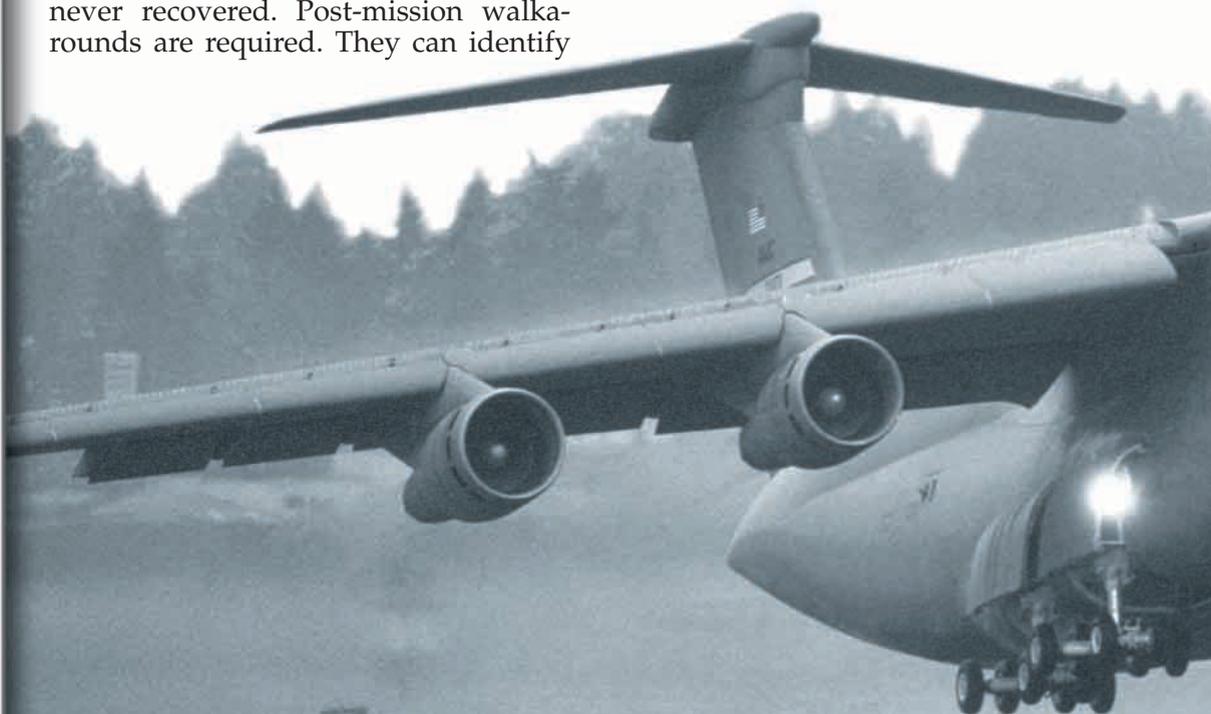
- Another NLG problem led to the only strategic airlift Class A of the year. On take-off roll, the nose gear strut failed explosively, causing collateral damage to the aircraft outside of the nose wheel well. The crew rejected the takeoff and the aircraft came to rest on

the runway with the nose riding on the NLG outer cylinder strut.

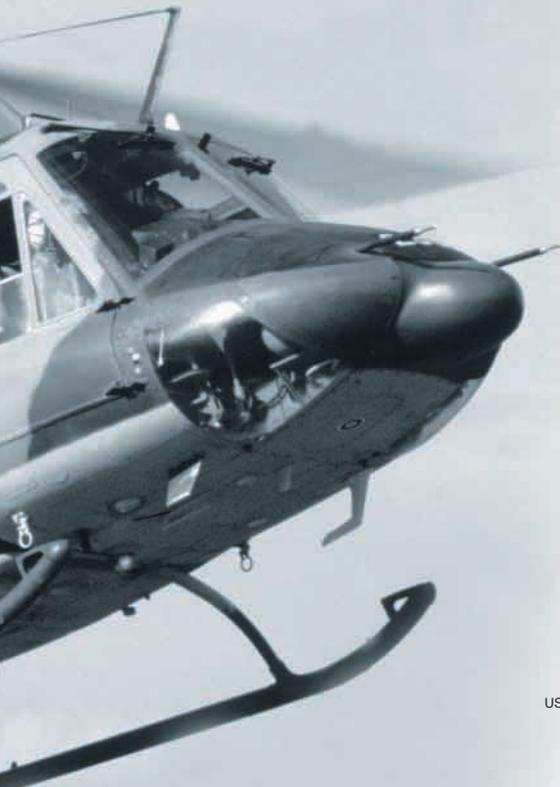
The mishap flight engineer (MFE) was accomplishing a routine preflight inspection on top of the helicopter. Weather at the time of the mishap was light snow mixed with rain. While stepping from the forward hydraulic cowl-ing area to right engine intake area, the MFE's feet slipped, causing him to fall

to the ground. He broke a wrist in several places and was unable to fly for almost three months.

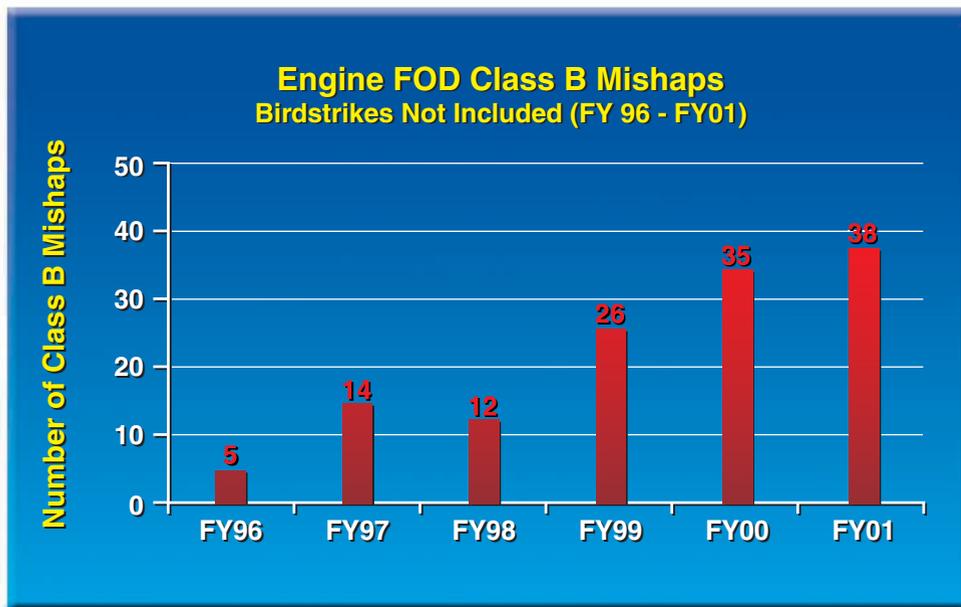
Figure 5

If you need more proof that FOD prevention needs your attention and involvement, take a look at Figure 5. It shows that engine FOD mishaps in the Class B range—repair costs totaling more than \$200,000 but less than \$1 million—have been steadily increasing. While there were five engine FOD mishaps in the Class B Mishap category in FY96, there were 38 in FY01—an increase of more than 700 percent!

The ground observer realized the end of his ground cord had detached from the aircraft and was in the engine inlet.
