# FLYING

November 2001

## F-15 Class A Ground Mishap: An AIB Report Synopsis

## **A-10 Class A Flight Mishap: An AIB Report Synopsis**

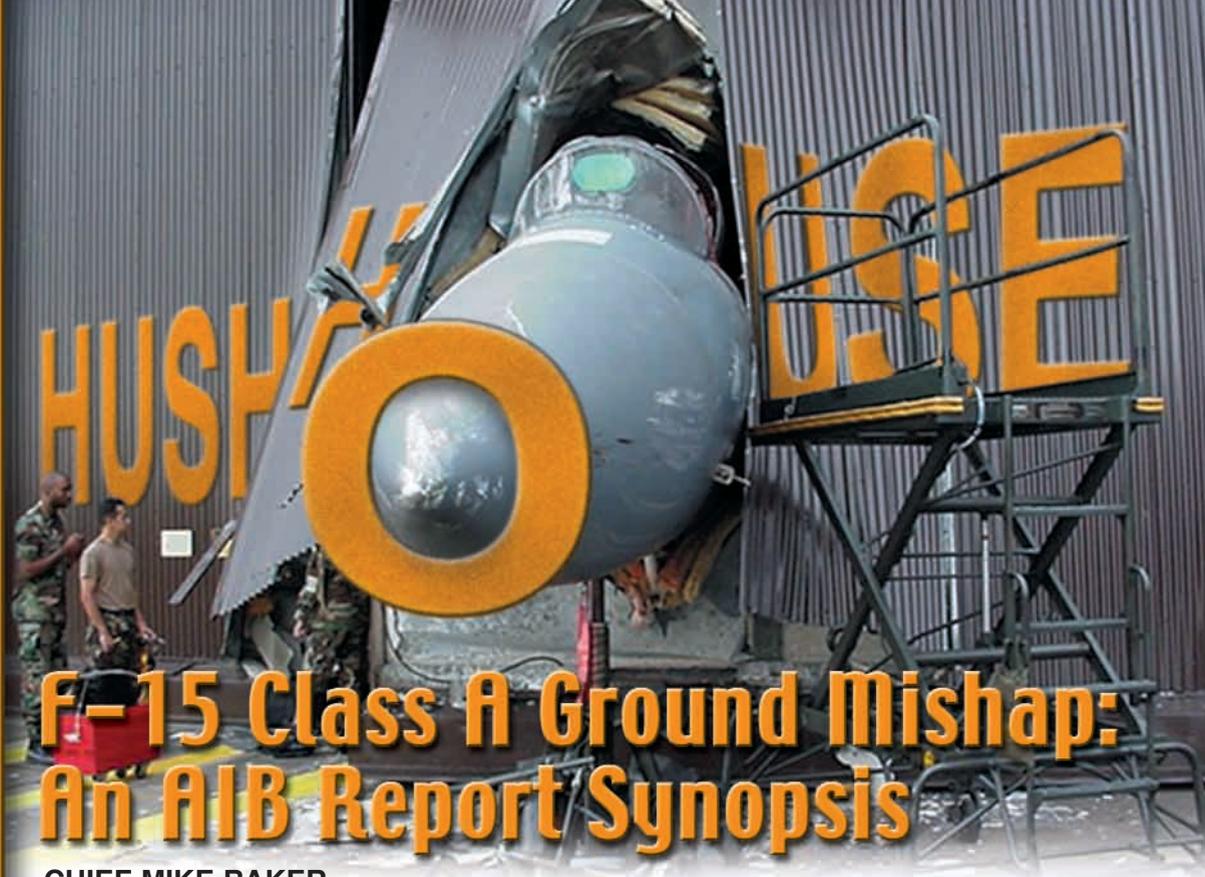
**The aircraft was towed with munitions loaded and the aircraft arresting hook was in the slung position.**

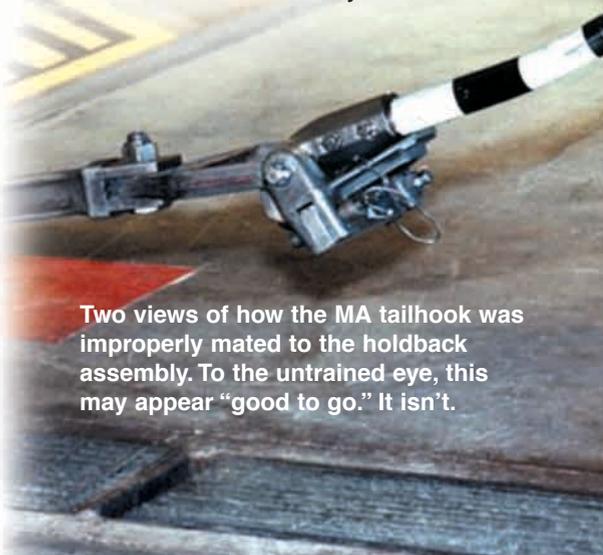
Two views of how the MA tailhook was improperly mated to the holdback assembly. To the untrained eye, this may appear "good to go." It isn't.

Compare these two views of a properly mated tailhook and holdback assembly to the improperly mated examples below.

**The accident was caused by failure to properly connect the holdback assembly to the aircraft arresting hook. There were five factors that substantially contributed to this accident.**

- Second, the holdback assembly and arresting hook each had distinctive scars consistent with improper seating of the hook in the holdback assembly. These scars were clearly visible in close-up photos of the holdback assembly and arresting hook.

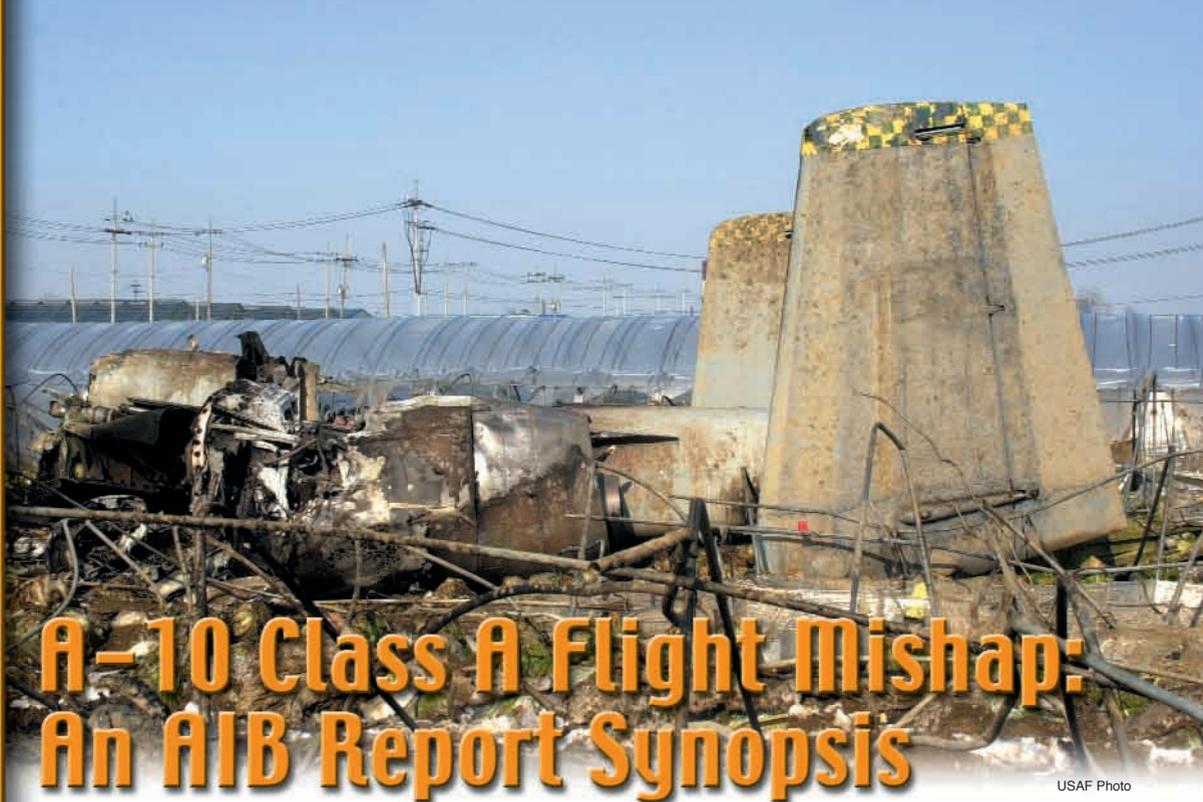
**An end-of-runway Maintainer noted oil/fluid dripping out of the cowling on the No. 2 engine.**

The MP parked the aircraft at the end-of-runway (EOR) for "Last Chance" inspection and arming. Upon visual inspection of the aircraft, an EOR Maintainer noted oil/fluid dripping out of the cowling on the No. 2 engine and asked the MP if oil pressure on the No. 2 engine was within limits. The MP acknowledged that it was and asked what the problem was. The EOR Maintainer explained the oil/fluid loss to the MP and began examining the leak for tolerances. The MP offered to make a radio call for Red Ball maintenance, but the EOR Maintainer declined the offer. He subsequently cleared the aircraft for flight. According to testimony, the EOR Maintainer believed the oil/fluid leak was deicing fluid. Post-mishap research revealed that the MA had been parked inside a HAS and had not been deiced the day of the mishap.

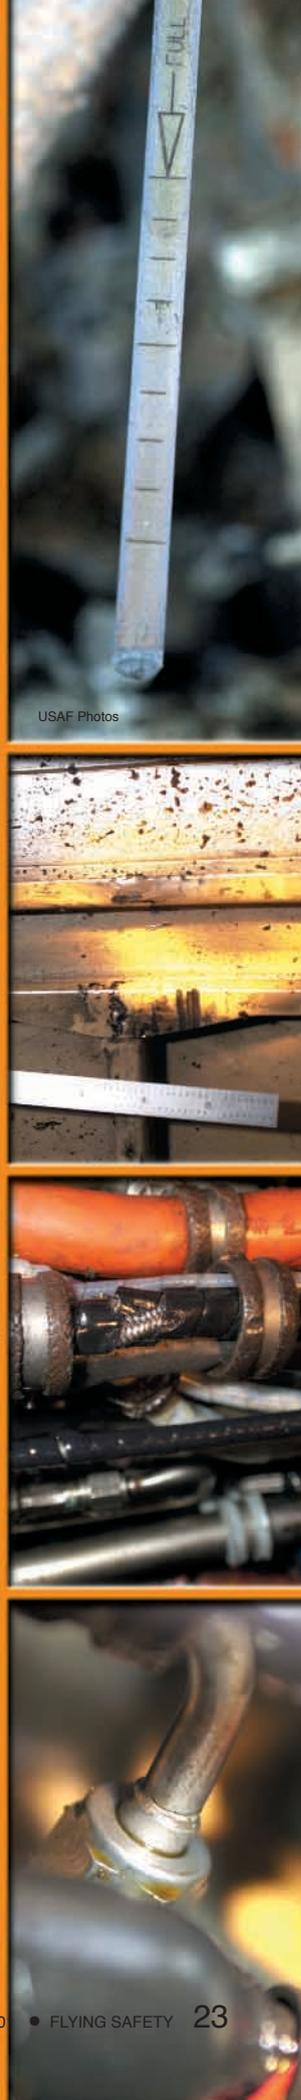
**The Mishap  
Maintainer  
did not  
clamp the  
oil pres-  
sure trans-  
mitter line  
IAW applic-  
able tech  
data.**

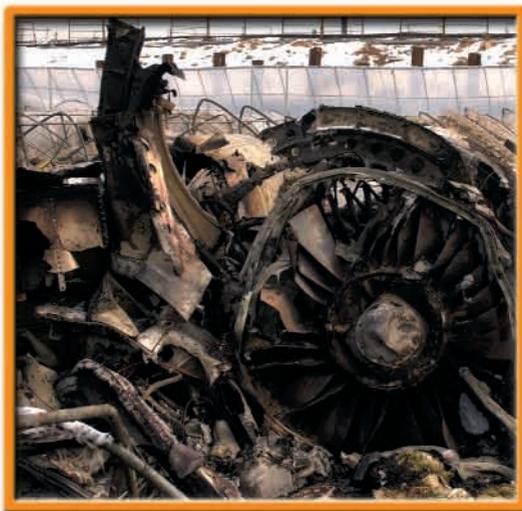
**The EOR Maintainer who found the No. 2 engine fluid leak misapplied allowable leak limits.**

Additionally, prior to the MA taking off on the mishap sortie (MS), the End-of-Runway (EOR) Maintainer performing "Last Chance" maintenance checks did not adequately assess a possible No. 2 engine oil/fluid leak. The EOR Maintainer did discover the leak prior to takeoff; however, he failed to ascertain with certainty the cause and severity of the leak. It was undetermined if this oil/fluid leak was in fact caused by the lube pump to oil pressure transmitter line crack. This flight was the MA's first sortie following oil pressure transmitter line replacement on the No. 2 engine. The failure of maintenance technicians to properly follow T.O. guidance was a significant contributing factor to this mishap.
