UNITED STATES AIR FORCE

# FLYING

DECEMBER 1999

*Safety*

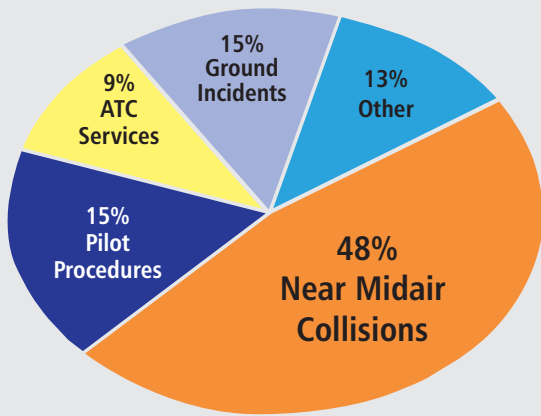
**FY99 Reportable Incidents**

This article breaks down the FY99 reportable incidents (figure 1), trends, HATRs by location (figure 2) and MAJCOM (figure 3), and recent and upcoming changes to the HATR Program.

There were 131 HATRs filed from 1 Oct 98 through 30 Sep 99. Near Midair Collisions (NMAC) represented approximately 48 percent of the reportable incidents. These incidents most commonly involved:
