# Aug 2001 M A G A Z I N E

## UNITED STATES AIR FORCE M A G A Z I N E

- 4 Running an Effective FOD Prevention Program
  Another success story: How Sheppard AFB is winning its
  war on FOD
- 8 Close Call: An Aircraft Maintenance Human Factors
  Tale
  Think what you do is inconsequential? Think again
- 10 Augmentor No-light Troubleshooting on the F100-PW-220/220E

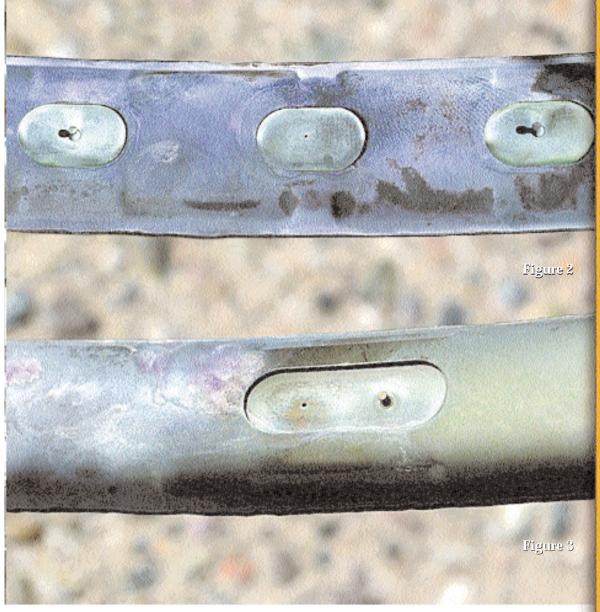
•The -100/200 engine has a single augmentor ignitor, hence its spray ring has a single, non-pintled ignitor orifice located at the 4:30 position. See **Figure 2**.

Remember: The -100/200 spray ring has a single, non-pintled hole at the 4:30 position. The -220/220E spray ring has a single, non-pintled hole at the 4:30 position, along with a non-pintled orifice and a pintled orifice, side-by-side, at the 7:30 position. Except for the differences noted above—and spray ring part numbers—

The most easily identifiable difference between the -100/200 spray ring and the -220/220E spray ring is the number of ignitor orifices—the holes upstream of the ignitors—that initially supply ignition fuel to the augmentor. The ignitor orifices can be identified by the absence of pintles in the fuel holes. These non-pintled holes ensure fuel delivery for proper augmentor ignition. Reference Figure 1 to see orientation of the spray ring in the engine.

If you suspect a mismatch in the spray ring and engine application, then verify the part number, which is found on the spray ring feed tube mounts (feed tube mounts are highlighted in Figure 1). Part numbers for the -100/200 spray rings are 4051866 or 4074478. Part numbers for the -220/220E spray rings are 4056925, 4074497 or 4085197.
