Aerospace

SAFETY

JULY 1970

FOR AIRCREWS, MAINTENANCE & SUPPORT TECHNICIANS

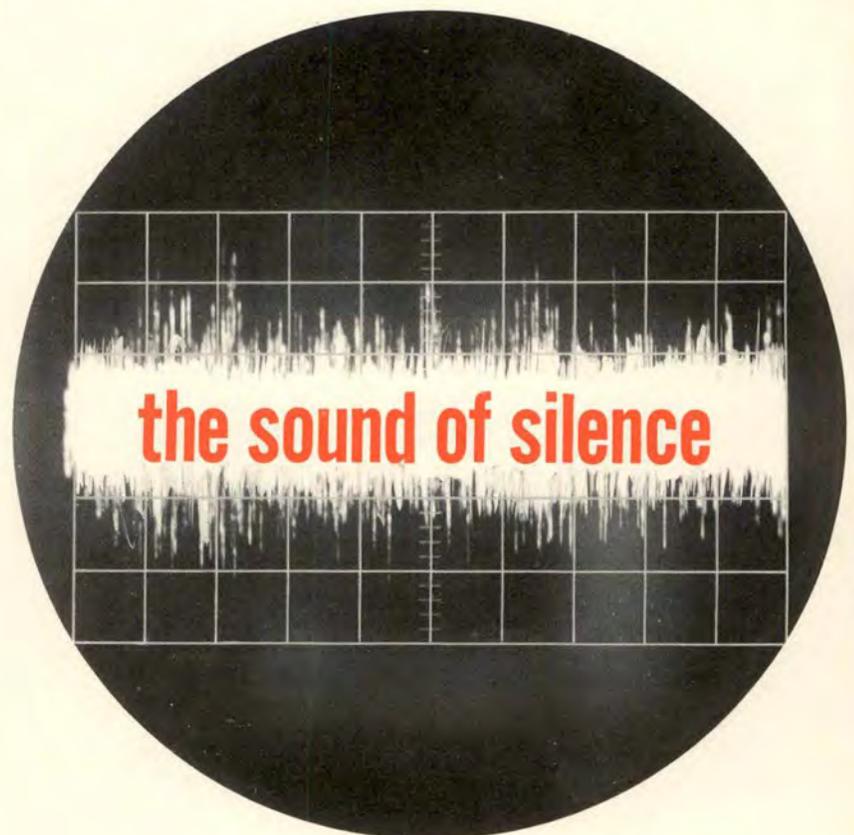
Boeing's Harvey Balderston listens in on bearing failure.

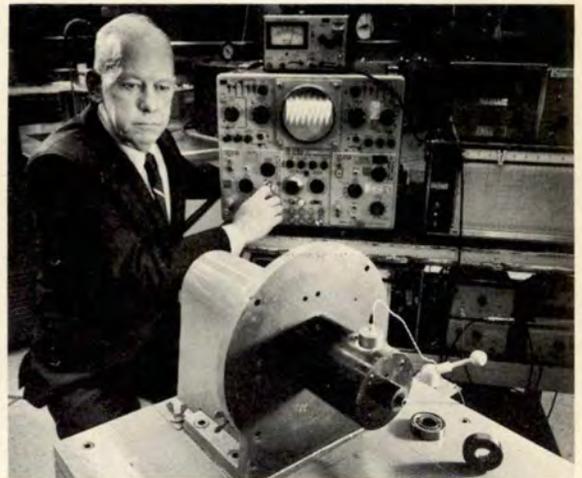
Bearing, wired for sound, sings a worried song.

Work now under way in Boeing's aerospace laboratories clearly indicates that tuning in on this cacophony of silence may be of tremendous benefit to both man and machine. The Boeing work is the brainchild of Harvey Balderston, a research specialist in Boeing's failure analysis laboratory. Balderston reasoned that it might be possible to hear tiny mechanical defects if some way could be found to screen out unwanted noise.

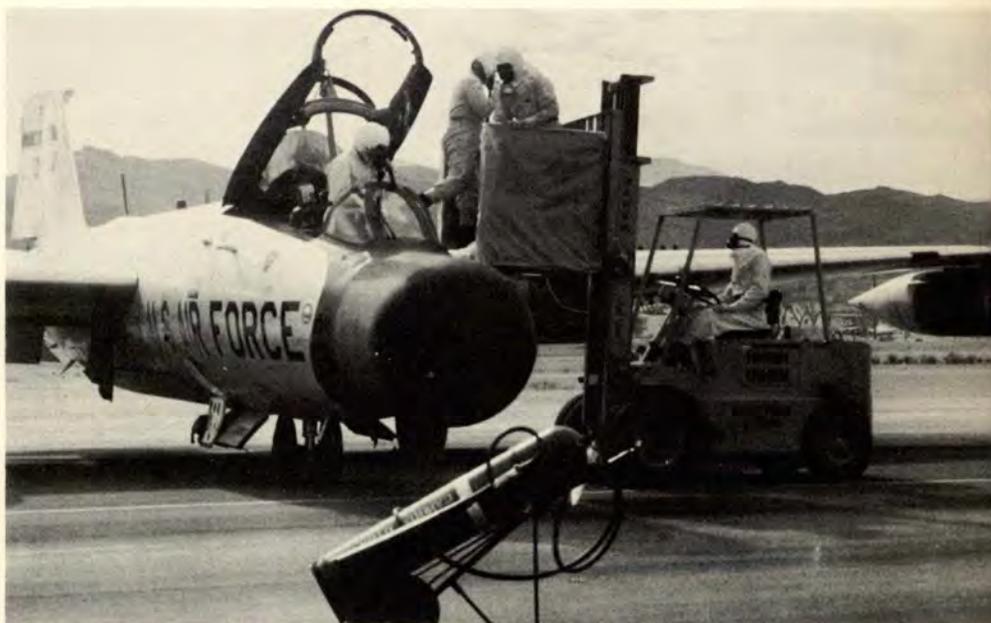
CREW RECOVERY. The crew of an RB-57C is shown climbing into a forklift-mounted box. Care is taken not to touch the contaminated aircraft exterior.

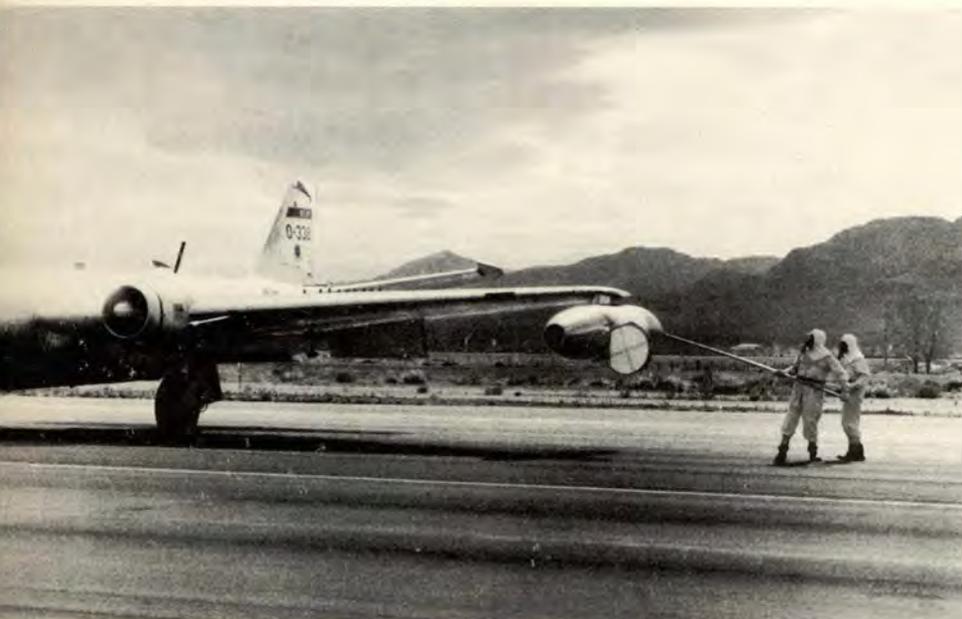
SAMPLE RECOVERY. Two members of the Sample Recovery Team pull the sample "flimsy" from the wing-tip sampling tank. Note the use of long-handled tools to keep the individual at a distance from the radioactive source.

The particulate samples were collected on a special filter paper held inside the sampling tank by a "flimsy" metal screen. After removing each paper from the sampling tank,

with its "flimsy," it was placed inside a three-inch thick lead "cave," where the "flimsy" was opened and the paper rolled into a lead "pig." The "pigs" were then crated and shipped to the laboratory, but they did not require special handling preparations.

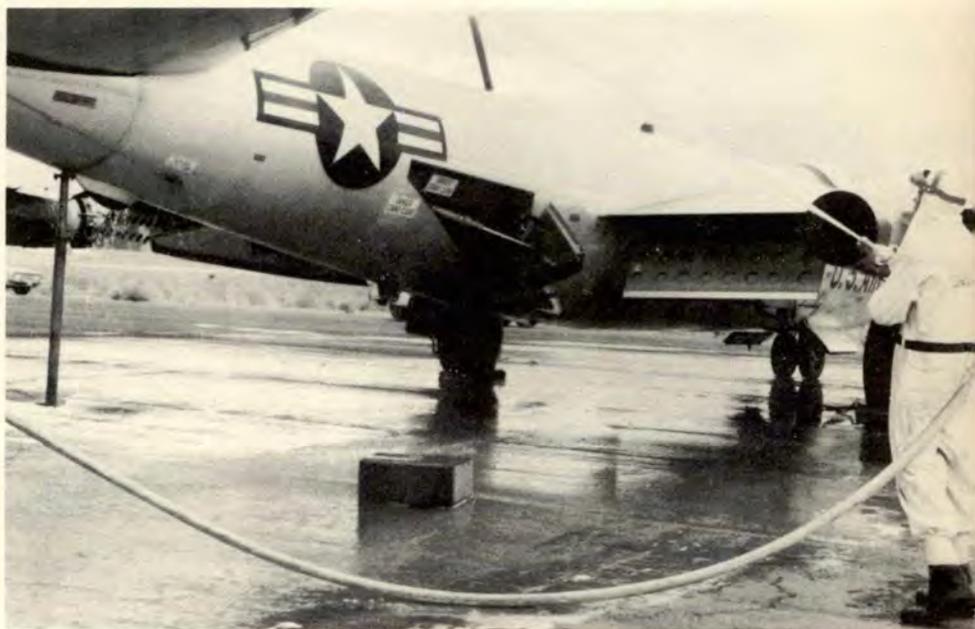
DECONTAMINATION. The most effective means of decontamination is the use of soapy water. Solvent is used to cut through grease and oil deposits.

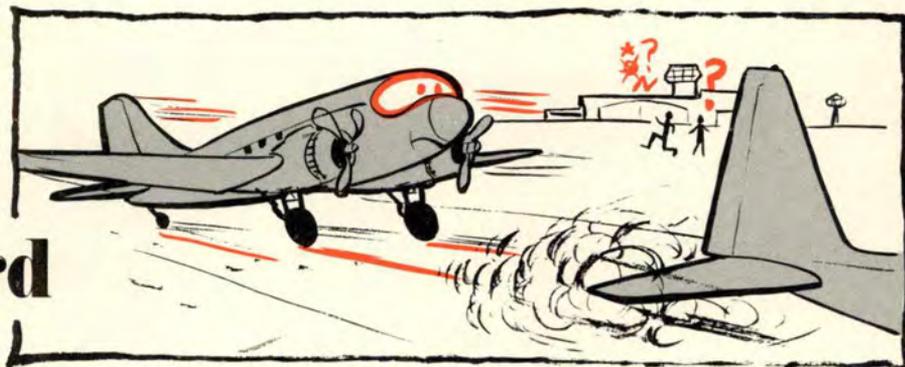
blowhard

A C-47 WAS BLOWN almost 1000 feet across the ramp, striking two RB-57s in its travel. The tie-down rope on one wing broke and the tie-down attach point was pulled out of the other wing which allowed the

aircraft to start its unscheduled movement.
