AIR FORCE RECURRING PUBLICATION 127-2

FEBRUARY 1986

SAFETY MAGAZINE

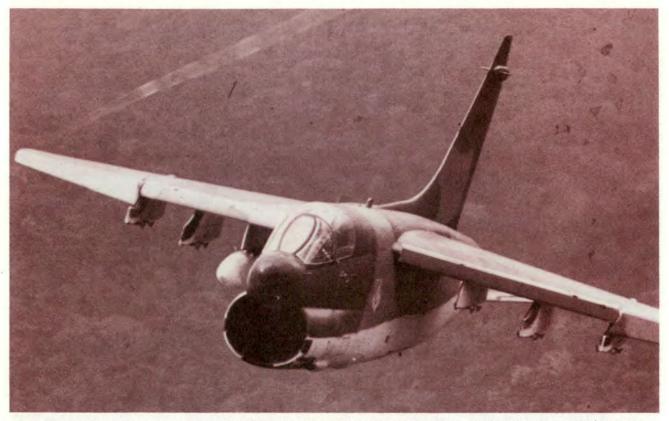
Most of the logistics mishaps occurred in fighter/attack aircraft, but the overall rate showed a marked improvement over last year.

enced this year for a total of 15, down 21 percent from 1984. Of the 15 mishaps, 14 aircraft were destroyed, 12 involved fighter/attack aircraft, and there were 14 fatalities. Fifteen ejections were attempted, and all were successful.

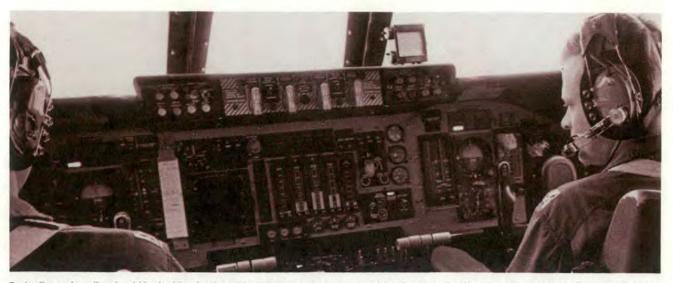
Both pilot and copilot should be looking for the critical triangles of agreement. A basic cross-check and proper crew coordination will guard against misinterpretation of aircraft performance.

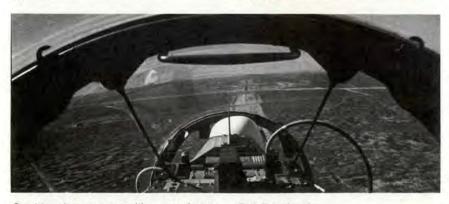
RPM's F/F, EGT EPR NOZZLES

Outside references can either complete or confirm the triangle.

performance source. Graphically, the triangle would look like this: The alarm clock in the center of the triangle rings when things don't feel right. When that happens, don't shut it off — your feelings are trying to save your life! Check the triangle!

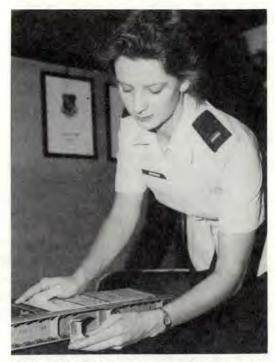
Lieutenant Boskovich demonstrates the placement of the rib stiffener she helped develop.

Lieutenant Boskovich was given the task of preventing the recurrence of an incident in which a T-38, out of Holloman AFB, New Mexico, lost a wingtip during a high stress maneuver. The rib where the honeycomb wingtip joins the main part of the wing had cracked and failed, she explained.

Lieutenant Boskovich, an aerospace engineer assigned to the Center's Fighter/Tactical/Trainer System Program Management Division, said preliminary tests determined that stiffeners added to the rib would *reduce* the stress that caused the crack and ultimate failure.

Meanwhile, nondestructive testing of the T-38 fleet at Holloman AFB revealed cracks in the wing rib of seven additional aircraft at the wingtip/main wing juncture. "Our supply of these specific ribs was nearly exhausted by the requirement to replace these cracked ribs," the Lieutenant said. "It would be approximately 2 years before we could get improved ribs from Northrop," she added.

According to officials at Kelly AFB, Texas, the stiffeners are a satisfactory alternative to rib replacement for the T-38 fleet. Officials estimate the rib replacement would cost approximately \$630,000.
