Flying Safety

HEADQUARTERS UNITED STATES AIR FORCE • RESTRICTED

AUGUST 1948

Volume 4 No. 8

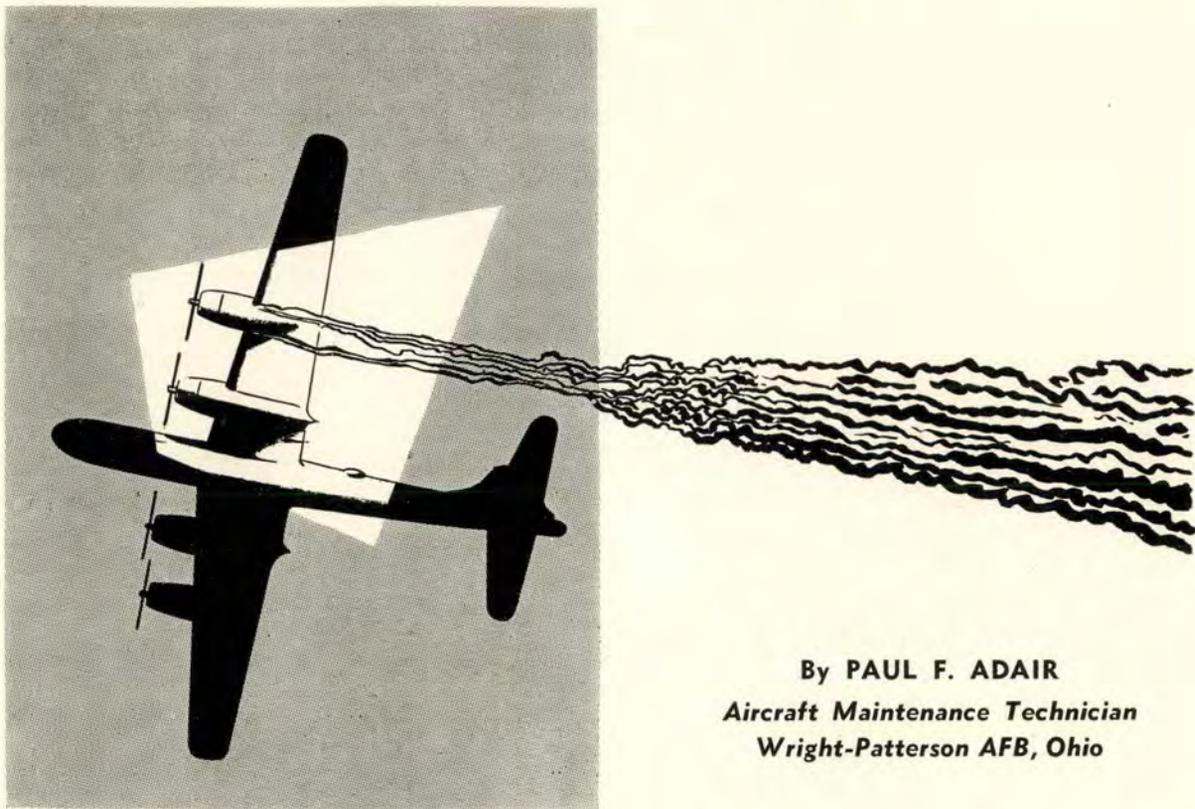
TORCHY --- THE B-29

THE PILOT CRAWLED out of the B-29 and requested that a fire truck be installed permanently on top of the No. 1 outboard engine as it was still torching excessively during takeoff. The engine appeared normal in every respect except for the torching condition at takeoff power.

The time required for the complete checks performed by the team including the installation of the new fuel nozzle and re-checking the engine was approximately one hour. In this case the torching was due to the unburned fuel from No. 16 cylinder being dumped into the exhaust system where it was ignited and burned. This gave an indication of torching or excessive rich fuel metering.
