UNITED STATES AIR FORCE

January/February 2002

2001 MISHAP REVIEW

FLYING *Safety*

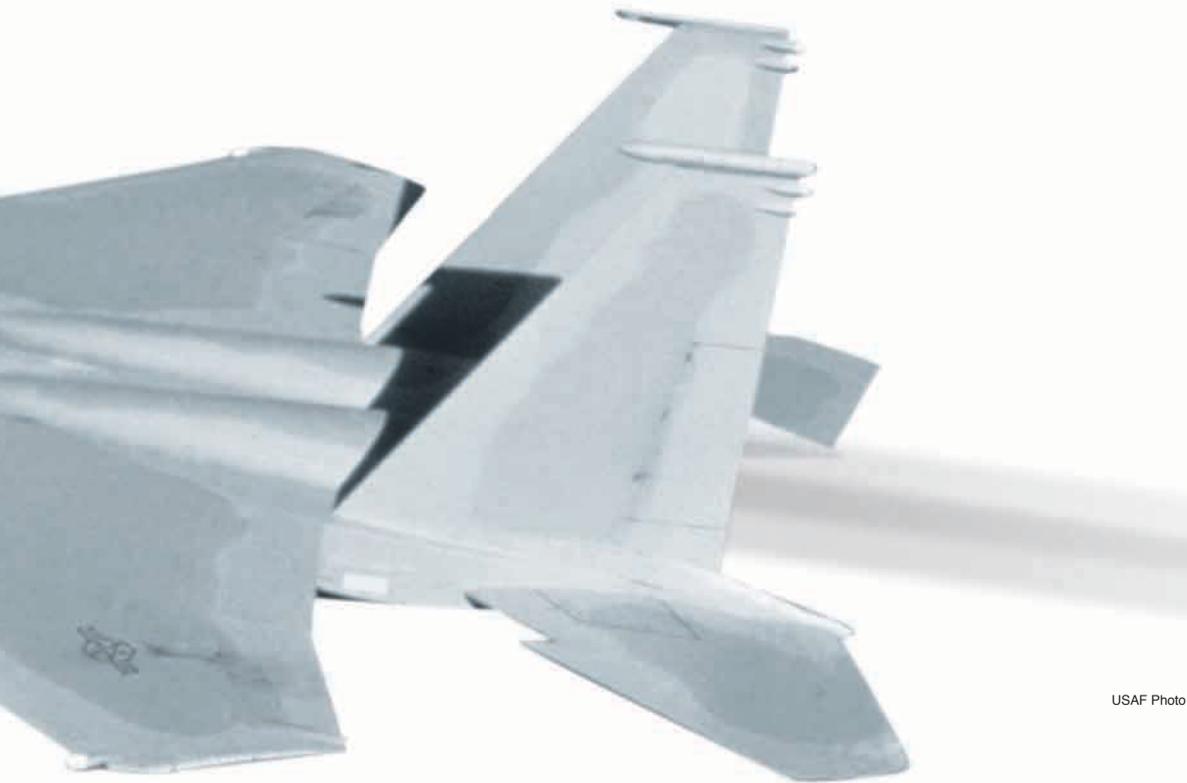
Mishap 2: An F-15E based at Seymour Johnson AFB was conducting a night, local, Surface Attack Training (SAT-3) mission. The aircraft impacted 17 Lesser Scaup (basically ducks averaging 1.75 lbs. each) at an altitude of 650 feet AGL

and a speed of 450 knots. The right hand engine catastrophically failed and caught fire. The left engine was damaged, as were the right conformal tank, left ramp, navigation pod, targeting pod, left side of the canopy bow and panels 47L and 155L. The crew managed to fly the aircraft back to Seymour Johnson using the damaged left engine, while the right engine continued to burn. The aircraft landed safely and neither crewmember sustained injuries.

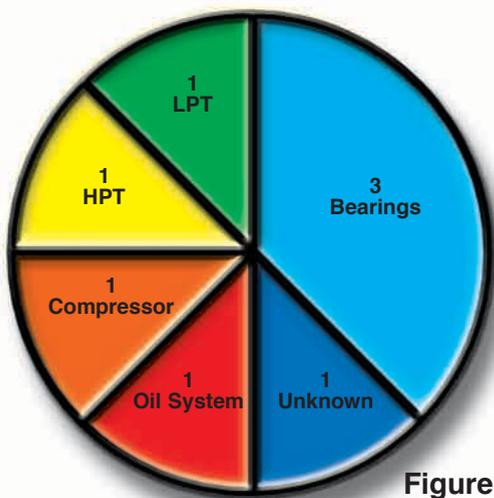
Examining particular engine areas that brought down airplanes in FY01, we present Figure 3 (left). Except for engine bearings, what we have here is pretty much "one-sies," with no "two-sies." In the case of the single "Unknown," the mishap aircraft impacted the water and wasn't recovered, so the engine couldn't be inspected to conclusively determine failure cause.

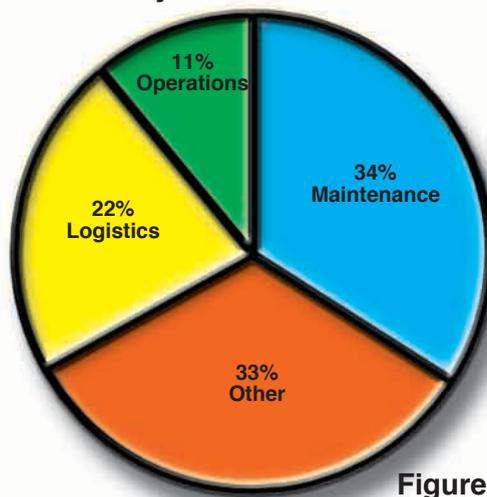
Figure 4 (right) provides a snapshot of mishap factors. Of the eight engine-related mishaps that resulted in a destroyed aircraft for FY01, one of them was directly related to incorrect engine assembly procedures at depot ("Maintenance"). One was attributed solely to field maintenance procedures (another "Maintenance"), while another was a combination of field maintenance with an assist from the pilot (score one each for "Maintenance" and "Operations"). Two of the mishaps involved failure modes which have caused mishaps before and are currently being addressed through component upgrades ("Logistics"). And there were three in the "Other" category—one from a previously undetected FOD event and two that remain "unknown." Obviously, attention to detail in the assembly and maintenance of engines is of paramount importance in keeping a single-engine fleet safe, along with aggressive incorporation of design fixes for known problems.
