flyiing

OCTOBER 1989

Cases, Causes, and Cures

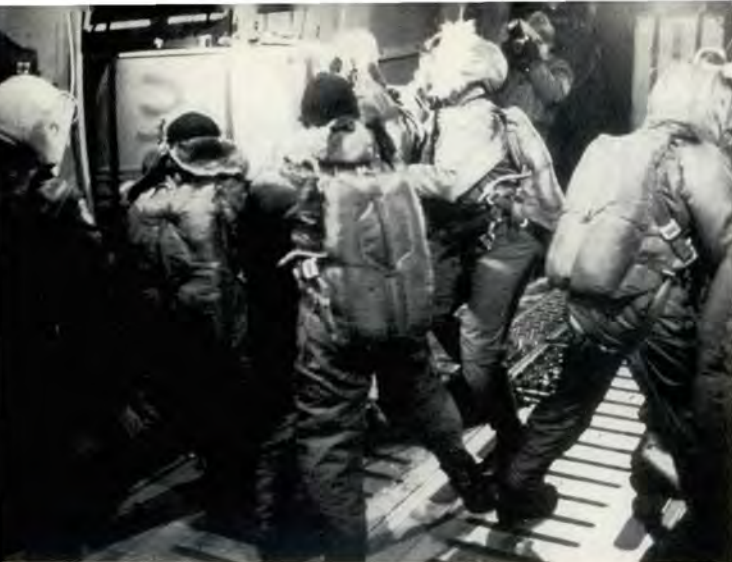
It is so cold at the Pole the C-141's ramp and petal doors must not be opened! The containers are built to a specific size allowing exit out the paratroop doors.

There is a 2,000-meter drop zone the crew must hit. The full moon and the strobes connected to selected bundles help those on the ground recover these vital supplies.

As I mentioned, the bundles for the South Pole must be a specific size to allow exit from the paratroop doors, vice over the ramp and through the petal doors. It is so much colder at the Pole than at McMurdo, MAC directed the crew not to open the ramp and petal doors of the C-141 at the Pole. An attempt to open these doors would be very difficult as the extreme temperatures increase the likelihood of their freezing shut. Even if the doors were to be opened, there is a greater risk in *not* getting them closed.

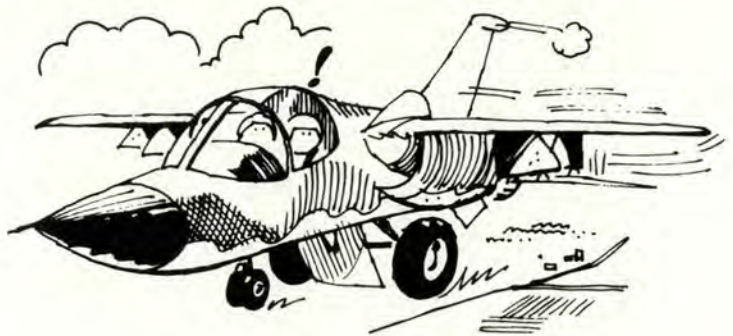
The cause of the problem turned out to be the no. 2 pivot pylon which was cocked at about 70 degrees. Investigation revealed the technicians had

problems installing the pylon during the last phase inspection. The investigating team had the pylon removed and found the spline teeth were lined up tooth-to-tooth instead of being meshed. They also found the support collar was installed upside down, and the ring nut threads were stripped. The team concluded the cause of the mishap was the failure of maintenance people to follow tech data when installing the pivot pylon.

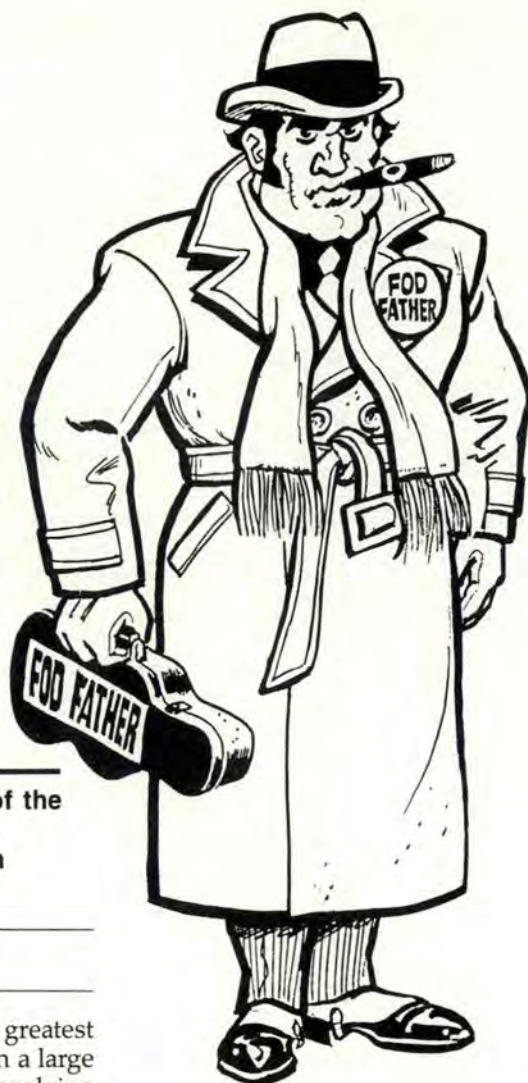
During a postflight inspection after a seemingly uneventful flight, the Weasel's crew chief noted a screw was missing from panel 6R. Because this panel is just forward of the no. 2 intake, the crew chief performed an inspection of the no. 2 intake and found damage to several of the fourth stage blades. The engine was removed and sent to the prop shop where it was top halved. Engine specialists found extensive damage throughout the entire compressor section. The compressor was returned to depot for major repairs.

found the nut plate the screw fell out of was worn and should have been replaced. But the team determined the major cause of the FOD was because the specialist had unknowingly installed a screw that was too short.
