FLYING SAFETY

U N I T E D S T A T E S A I R F O R C E

**WHEN
THE
SKY
THREW
ROCKS**

Materiel Minus Maintenance Equals Mishaps	2
Well Done	7
Horror in Hell's Canyon	8
Keep Current	13
When the Sky Threw Rocks	14
The Slow Speed Demon	16
No Problem Approach	21
Frantic Firefly	22
Quantity Unknown	25
What Gear?	26
Tips for T-Bird Drivers	28

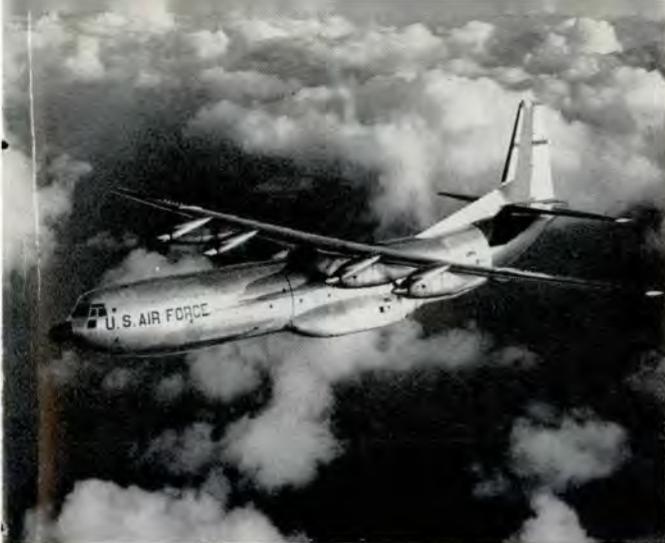
If there are any more non-believers who scoff at the destructive force of hailstones, these pictures should suffice to convert them. The C-133A shown here was subjected to the fury of baseball size hailstones for just thirty seconds. Preliminary sheet metal repair estimates run to 11,500 manhours. Overall repairs are expected to take up to 14,000 manhours.

cording to the scope there were four to five miles between the two areas of heavy return, and the C-133A was in the clear between layers of stratus, when the crew was startled by a rhythmic loud ticking noise. This lasted about four seconds when there was a terrific roar and explosion, and the copilot's center window was penetrated by the hail. At no time was more than relatively light turbulence encountered. The hail was not picked up on the scope prior to the incident because it just wasn't there. The falling of the hail and the arrival of the C-133A at that precise point in space were apparently simultaneous—a coincidence as unexpected as it was unfortunate. What's the answer? Top all cumulus type clouds if possible. In this case, according to the pilot, the freight load on board would allow no higher flight altitude than 20,000 feet at the time of the incident.

During the entire incident the engines ran smoothly and although the oil coolers were severely damaged, the engine temperatures remained normal. Using a higher flare speed than normal, because of the severe damage to the leading edges of the wing surfaces, the plane was landed at El Paso without further damage. ▲

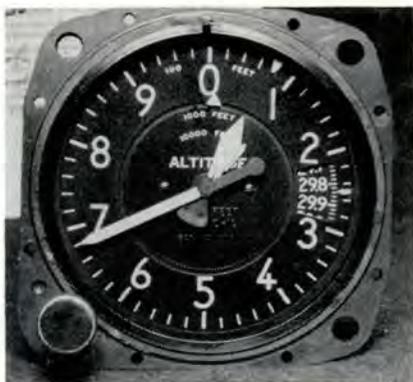
Even under ideal conditions, seven seconds are required to read the standard altimeter. During this time a jet might move 3600 feet along its flight path, and 600 feet downward.

A practical example of the time consumed in a visual process is the time required for the reading and interpretation of a standard flight instrument, the altimeter. Evidence developed almost ten years ago indicates that it takes approximately seven seconds for each reading under ideal laboratory conditions. Even under these conditions, almost one-sixth of them being in error by as much as 1000 feet. During the seven seconds required for a reading of this instrument, a pilot in a standard jet penetration from 20,000 feet at 350 mph at a rate of descent of 5200 feet per minute would have traveled 3600 feet along his flight path and descended 600 feet vertically during this seemingly short period of time.
