A E R O S P A C E

SAFETY

UNITED STATES AIR FORCE

April • 1962

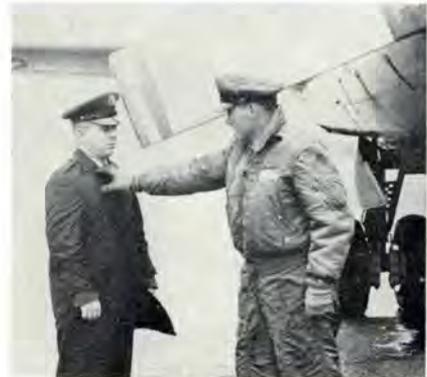
Posed photo shows proximity of victim and crew chief to spinning propeller. Jagged tear in hat testifies to near tragedy.

The engines of a T-29 were operating while the crew awaited the arrival of additional passengers. The weather was stinking—temperature 15°, blowing snow. The passengers approached from the left and went around behind the aircraft and forward toward the entrance door located on the right side between the wing and the cockpit. The crew chief had been stationed between the rotating prop and the loading stairs as a precautionary measure to guide passengers aboard. As the Army officer neared the turning prop from the rear it was evident that he would walk in to it. Another passenger yelled a warning which the Army officer apparently didn't hear. The prop tip struck his forehead but before further injury was incurred, the crew chief risked his own life by leaping forward and shoving the injured man away from the propeller.
