A E R O S P A C E

SAFETY

UNITED STATES AIR FORCE

October • 1962

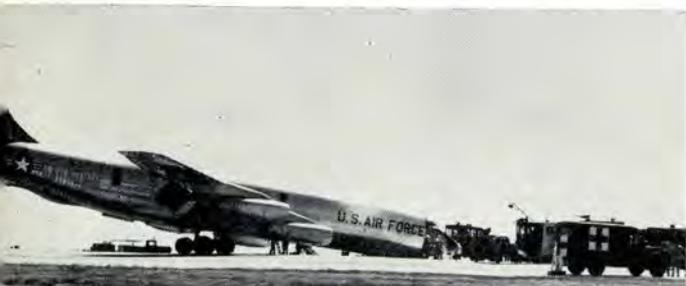
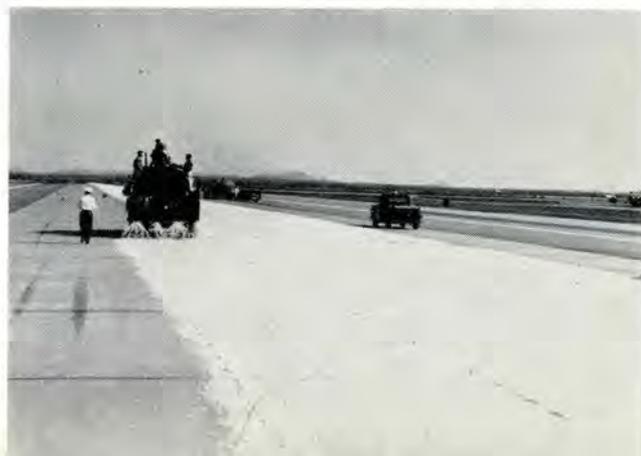
Left, a KC-135 after coming to rest during a nose gear up landing. Right, typical runway foaming operations at a U. S. Air Force base prior to an emergency landing.

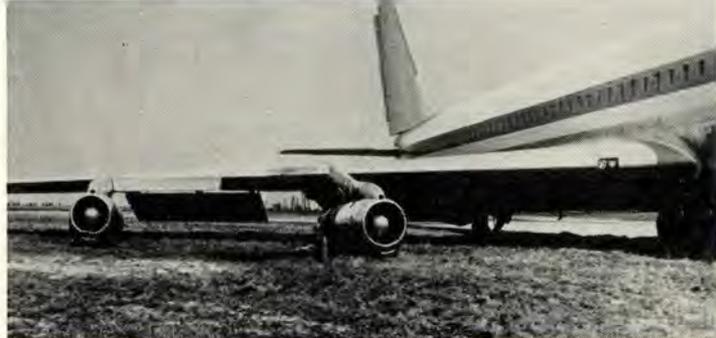
With one main landing gear gone, the aircraft rests on the two nacelles and the remaining main gear and nose gear. Damage is usually limited to the nacelles and engines. Prompt action in extinguishing any fire that develops at the lower part of the engine will prevent the fire from spreading. This is a commercial model Boeing 707 and is pictured here because of the similarity between this aircraft and the military KC-135 and C-135 for which similar results could be expected during this type of a landing.

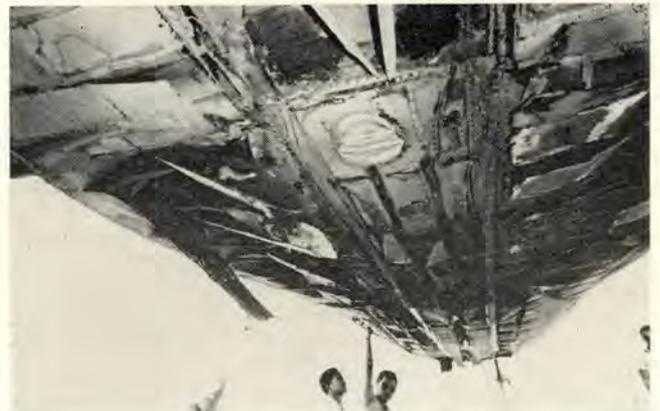
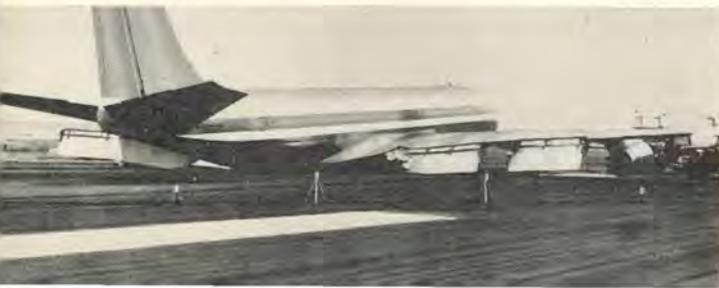
After collapse and loss of both main gears due to premature ground contact short of the runway, the aircraft made a two-point landing on the nose gear and aft lower body. The inboard engine pods provided lateral stability. Damage to the lower aft body is shown in picture on right. Similar damage may be expected on a C/KC-135. Fire in No. 3 engine pod was quickly extinguished.

Lower aft fuselage damage to the aircraft shown at left resulted from landing with the nose gear down and main gear off. Sliding 5200 feet on dry concrete caused wear of skin and longitudinal stringers but minimum damage to fuselage frames. There was no evidence of fire in the area. Landing a C/KC-135 under similar conditions would result in the fuselage contacting the runway at the pod and between stations 1040 and 1120.

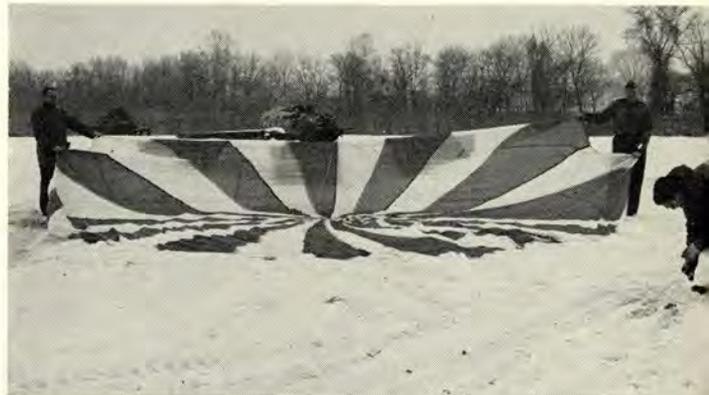
This is the nylon parachute which was inside an HT-1 parachute pack burned during a test in aircraft fuel fire. The parachute was tested in a dummy drop and worked almost as if it had no holes.

A double layer of HT-1, with a sheet of aluminum foil sandwiched between, protected the canopy assembly in a simulated aircraft fire test. The outer layer burned

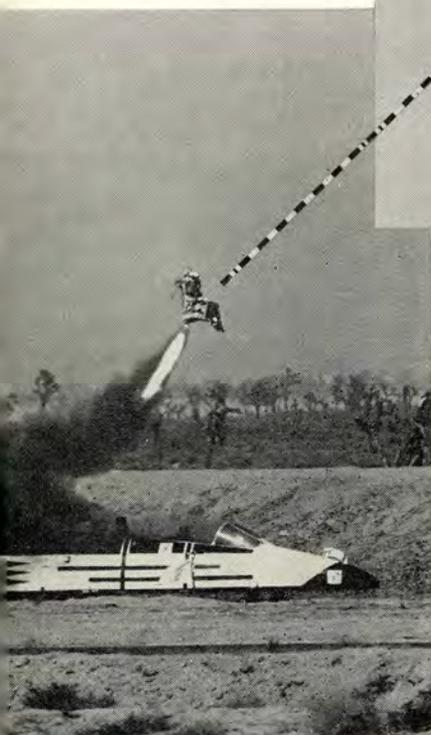
This scene depicts a dynamic sled test at Edwards Air Force Base Sled Track showing a dummy ejection with a North American Aviation ground level escape rocket-catapult seat. Two static and 11 dynamic sled tests were performed with peak ejected altitudes of up to 205 feet at speeds of 90 knots to 600 knots.

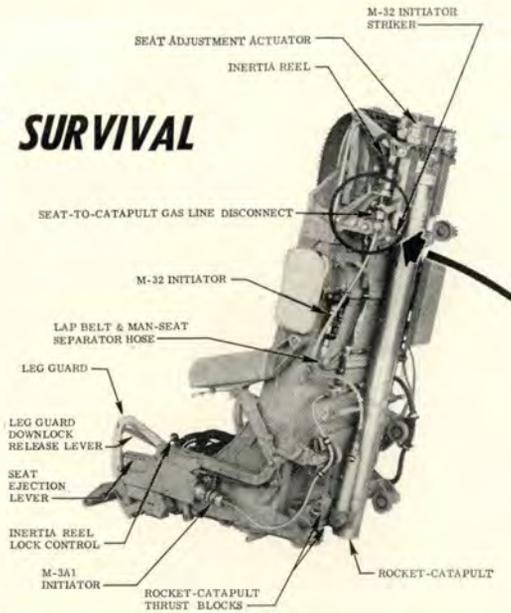
Disconnect completely engaged.

The disconnect bracket on the seat should be handled with care to prevent misalignment of the disconnect with the trigger bracket on the airplane. Any time the seat is removed for maintenance or a new seat is installed the tripper bracket on the aircraft should be checked in accordance with the TO to insure engagement of the tripper bracket with the tripper arm.

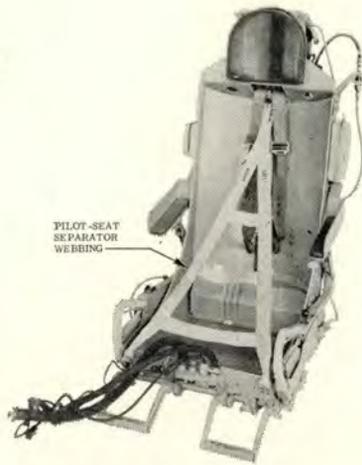
Pilot-Seat separator webbing shown in actuated position.

Man-seat separator. The F-100 series is also being modified (TO-1F-100-788) to provide a positive means of man-seat separation. An A-shaped webbing is used to automatically separate the pilot from the seat at the same time that the lap

after the original design to allow for a reduction of two inches in the current parachute pack and a proper position of the pilot's eye level. Both blocks are necessary and the man-seat separator webbing was designed with blocks installed. The webbing is not the proper length with either of the blocks removed. ★

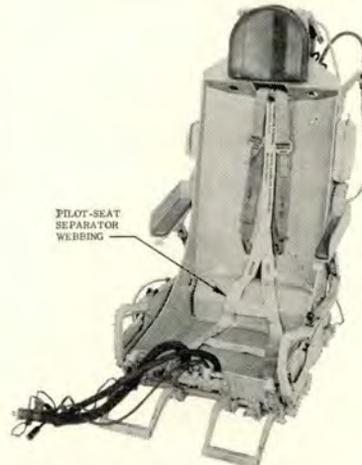
Pilot-Seat separator webbing shown in stowed position.
