April 1968

A E R O S P A C E

SAFETY

UNITED STATES AIR FORCE

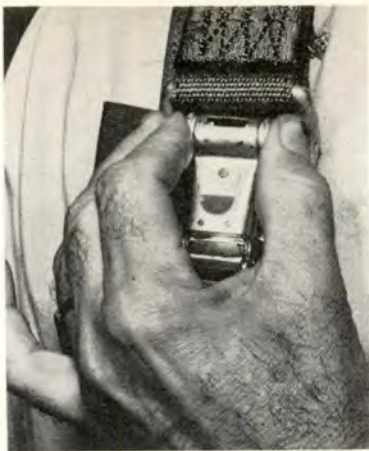
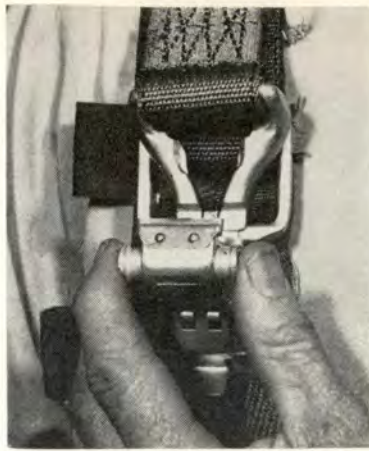
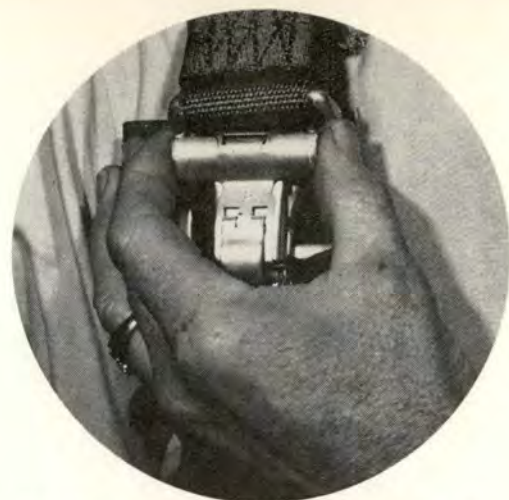
ABOVE LEFT we see the same motion being accomplished with about equal squeeze force being applied to each button. Both retention hooks are disengaged and the latch arm is free to swing out. To achieve this it helps to give specific thought to the squeeze motion before you think about pulling out on the latch arm. Combine this with alternating side to side or shaking motion of the hand and the retention hooks tend to "bounce" out of any small remaining engagement. In the center photo the latch arm is shown after it has been swung out from its stowed position. For additional reference on the three basic release motions, refer to Figures 3-16,

3-17 and 3-18 in Technical Order 14D1-2-1, Section III. A caution note in paragraph 3-17b states: "When depressing the latch arm buttons the latch arm may be forced sufficiently to one side to prevent complete disengagement of one of the button latches. A sideward pull on the latch arm, first in one direction then the other, while the buttons are depressed, may be required to free both button latches." At your first opportunity go through the whole sequence of operating and reassembling the release several times. Start by pulling off the safety clip (ABOVE RIGHT).

The clip may seem to pull off hard at first since it is designed to be firmly seated and resist being jarred out during the parachute opening. Give a sharp outward jerk on the finger grips. No preliminary squeeze is necessary (as in the motion to follow). The TO advises that this safety clip be removed during descent as a part of preparation for landing. After the clip is open (BELOW LEFT) squeeze the buttons (CENTER) and shake from side to side (like a puppy shakes a sock). Avoid a conscientious effort to pull outward on the lever arm until you feel the lever arm come free from its retention hooks. The lever arm will now swing easily out and down to permit the riser link to rock loose. BELOW RIGHT, reassemble the release for another practice run.

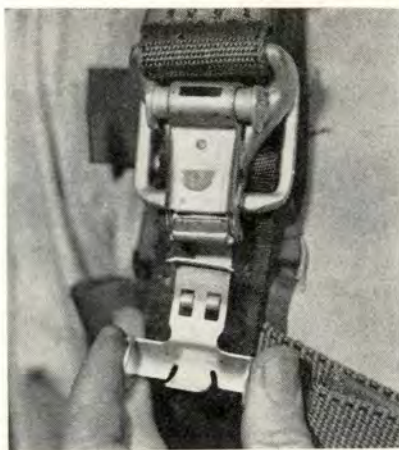
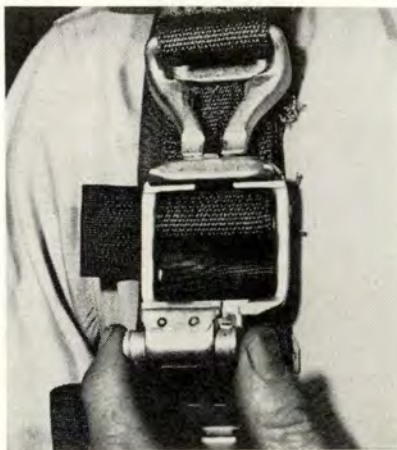
Fit the "heel" of the riser link into the hook-shaped (notched) body of the release. BELOW LEFT, swing the "toe" of the link down flush with the body and fold the lever arm over it and press firmly until the retention hooks click into engagement. BELOW CENTER, prop the straight end edge of the safety clip against the square end of the lever arm as shown. This poises the end edge of the clip over the safety clip groove immediately below the square end of the lever arm. Push the clip up toward the buttons until it springs over center and snaps into place. The release is ready to go again, BELOW RIGHT. Practice some more; this may save you from being dragged through a barbed wire fence some day.

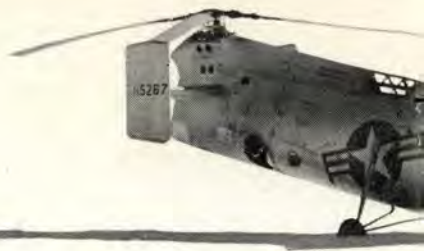
Bring the helicopter smoothly to a one- to two-foot hover. Low hover requires a minimum of power,

reducing the possibility of RPM loss and subsequent settling. Should settling occur, the helicopter will touch down more gently from the low hover. Land as soon as possible. Decrease the collective pitch slowly while maintaining maximum RPM until the entire weight of the helicopter is supported by the landing gear. Maximum RPM should always be maintained until it has been determined that the surface will support the helicopter.
