A E R O S P A C E

SAFETY

UNITED STATES AIR FORCE

August 1963

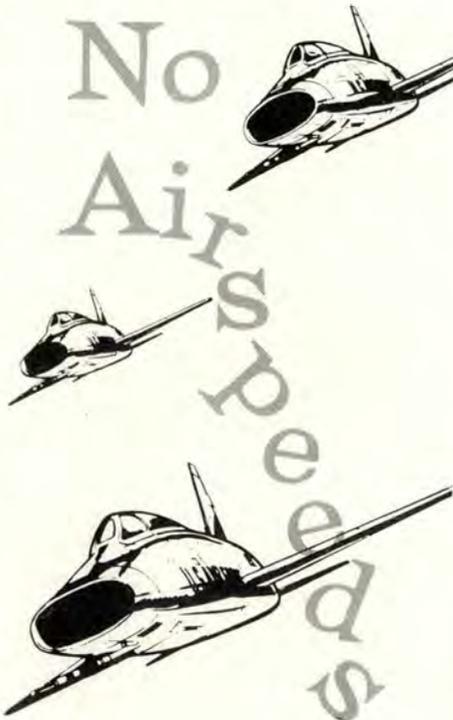
Look
Ma,
No
Airspeeds

So . . . o . . . o, as was apparently the case in this incident, some of the moisture picked up in the pitot boom does what comes naturally when it gets to 32 degrees — it freezes. And ice in the pitot boom makes for a no airspeed indication.

After an inflight refueling near Lajes, the flight climbed through cirrus clouds to flight level 330. Shortly thereafter the airspeed indicators malfunctioned. Sure, there is pitot heat for the air intake, but therein lies the gimmick. The Dash One explains that hot engine compressor bleed air for the deicing and rain removal is taken from the mixing chamber of the air conditioning and pressurization system. And, to ensure that sufficient heat is available for pitot boom anti-icing, the windshield anti-icing or defrosting systems should be turned on. (This is not true on airplanes modified by IF-100 D-510). Anti-icing of the pitot boom is controlled by a pitot boom heat switch which should be left on at all times. Further, under any icing conditions it is necessary, on some F-100A and C models that the canopy defrost lever be at full increase, otherwise full available heat will not reach the boom. (Dash-Ones and recent TOs should be checked on this.) This does not apply to the F-100F-20 with the electrical elements in the boom.

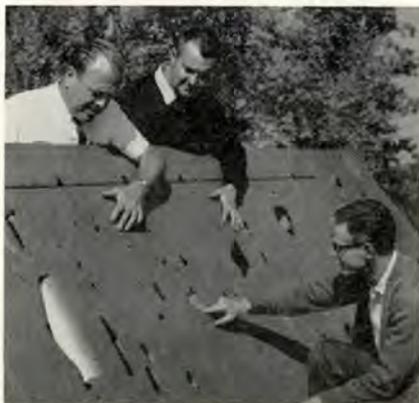
AFTER THE STORM—investigators check hail damage to a C-119 control surface. A highly localized, unpredicted hail storm caused major damage to 25 ailerons and 15 elevators, necessitating surface change. In addition, minor damage occurred to 38 ailerons and eight elevators. This one storm, lasting but a few minutes, rendered 34 aircraft out of commission for surface changes and repairs.

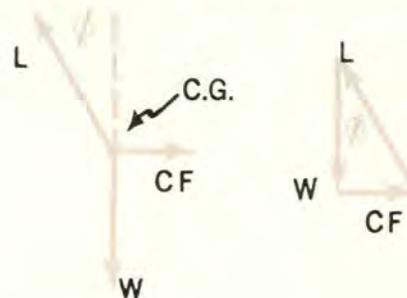
EQUILIBRIUM TURN FORCE DIAGRAMS

$$\text{Load Factor} = L/W = 1/\text{COS } \phi: \text{ for } \phi = 30^\circ$$

$$\text{COS } \phi = 0.866: \text{ LF} = 1.16$$

Bank	Load Factor	HUS*	HUP*	HOK*	HRS*	% Increase
10°	1.02	226	106	118	150	2%
20°	1.06	678	318	354	450	6%
30°	1.16	1808	850	945	1200	16%
40°	1.3	3390	1600	1770	2250	30%
45°	1.42	4750	2225	2470	3150	42%
50°	1.55	6200	2900	3250	4100	55%
55°	1.74	8370	3900	4370	5500	74%
60°	2.00	11,300	5300	5900	7500	100%

H-34 (HUS) loaded initially to 11,300 lbs.
 UH-25 (HUP) loaded initially to 5300 lbs.
 OH-43D (HOK) loaded initially to 5900 lbs.
 CH-19E (HRS) loaded initially to 7500 lbs.

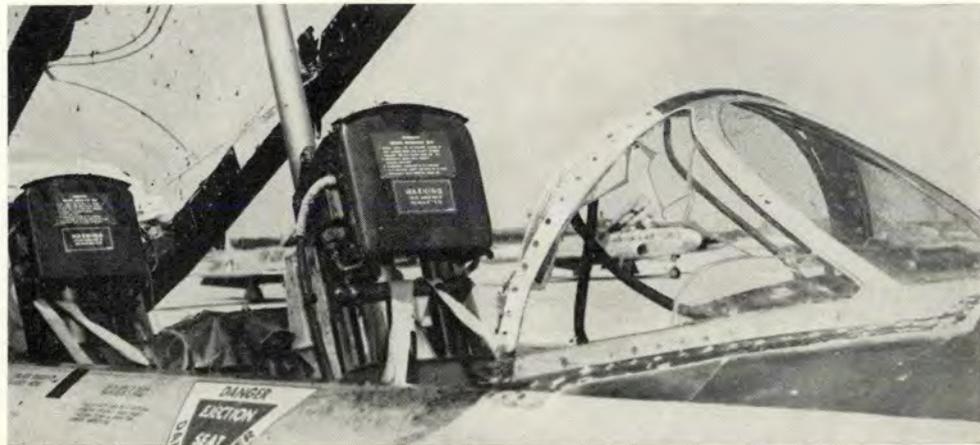
This photo shows impact point on lower right corner of right windscreen of T-33. Although considerable damage was done to the windscreen frame, the canopy was only slightly damaged.

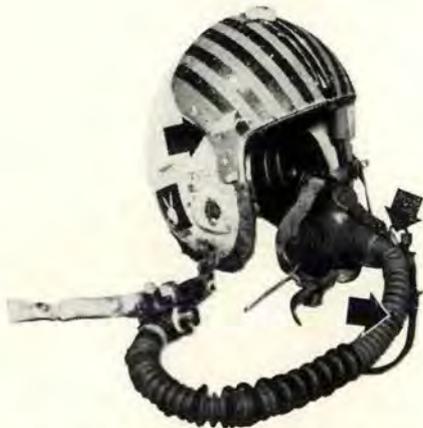
Dents on this visor cover were probably caused by the magnetic compass which broke loose. The microphone connection on the front of the mask was shattered. A hole in the O₂ hose can be seen about 4 inches from the mask. The flight surgeon stated the visor and mask protected pilot's face.

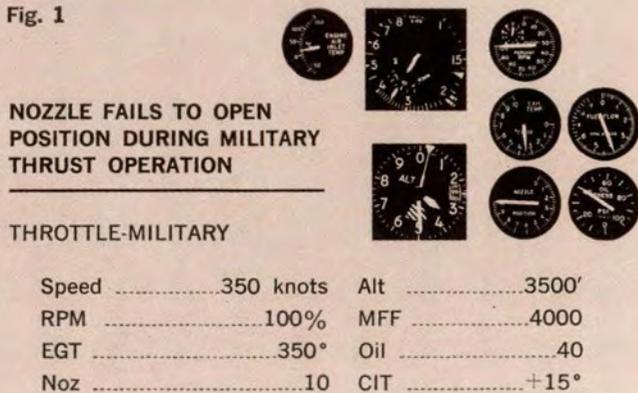
Fig. 1

On this page are several displays depicting engine problems in the F-104. The idea is to examine the instrument readings, determine the trouble and test yourself as to the best procedure to use for correcting the problem. Diagnoses and recommended procedures are to be found on the next page along with a brief discussion of the Concerted Flight Safety Program from which these problems were extracted.

SITUATION	KEY RECOGNITION POINTS	PROCEDURE FOR CURE
FIG. 1 NOZZLE FAILS TO OPEN POSITION DURING MILITARY THRUST OPERATION	<ol style="list-style-type: none"> 1. EGT low 2. Nozzle max open position 3. Noticeable loss of thrust 	<p>Nozzle fails open during flight</p> <ol style="list-style-type: none"> 1. THROTTLE - MILITARY 2. EXHAUST NOZZLE HANDLE - PULL 3. Check for nozzle closure and monitor EGT. If nozzle fails to close, push handle in. <p>NOTE: If nozzle fails open in landing pattern</p> <ol style="list-style-type: none"> 1. EXHAUST NOZZLE HANDLE - PULL 2. REDUCE DRAG 3. FLAPS - TAKEOFF 4. Monitor nozzle position.
FIG. 2 IGV CLOSURE	<ol style="list-style-type: none"> 1. RPM, EGT normal 2. Nozzle too far open 3. Fuel flow abnormally low (less than half of normal) 4. Severe thrust loss. 	<ol style="list-style-type: none"> 1. Throttle - AFTERBURNER Monitor EGT to minimize over-temperature 2. Stores - JETTISON as required 3. Make precautionary pattern, T.O. flaps only, extend gear only after flare is assured. <p>NOTE: This failure and procedure is not listed in the Pilot's Handbook at the present time. It is included in this instruction by G.E. to serve as an interim until appropriate instructions are issued in the Pilot's Handbook.</p>

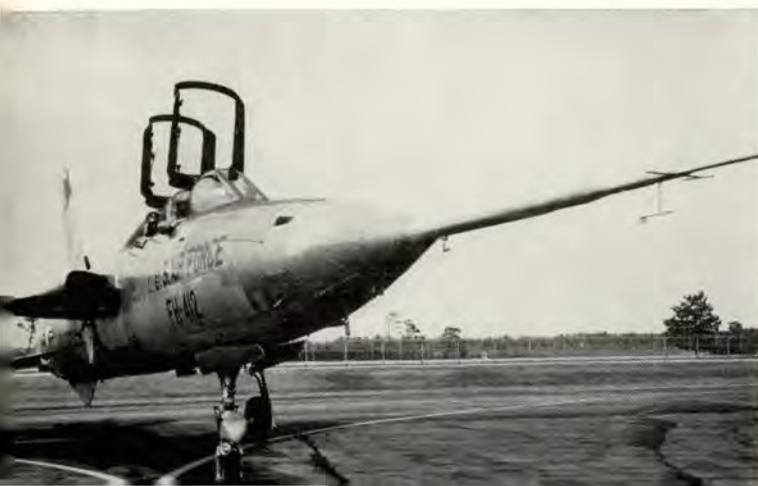
▲ **TWO-MAN GANG.** First photo of the Air Force's new two-seat supersonic tactical fighter, the F-105F after it came off the assembly line at Republic Aviation Corporation, Farmingdale, L. I., May 23. The 1400 mile-an-hour jet can carry 4000 combinations of nuclear and conventional weapons. The F-105F will see service with the seven Air Force wings now flying the single-seat version of the Mach 2 jet, with the Tactical Air Command in the U. S., and with Air Force units in Europe and the Far East.
