A E R O S P A C E  
**SAFETY**

UNITED STATES AIR FORCE

*DECEMBER 1963*

## *. . . Needle in a SILO*

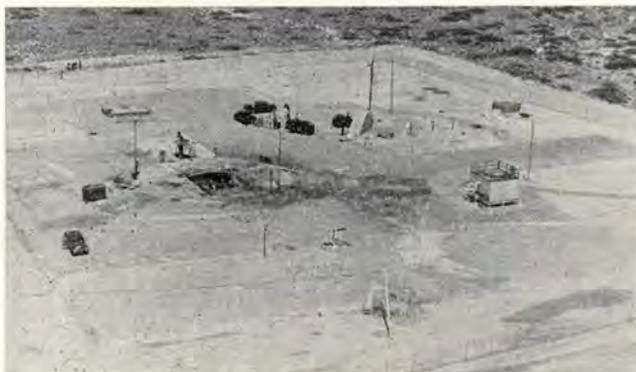
The silo cap doors lay 99 and 109 feet to the east and west.

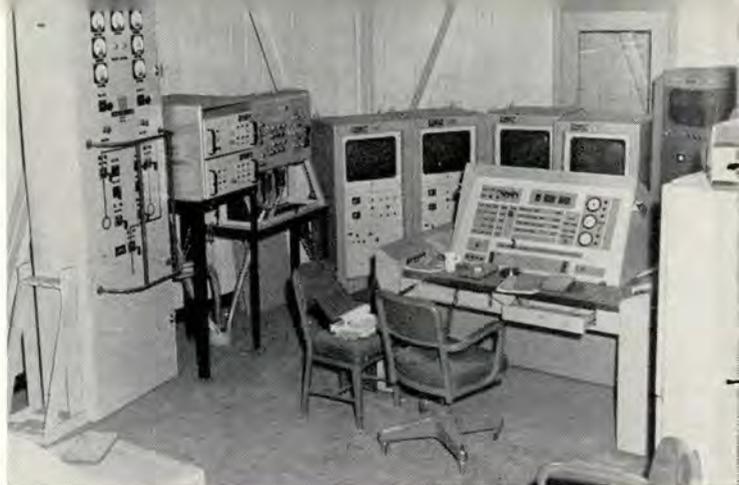
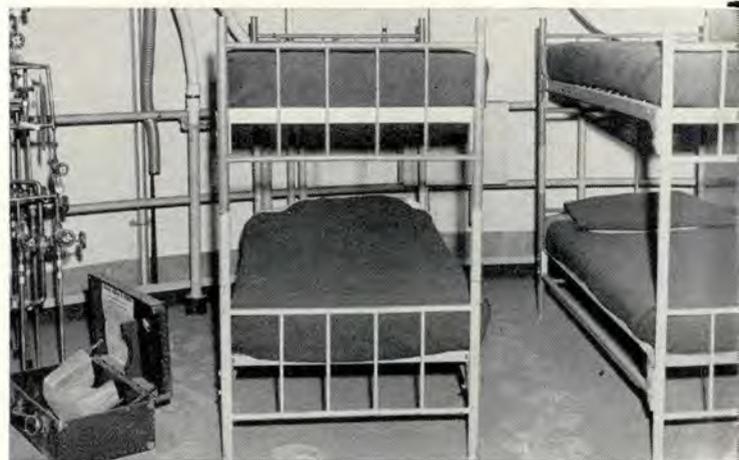
**Top photo, note dust on floor of Level 1 of Launch Control Center. Following blast, investigators, using breathing equipment, entered Launch Control Center at 1620 hours. Oxygen content of Level 1 and Level 2 (below) was normal.**

On the third day the industrial hygiene engineer sampled air within the launch control center. There were no toxic vapors present and the oxygen content was still normal. Aerial photos were taken of the silo cap and surrounding area to assist the wreckage plotting effort. The control officer who participated in this flight failed to establish a recognizable pattern for this photo effort. Consequently, most of those pictures which did not include a portion of the complex within the picture frame could not be correlated since the surrounding area presented no recognizable landmarks. Photo mapping is normally a highly satisfactory method of establishing a wreckage location diagram. However, personnel experienced in photo mapping techniques are needed to insure a usable product.

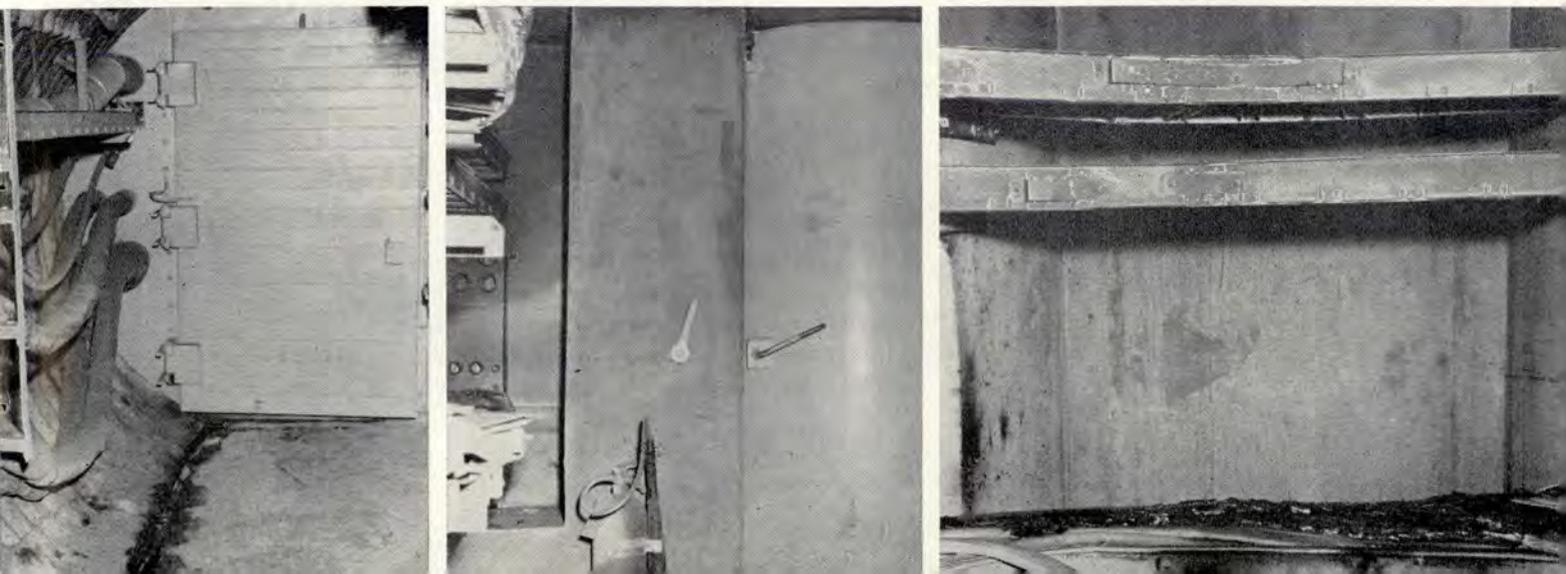
**In photos below, left to right, we note that beyond the debris door in the tunnel there is dust and smoke, but no debris. Blast doors were still intact, but blast wall sealing material and wiring insulation were burned away at the silo entrance.**

Investigators entered the tunnel between the launch control center and the silo. Dust similar to that found in the launch control center was found throughout the tunnel. The debris door and two blast doors were intact

and there was no debris in the tunnel. Blast wall sealing material (lead wool) and the insulation on wiring in the cable trays was burned away adjacent to the blast door at the silo level 2 entrance.

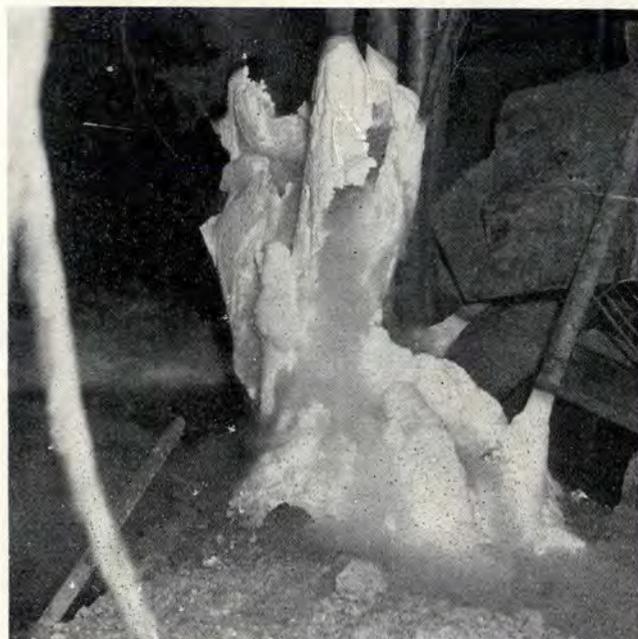
**Silo interior was more like a Hollywood science fiction set.**

the silo, a small flow of diesel engine generator lubricating oil was noted dropping down to the water below level 8. The silo interior was more like a Hollywood location for a science fiction thriller than anything you could associate with the Air Force. Even the sound effects were weird. Peculiar whistles, groans, crackings, gurglings, and the intermittent showering of small chunks of concrete spall made the investigators wonder if the whole mess was about to go into orbit.

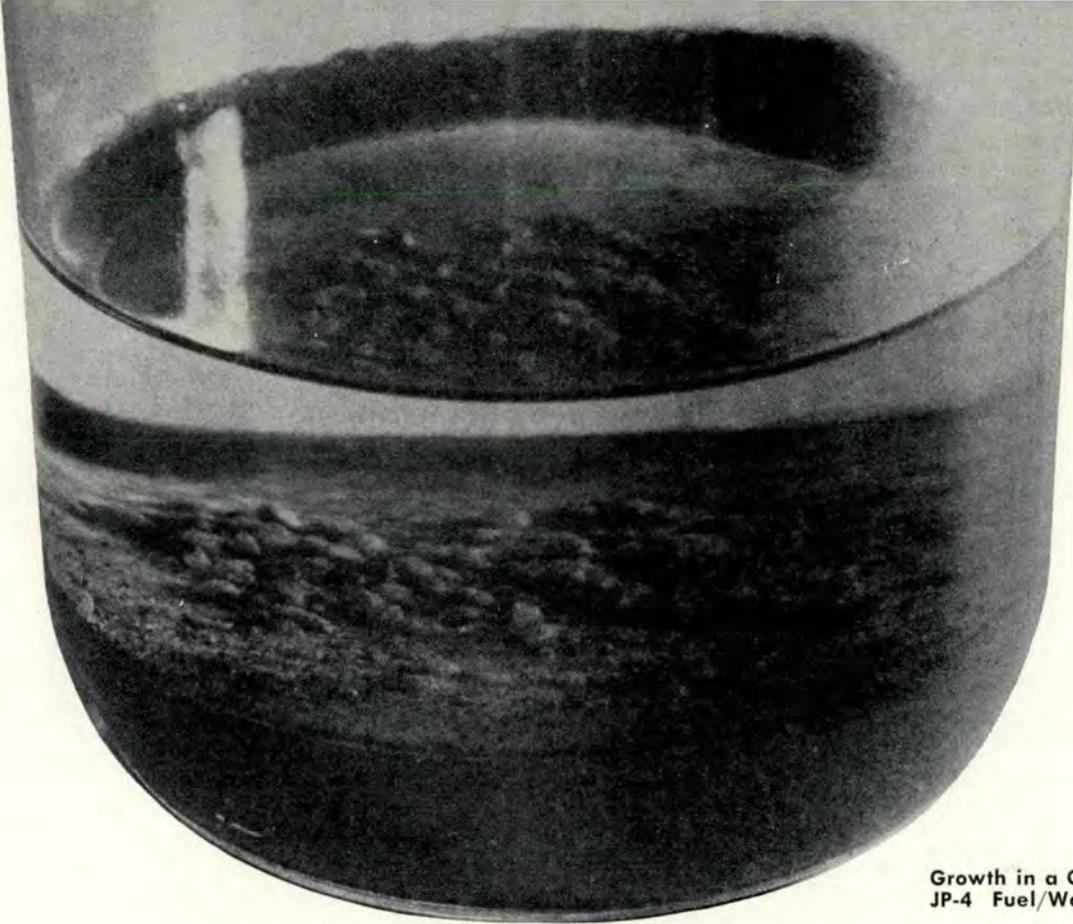
Growth in a Contaminated  
JP-4 Fuel/Water Sample.

The problem of microbiological sludge in jet fuels was first observed in the Air Force during the summer of 1956 when samples of contaminated jet fuel from various locations were examined. Results of this initial study indicated that microorganisms were present in the samples and that they live primarily in the water layer or at the fuel-water interface. This investigation and more recent ones have shown that these microorganisms feed on hydrocarbons and produce slimes, mycelia mats, residues and stable emulsions. Figure 1 illustrates a contaminated jet fuel/water sample obtained from a base fuel facility.

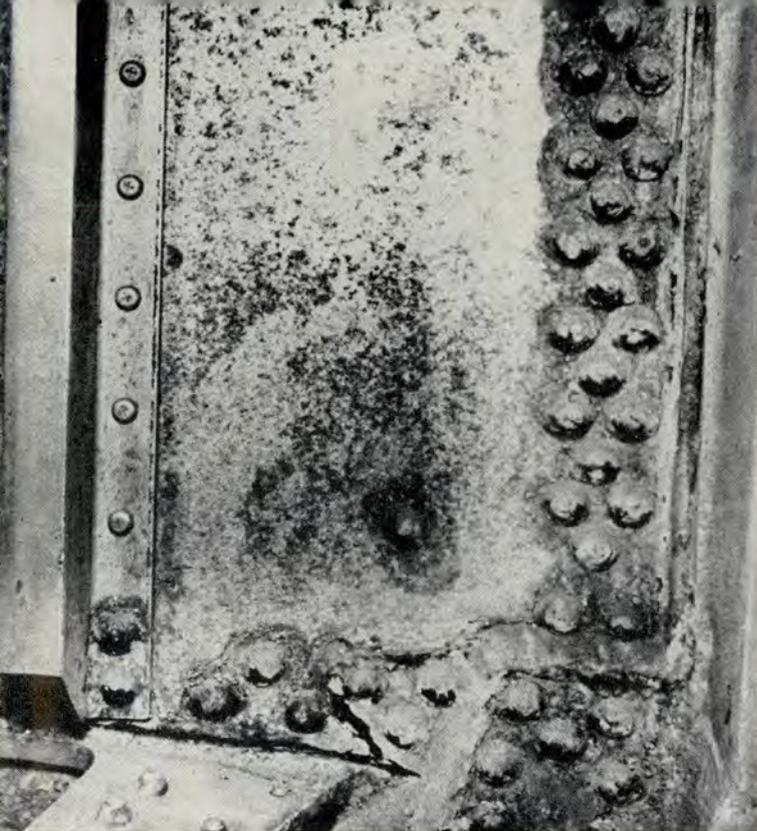
Fig III

Microbiological Contamination in an integral fuel tank.

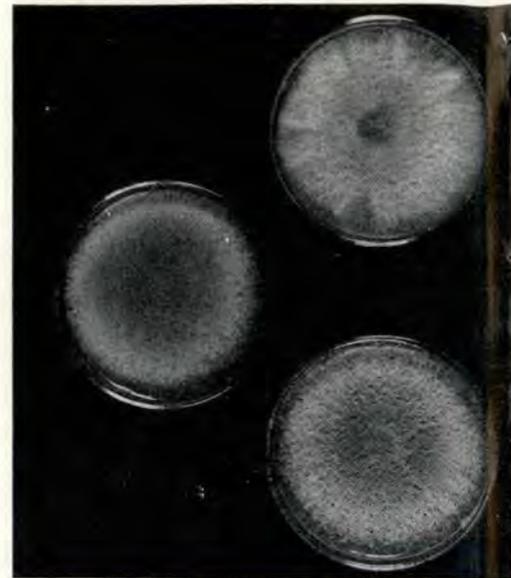
Fig VI

Colonies of Brown Fungus are shown in photo on Sabouraud's Agar.

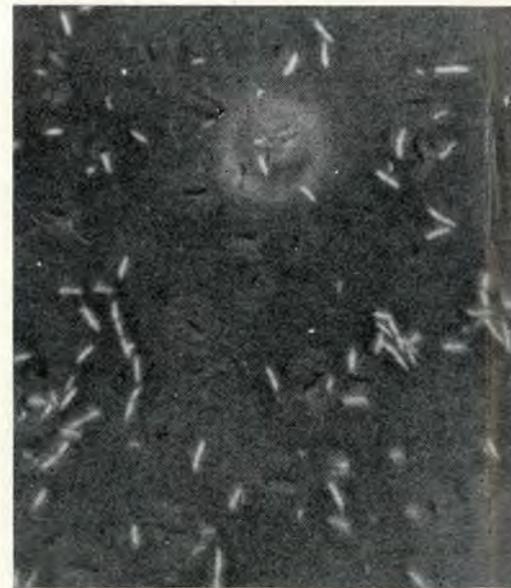
Fig VIII

Photomicrograph is of Transparent Bacterium Dark Low Phase Contrast.

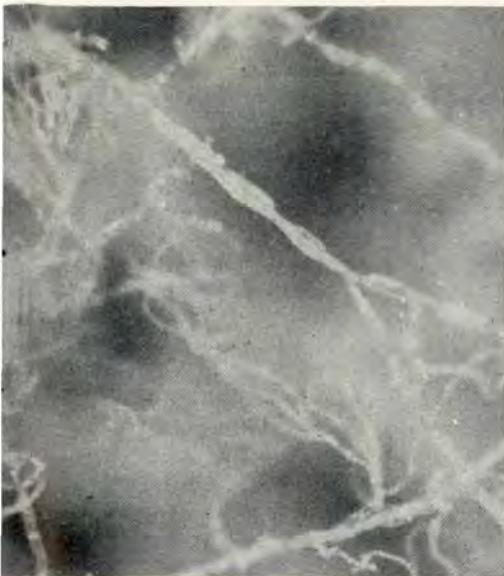
**Fig VII**

Above is an actual photograph, that shows integral fuel tank corrosion.

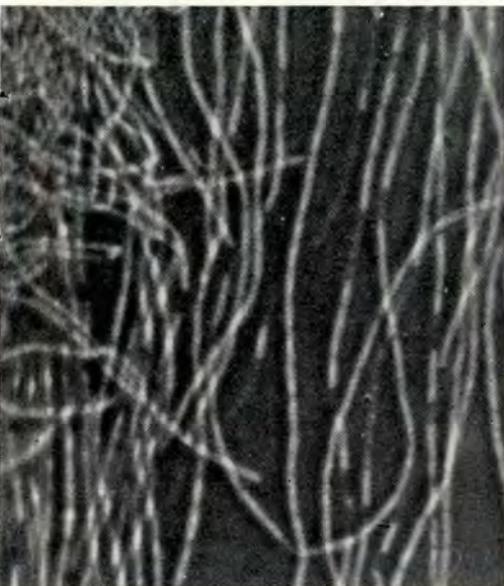
**Fig IX**

Another Photomicrograph is of Mucooid Bacterium Dark Low Phase Contrast.

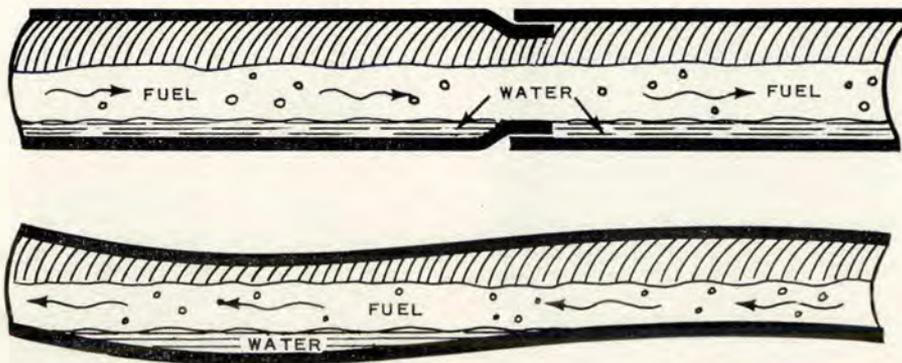
Below are two artists' illustrations showing how entrapped water can remain beneath the lower level of fuel in transfer manifolds of a base POL complex.

We now have hose carts at each pit which will shut off fuel flow when water is present. We also have a lot of aircrews who are flying much easier now that they know where the water came from and that it probably won't happen again. To date it hasn't. It took nine months and a lot of hard work, but thanks to a couple of dedicated maintenance men, a unit safety officer, and a POL type who wouldn't give up, a really serious problem was solved. ☆

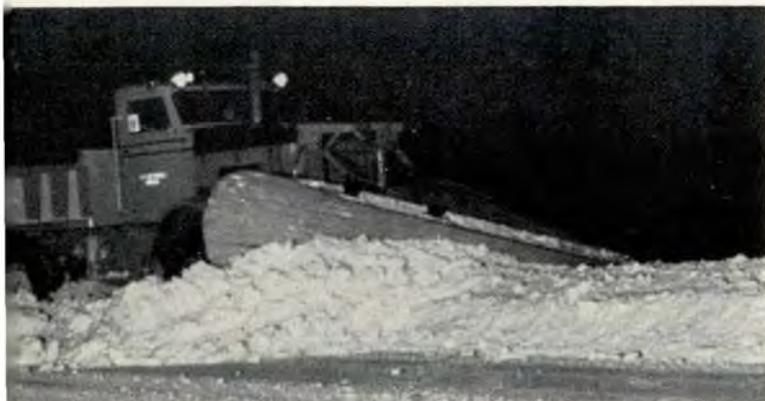
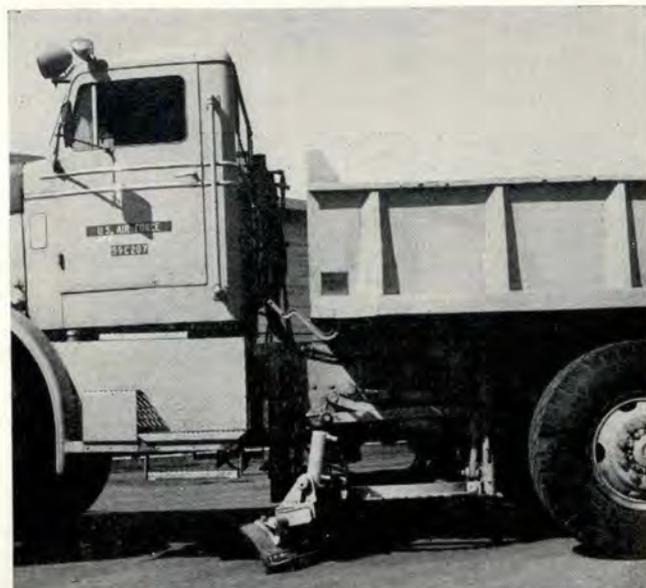
Center drag blades are followed by the airblast sweeper.

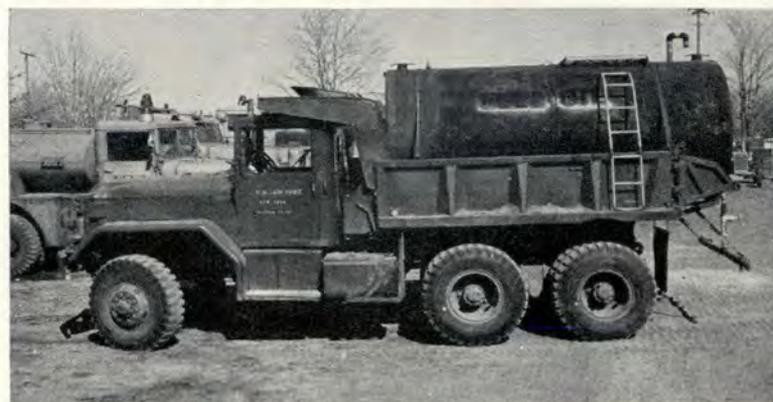
**Spray tanker is used for applying de-icer fluid at Kincheloe.**

the spray tanker with about a 70 (water) 30 (alcohol) solution. We spray four strips down the center—four widths of the spray bar—for the first 3000 feet on the takeoff end and four widths down at the far end of the runway and then run back up the center with what we've got left in the truck. We found that 1000 gallons will effectively clean off about a 100-foot wide strip down the center of the runway. When conditions are just about right we go over this area, loosening the snow and ice with the drag blades, as I described before, and the airblast sweeper will sweep this off to the side and gradually widen the area down the center where there is no ice. Many times we've had conditions of 15-20 degrees below zero with a wet runway and we get a runway condition reading of WR 18 or 20 or even 24 even though the temperature is many degrees below freezing. When the airplanes start using the runway they tend to blast the water off and then we run the Sicard Airblast Sweeper over it. We are thus able to gradually dry the runway. If we get just a little bit of sun through the clouds, we've got a dry runway.

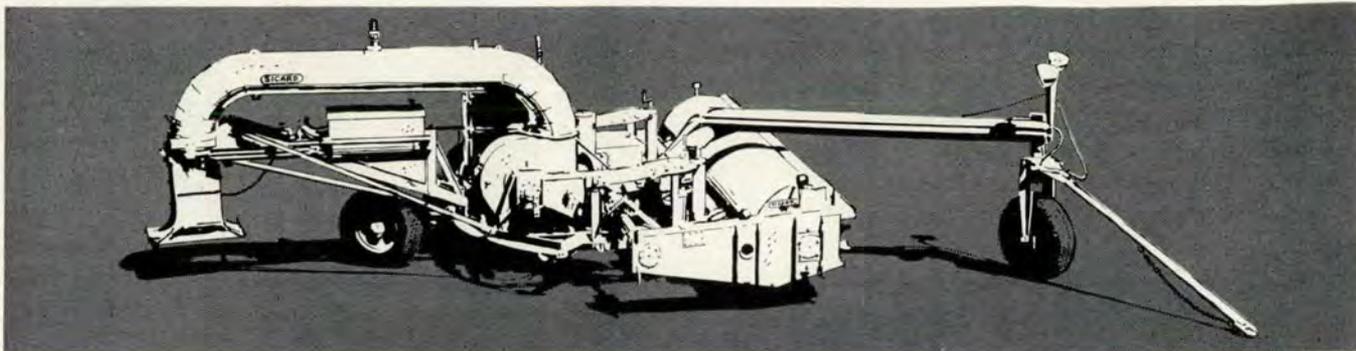
Above is the Sicard Airblast Sweeper, an item of specialized snow removal equipment used at Kincheloe AFB in winter.

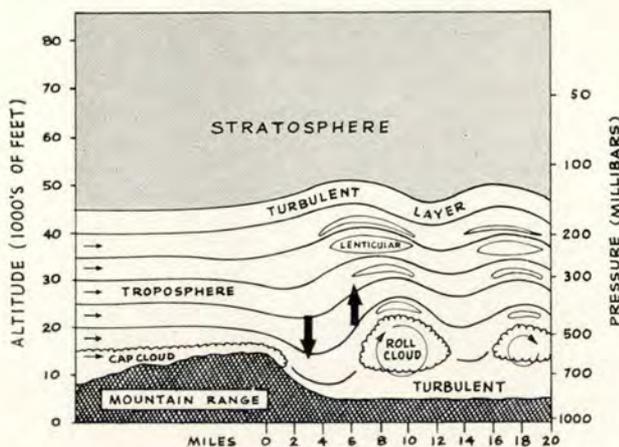
### Mountain Wave Turbulence

Generally speaking, there are two types of turbulent layers associated with the mountain wave. The lower level turbulence is associated with the rotor clouds which exist on the lee side. This is not considered CAT; however, the higher level turbulence is in the CAT family. It averages about 5000 feet in thickness and is usually above the lenticular clouds. This turbulence can extend as much as 300 miles down wind from the mountain ridge.

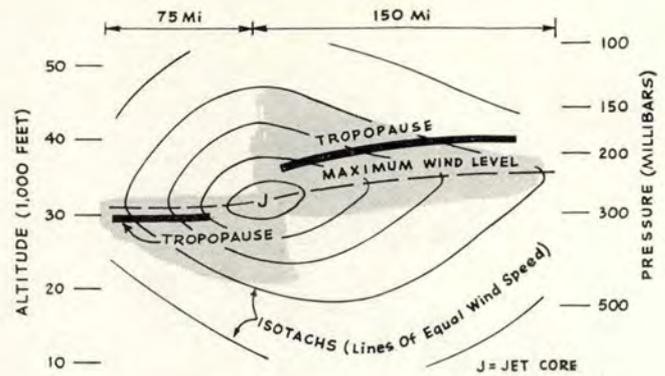
## Jet Stream Turbulence LOOKING DOWNSTREAM

may not be present, areas of turbulence may change in intensity, maximum wind currents are not necessarily continuous and may merge or split into two or more currents and many wind maxima may occur on a given day. CAT increases with increased wind shear along either the horizontal or vertical plane.

Usually there are no tell-tale clouds by which to identify turbulence associated with the jet stream. Other forecasting problems are: turbulence may or

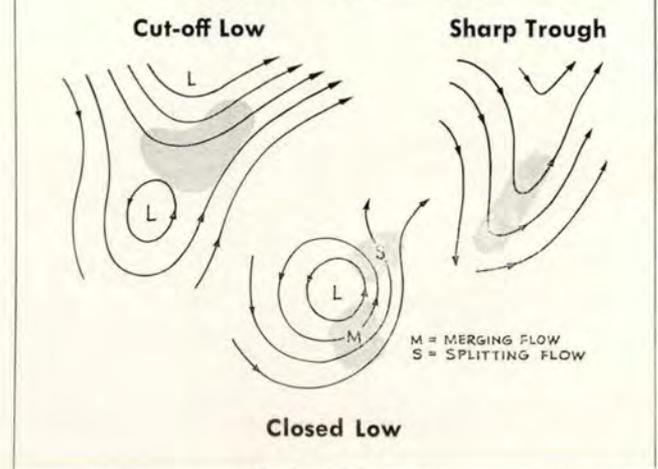
### CAT ASSOCIATED WITH:

Any one of the above situations can produce moderate to severe clear air turbulence. However, the combination of any two or more of the conditions is almost certain to produce severe or even extreme CAT. A jet stream may be combined with a mountain wave, or be associated with merging or splitting flow. The 300-mb chart for 0000Z, 20 January 1961, just a little more than an hour prior to a B-52 crash in southeastern Utah, shows the merging flow of two jet streams which no doubt was associated with mountain waves in the area. The combination of these conditions undoubtedly resulted in the severe to extreme clear air turbulence which this B-52 encountered.

Also, to the northeast of a cut-off low aloft, significant CAT can be experienced.

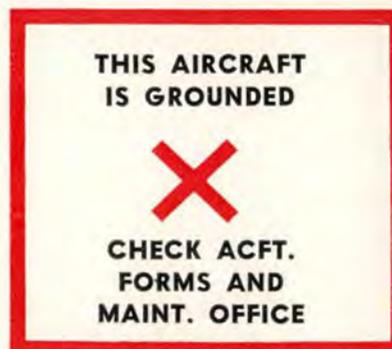
The Transient Maintenance Officer at Hq AFSWC has a plan to prevent pilots from flying (inadvertently, of course) an aircraft that has been grounded. He requires that a red bordered, 8 x 10" placard (pictured here) be attached to the control stick or control column of the grounded aircraft. It isn't easy to ignore such a colorful placard, therefore if prominently displayed it should eliminate the possibility of a pilot's flying an aircraft that has been grounded. ☆

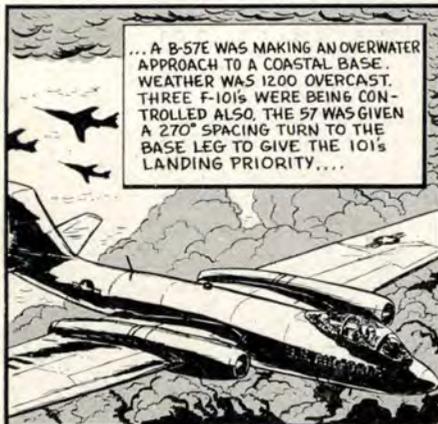
... A B-57E WAS MAKING AN OVERWATER APPROACH TO A COASTAL BASE. WEATHER WAS 1200 OVERCAST. THREE F-101s WERE BEING CONTROLLED ALSO. THE 57 WAS GIVEN A 270° SPACING TURN TO THE BASE LEG TO GIVE THE 101s LANDING PRIORITY...

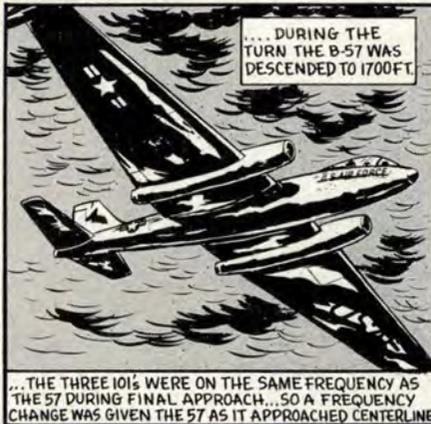
... DURING THE TURN THE B-57 WAS DESCENDED TO 1700FT.

... THE THREE 101s WERE ON THE SAME FREQUENCY AS THE 57 DURING FINAL APPROACH... SO A FREQUENCY CHANGE WAS GIVEN THE 57 AS IT APPROACHED CENTERLINE

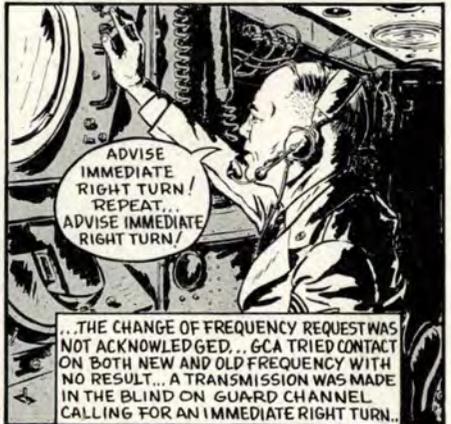
ADVISE IMMEDIATE RIGHT TURN! REPEAT... ADVISE IMMEDIATE RIGHT TURN!

... THE CHANGE OF FREQUENCY REQUEST WAS NOT ACKNOWLEDGED... GCA TRIED CONTACT ON BOTH NEW AND OLD FREQUENCY WITH NO RESULT... A TRANSMISSION WAS MADE IN THE BLIND ON GUARD CHANNEL CALLING FOR AN IMMEDIATE RIGHT TURN...

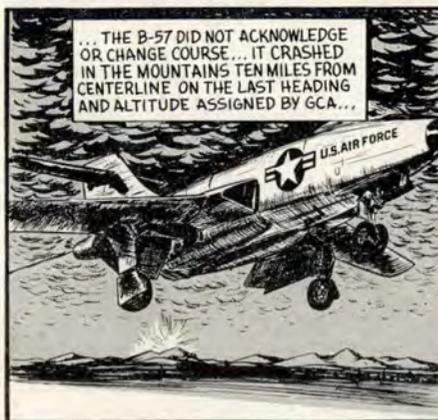
... THE B-57 DID NOT ACKNOWLEDGE OR CHANGE COURSE... IT CRASHED IN THE MOUNTAINS TEN MILES FROM CENTERLINE ON THE LAST HEADING AND ALTITUDE ASSIGNED BY GCA...

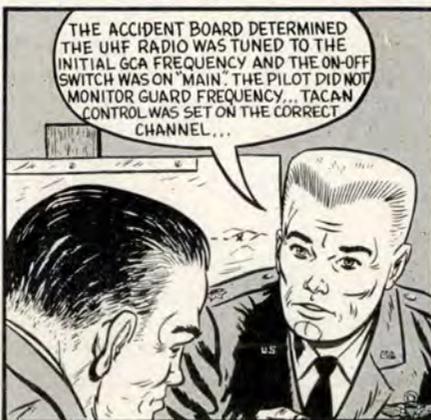
THE ACCIDENT BOARD DETERMINED THE UHF RADIO WAS TUNED TO THE INITIAL GCA FREQUENCY AND THE ON-OFF SWITCH WAS ON "MAIN". THE PILOT DID NOT MONITOR GUARD FREQUENCY... TACAN CONTROL WAS SET ON THE CORRECT CHANNEL...

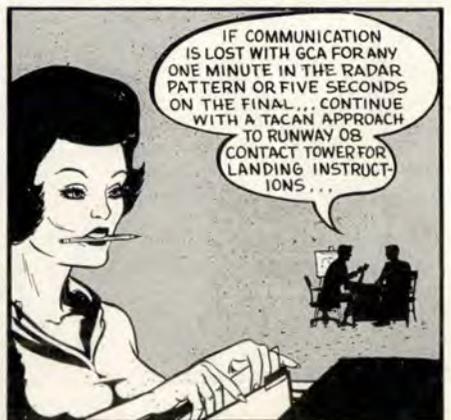
IF COMMUNICATION IS LOST WITH GCA FOR ANY ONE MINUTE IN THE RADAR PATTERN OR FIVE SECONDS ON THE FINAL... CONTINUE WITH A TACAN APPROACH TO RUNWAY 08 CONTACT TOWER FOR LANDING INSTRUCTIONS...
