A E R O S P A C E

SAFETY

UNITED STATES AIR FORCE

January 1964

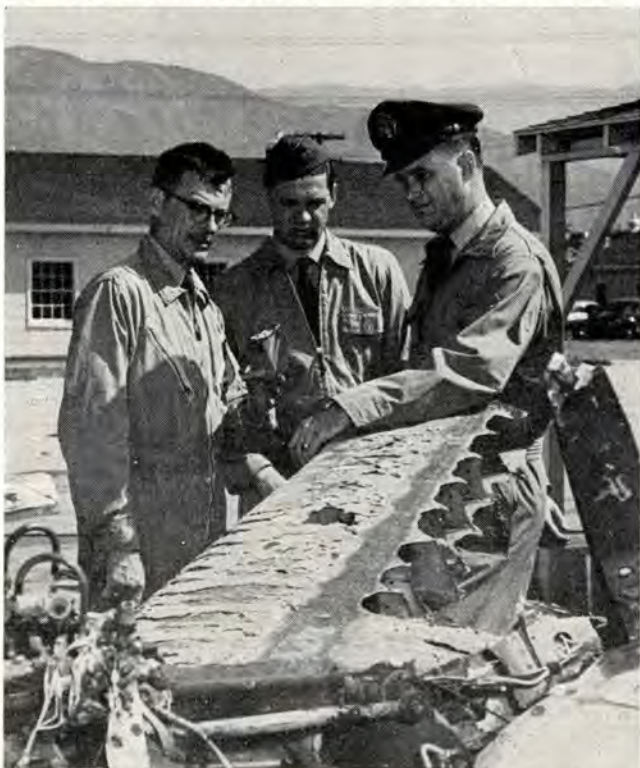
Recovery of wreckage is vital in finding cause of accident.

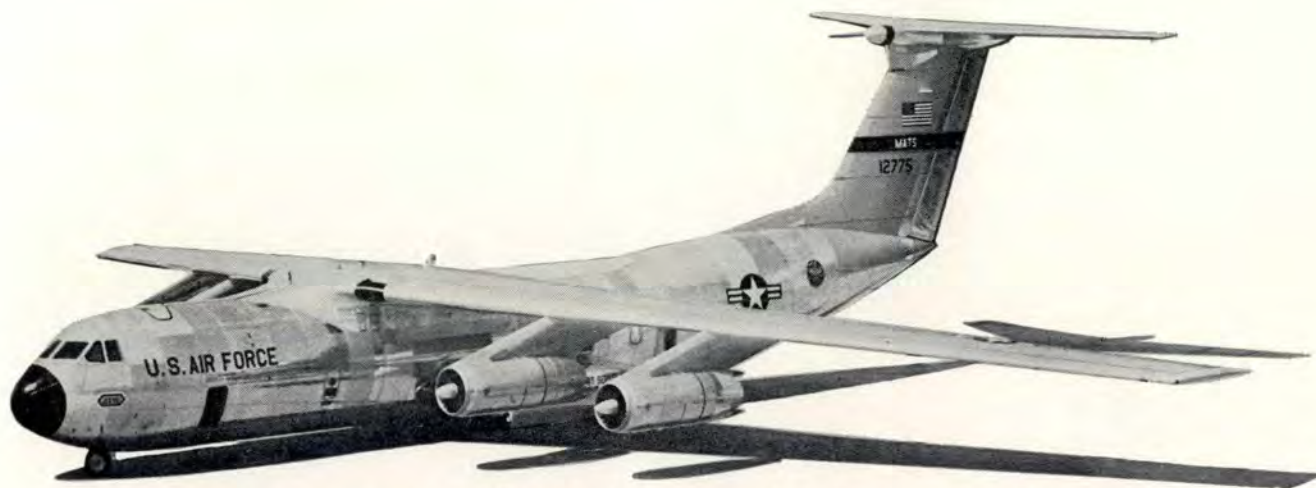
Four big engines providing 84,000 lbs. of thrust will push Air Force's new C-141A Starlifter.

The combined power of the four turbofan engines is 84,000 pounds in the static condition, with a total reverse thrust up to 53,000 pounds.

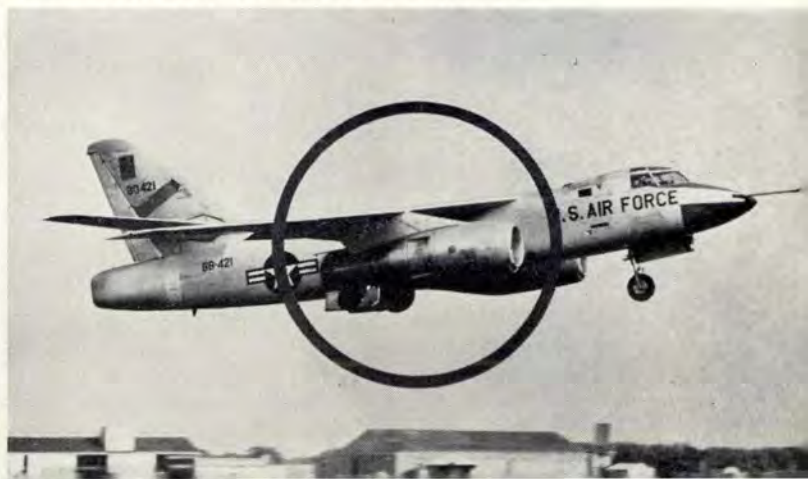
Pratt and Whitney TF33-P-7 engine during cold weather tests at Eglin, in flight on B-66 test bed.

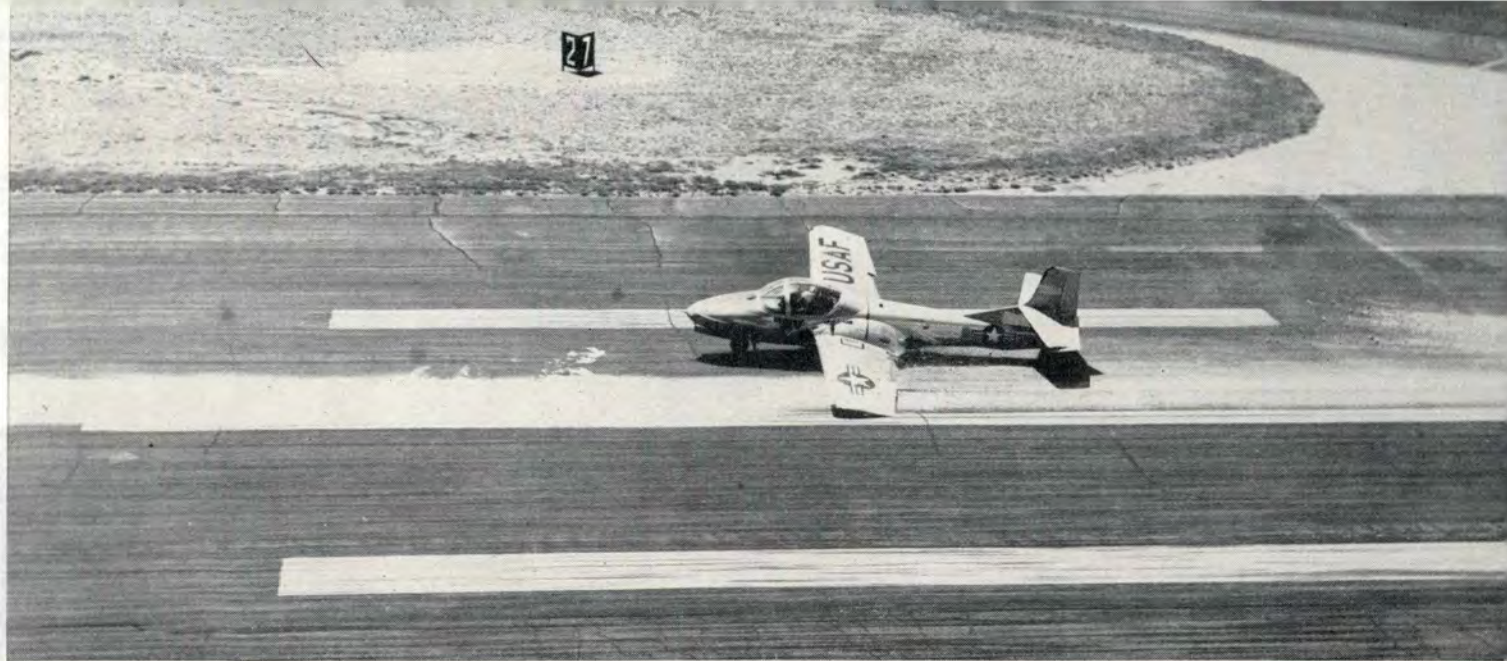
Figures 1 through 5, top to bottom: USAF's first barrier was used in Korea; improved, it became the MA-1A; shanked hook with air oil dampers used on F-102, F-104, F-105. F-106 with spring hook after engaging BAK-6; diagram illustrates water squeezer principle.

In Figure 1 you see the Granddaddy of all USAF barriers. This is the first successful adaptation of the Navy's low net idea to the USAF overrun problem on land bases. This picture was taken in Japan during the Korean war. Pilots argued about her flying qualities but barrier people loved the F-84 because she was the best barrier engager the Air Force ever had.

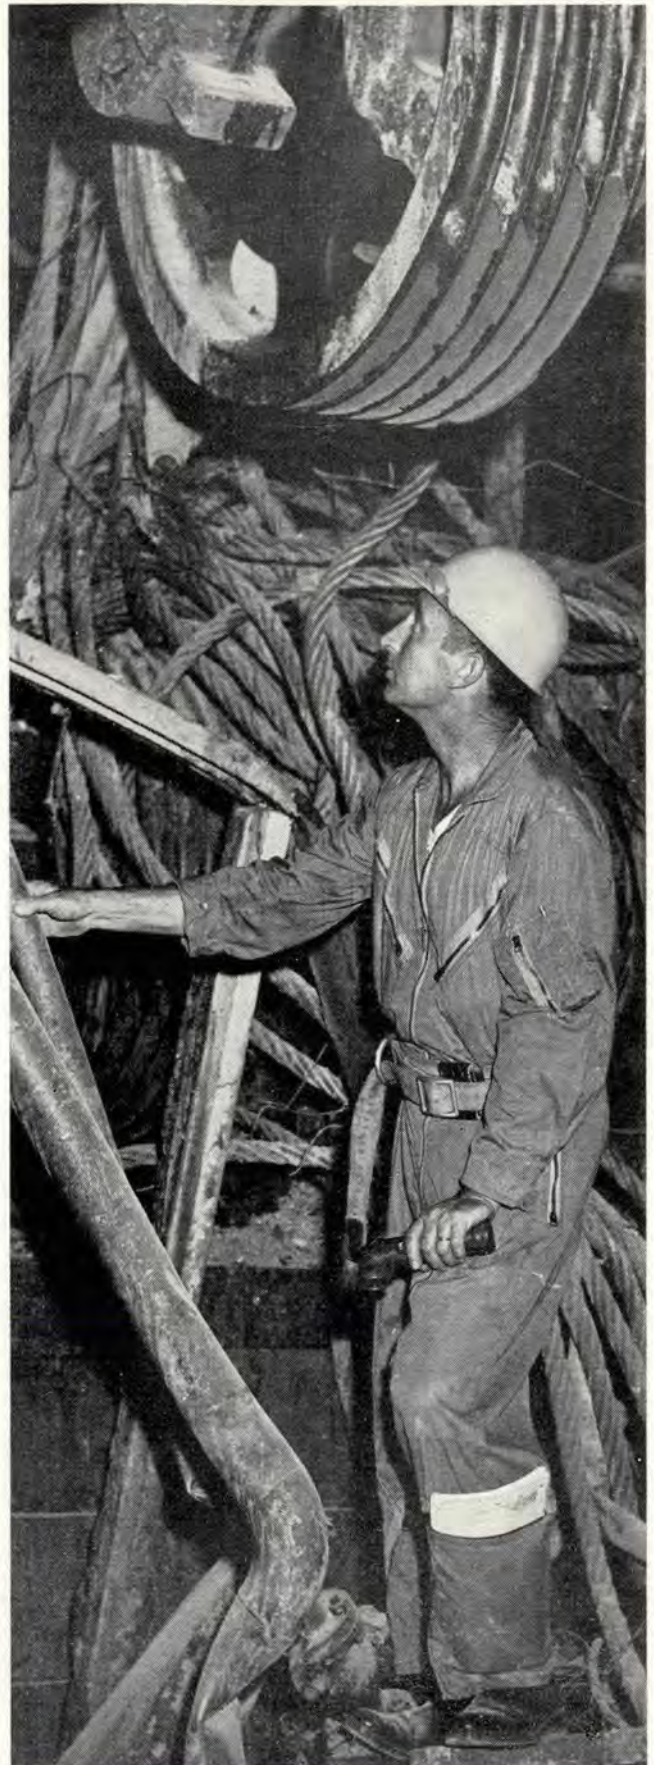
The observations, conclusions, and recommendations of the advisors from the architectural engineering corporation were: there was severe spalling of the concrete, particularly on the underside of the silo cap and the walls on the south side around the southerly shock hangar wall bracket and the southeast quadrant down

to level 7. The structural members of the crib were not damaged except that columns C and D were severely distorted at levels 3 and 2, the penthouse beams on the north and south sides were severely distorted, the counterweight hand guide rail was distorted and torn loose from its support, the principal member on level 3 between the launch platform area and the counterweight area was distorted and torn loose from its connection on the south end, counterweight cables were broken and the counterweight had fallen to the bottom of the silo, secondary members supporting heavy equipment on various levels were extremely deflected, shock struts were fully extended and the springs had bottomed on the south and west sides. The silo walls had failed due to spalling caused by prolonged exposure to fire and high temperature rather than blast forces. No further collapse of the walls or cap was anticipated since ring beam supports carry earth loading.

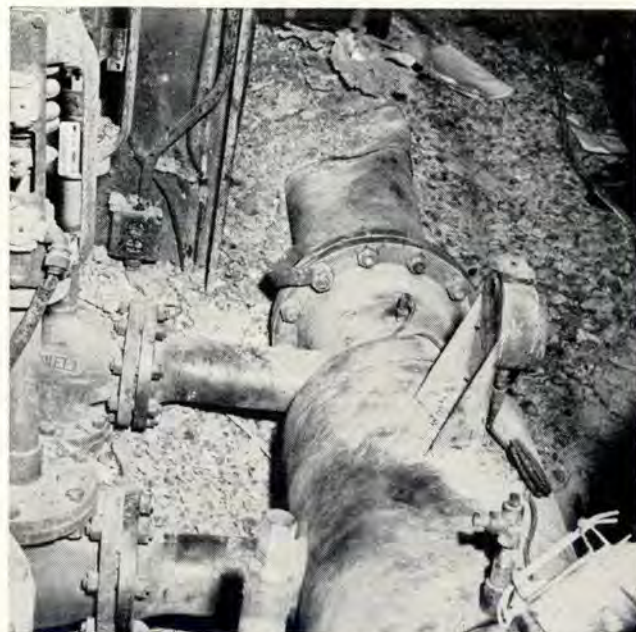
LOX transfer control prefab received careful scrutiny.

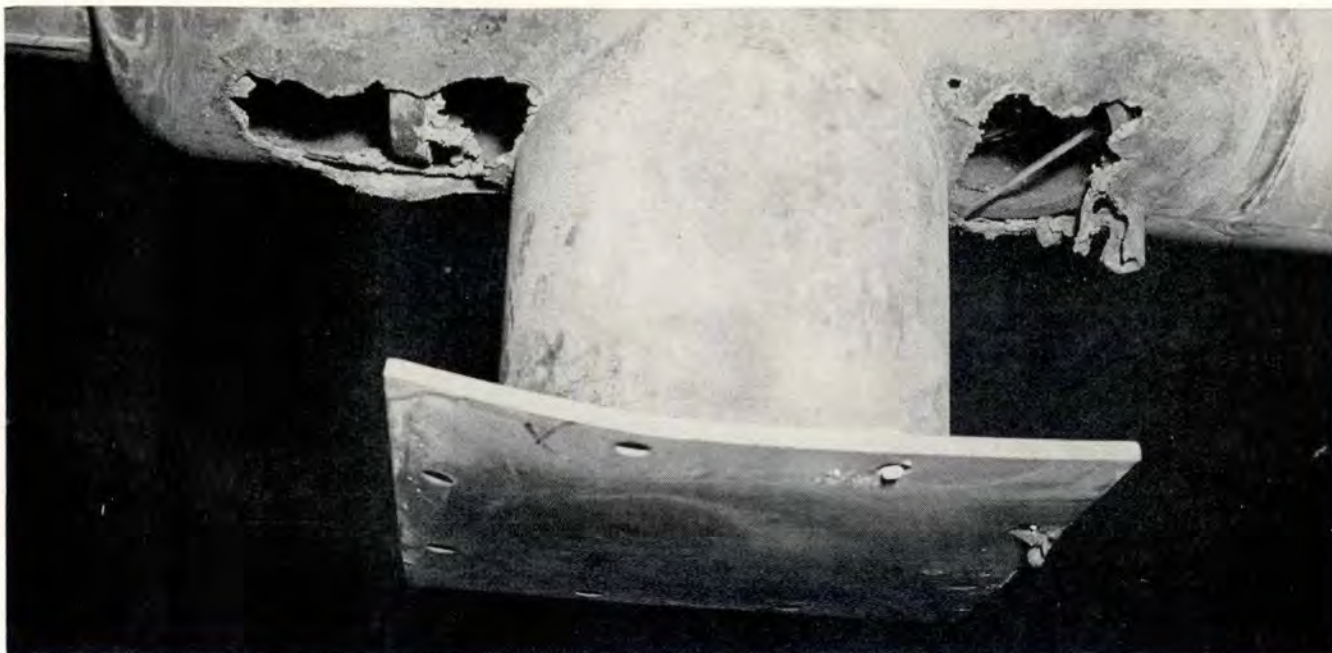
Large holes in LOX filter housing resulted from an internal oxygen-steel fire during missile downloading cycle.

The holes in the filter housing were the result of an internal oxygen/steel fire originating in the filter mesh and burning through the filter housing during the downloading cycle. There was evidence of LOX flow during the fire both through the L-16 valve and through the burned hole areas. LOX flow through the holes in the filter housing caused the cryogenic failures of the steel beams observed in the vicinity of the L-15 filter. Examination of the filter element J-bolts revealed a cold

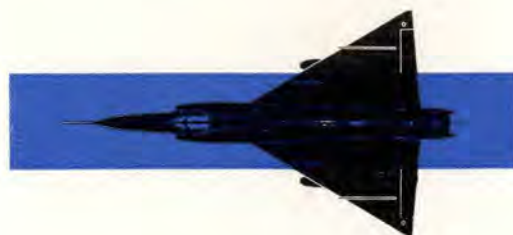
deployed the drag chute and lowered the nose wheel to utilize nose wheel steering for directional control. Immediately after touchdown severe vibrations were experienced from the left wheel. These vibrations were so severe the UHF radio was re-channeled and the pilot was unable to determine whether the nose wheel steering was operating. Marginal directional control was maintained with right brake, however the severe vibration from the left wheel caused a break in the high pressure pneumatic lines. Loss of the high pressure pneumatic system caused the drag chute to jettison. Effective directional control was lost and the aircraft began an uncontrollable swerve to the left. At this point the tail hook engaged the BAK-9 barrier near the center of the runway. The aircraft stopped 724 feet after

engagement. The pilot reported deceleration forces to be very mild, comparable to those experienced during drag chute deployment. The pilot escaped injury and aircraft damage was limited to incident classification. Cause of the blown tire was not determined.
