A E R O S P A C E

SAFETY

UNITED STATES AIR FORCE

MAY 1964

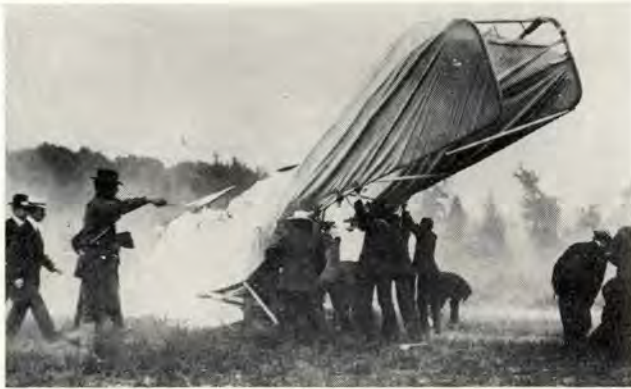
Wreck of the Army's first Wright airplane. Orville Wright, who was piloting, survived. Passenger, Lt. Thomas E. Selfridge, was the first man in the world to be killed in a plane.

Structural failure was blamed for the accident. Subsequent investigation revealed that Orville Wright first heard what he believed to be a light tapping in the vicinity of the right propeller, which was the one on his side of the airplane. A crack had developed in one of the hand-carved wood propeller blades, flattening the blade and setting up a severe vibration. This, in turn, loosened one of the wires supporting a steel tube which housed the propeller shaft. The unsupported shaft permitted the rotating propeller blade to swing around and cut the stay-wire to the vertical fin and rudder on the right side of the aircraft. Orville killed the engine at the first sign of trouble, but could not prevent a spin when con-

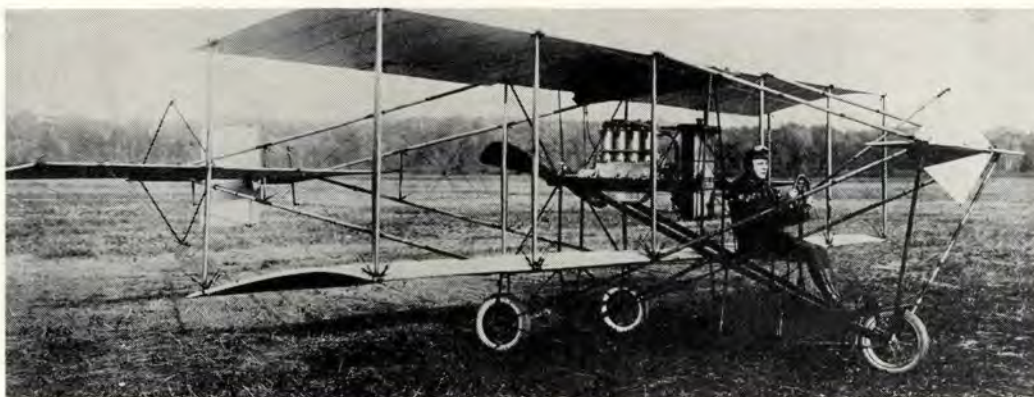
Lt. Frank M. Kennedy in the Curtiss trainer, S.C. 2, at College Park in 1911, after the aircraft had been rebuilt following Lt. Kelly's fatal crash at Ft. Sam Houston. Later, this same airplane killed Lt. Joseph D. Park in Calif. Lt. Kennedy, himself, crashed in a similar plane.

Kelly's landing was an exceptionally hard one. When the front landing wheel of the ship's tricycle gear struck the ground, the shock broke the seat supporting fork, which was a main structural member of the landing gear. The broken front ends of the fork stuck in the earth. This broke a bamboo outrigger which supported the horizontal elevator at the front of the airplane. Kelly applied power and was soon airborne again. In an effort to avoid a row of tents along the edge of the drill ground, he made a sharp turn while still very low. The weakened airplane dove straight for the ground, hitting left wing first. Kelly was thrown from his seat when his safety belt snapped. He hit the ground 20 feet away, breaking his neck. When he died a few hours afterwards, he became the first American military aviator to lose his life while piloting an aircraft. Kelly Air Force Base is named for him.

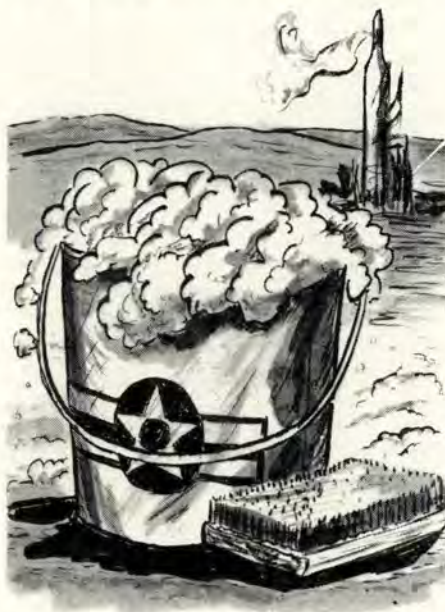
Diesel engines, fuel and oil tanks, and hydraulically operated equipment are located on Level 6 and above in the HGM-16F silo. LOX transfer and storage equipment are located on Levels 7 and 8. Spills and leaks of hydrocarbon fluids, if not promptly contained and removed from the silo crib structure and equipment, will penetrate lower levels and contaminate the LOX system. Hydrocarbon contamination of a LOX system can result in a catastrophe.

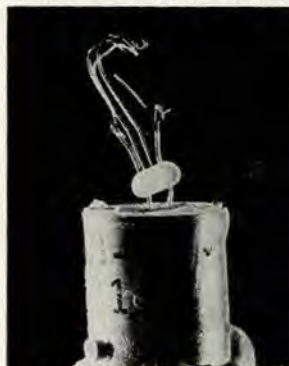
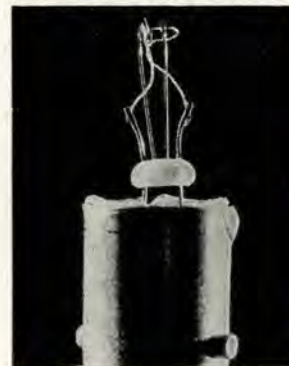
CORRECTION

Pictures, illustrating the Aerobit "Let There Be Light" in the April issue, were inadvertently reversed. They have been reprinted below, showing what happens to a small filament shocked in the cold state (left) and in the heated state.
