A E R O S P A C E

SAFETY

UNITED STATES AIR FORCE

OCTOBER 1965

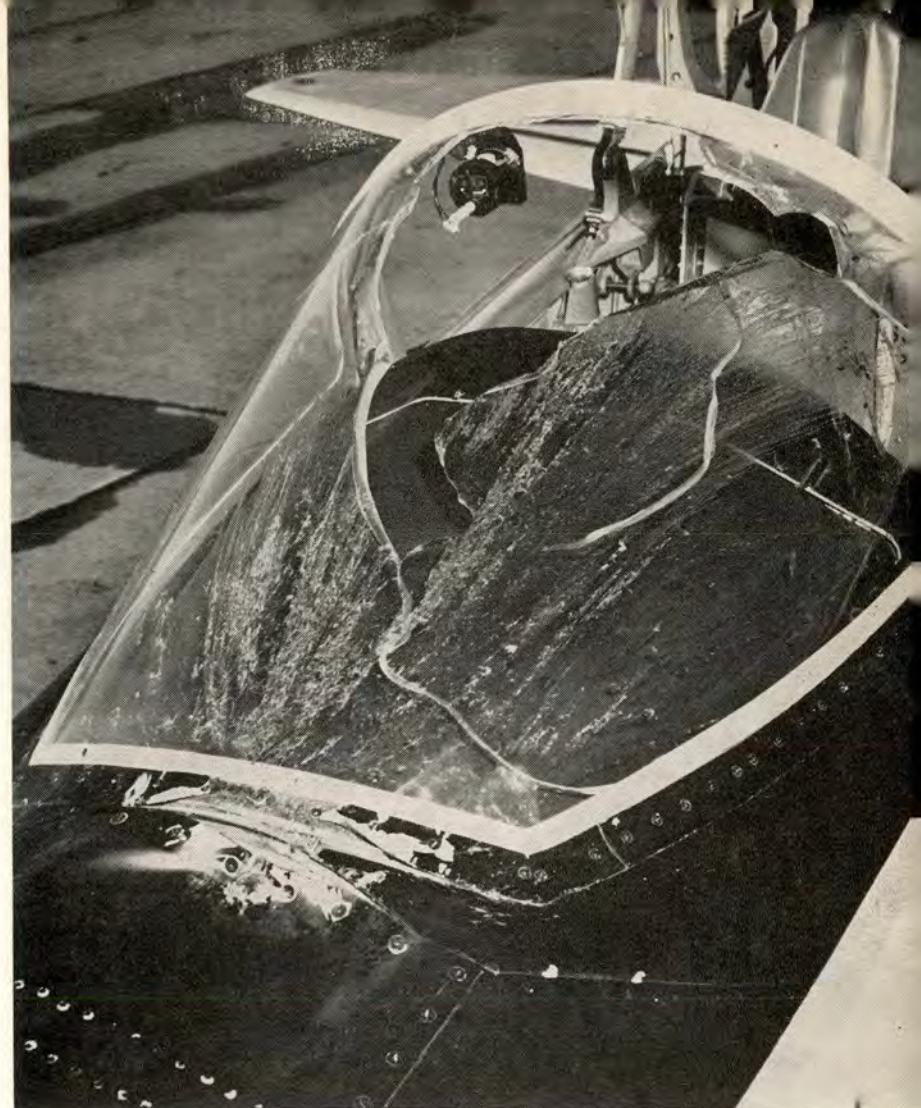
This is what happened when a 3-lb duck and the windshield of a T-38 collided. Bird did not enter cockpit, but residue was found on student pilot's visor, which was down.

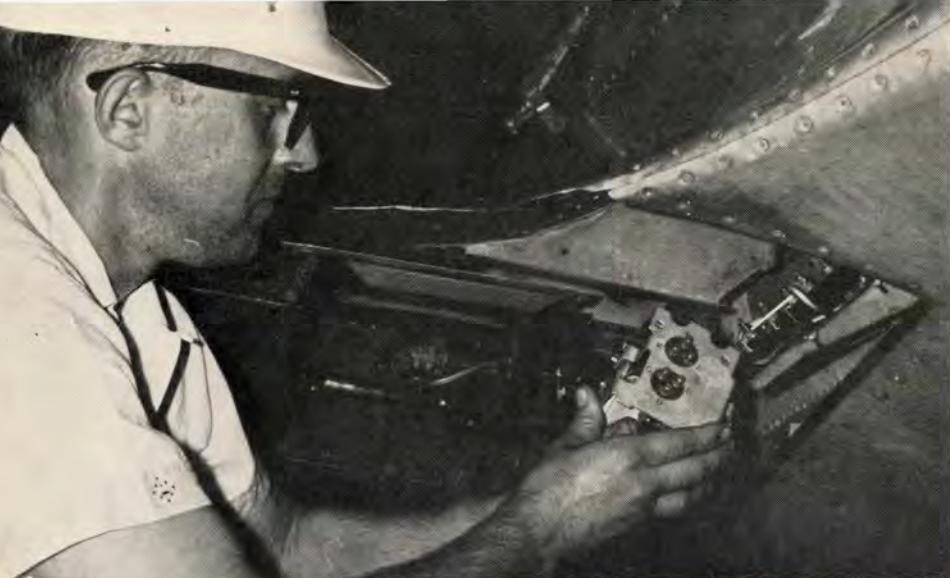
Culprit! Voltage regulators were involved in 12,600 malfunctions and nearly 500 aborts during a six-month period last year.

sight that confronted them when the smoke cleared was: one battery melted in half and the top of the other one melted away. Electrolyte covered the nose and canopy. After maintenance it was determined that the voltage regulator had fouled up. A near miss — *strike one*.

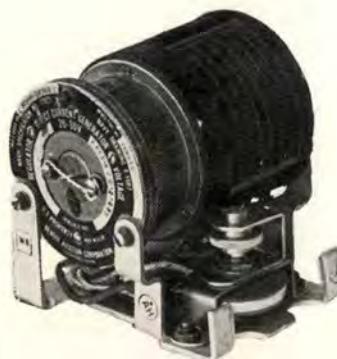
In the past three years, voltage regulators have been UR'ed only 26 times. Better reporting is necessary.
