A E R O S P A C E

SAFETY

DECEMBER 1965

HOW WE TAMED THE TIGER IN OUR TRANSMITTER

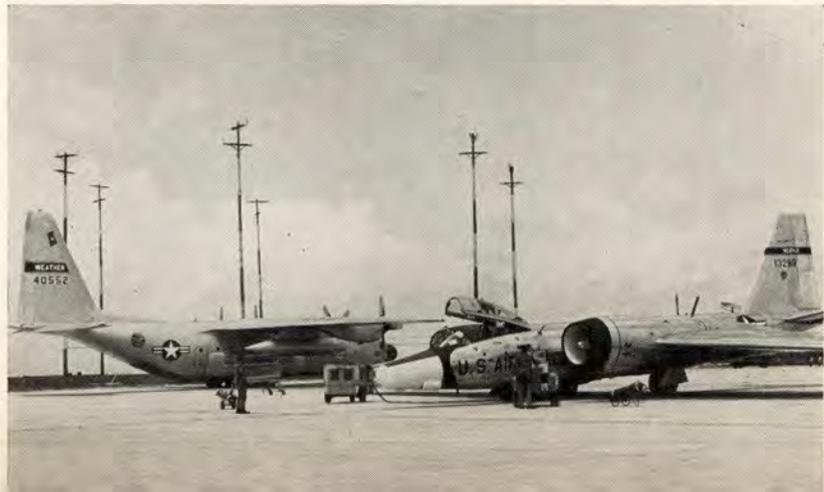
Two of AWS' newest aircraft, the RB-57F of the 58 WRS, Kirtland AFB, N.Mex., and a new WC-130E belonging to the 54 WRS. The WC-130 has been specially modified for weather reconnaissance work to include penetration of tropical depressions, storms and typhoons. The RB-57 is a high-altitude aircraft designed for atmospheric sampling operations.

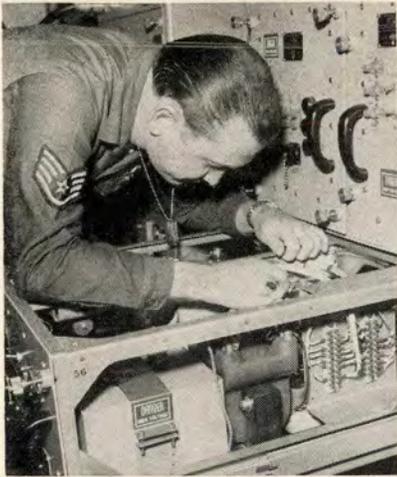
Fig 1, left, some typical hazards encountered daily. If equipment being handled were in a hot condition, this would be an ideal "How Not To" illustration, particularly for airman wearing metal pencil and security badge.

The TACAN transmitter component shown in Figure 1 illustrates some of the typical hazards that we encounter on a day-to-day basis. If the equipment handled by this man were in a hot condition, this would be a typical "How Not To Do It" picture. The component he is working with has many points of exposure of 300 volts or over. Much of this equipment must be

adjusted while hot, must be handled in confined quarters, and often has to be repaired in the minimum of time, such as would be the case with this TACAN component. Note this maintenance man is wearing a metal pencil and a metal security badge—this is not done when maintaining live equipment.

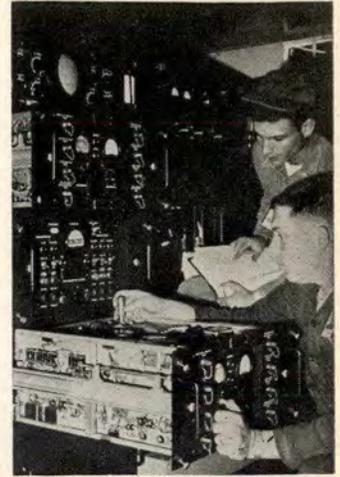
Fig 2, right, another NAVAID — a VOR transmitter. The safety observer is a standard requirement rigidly enforced in AFCS. Work on high voltage equipment is not permitted unless he is present.

Figure 2 shows another NAVID — a VOR transmitter. Note the safety observer. This is a standard requirement that is rigidly enforced in AFCS. We do not permit any work to be done on high voltage equipment unless a trained safety observer is present.

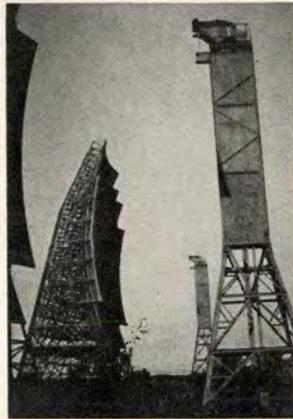
Fig 3, right, the Mark 85 tropospheric scatter antenna reaches 118 feet into the air and requires maintenance in all kinds of weather.

Figure 3 shows our Mark 85 tropospheric scatter antenna and illustrates several of the other problems that we face. Personnel must climb up into the feed horn. This is usually done with the equipment de-activated. However, some adjustments are made while the equipment is hot. If a man gets be-

tween the reflector and the antenna, he can receive quick, serious and, perhaps, fatal RF burns.

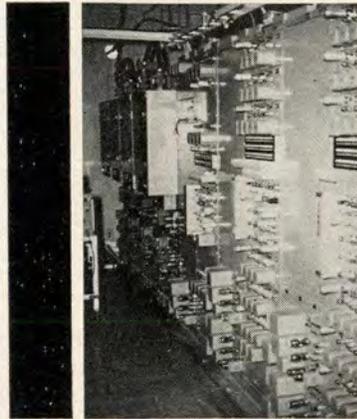
Fig 4, left, tropo site with transmission equipment. Tubes and checkpoints are accessible from exterior, eliminating working "in the blind."

Figure 4 shows some of the transmission equipment employed in a tropo site. Note the safety factors in connection with this equipment. Tubes and checkpoints are accessible from the exterior. A minimum of exposure to high voltages is required. Equipment is well lighted so that maintenance can be done without use of flashlights. Working "in the blind" is eliminated.

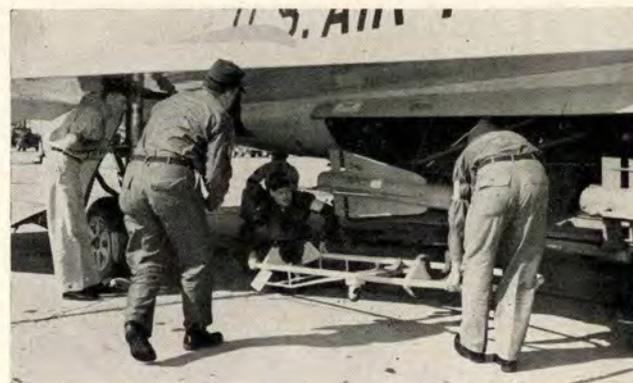
Downloading. Now here, somehow, is where the Falcon got together with the red and yellow garbage can. After missiles had been extended, and as the nose cone cover was being installed prior to downloading from the launcher rails, this badly bent Falcon was discovered. Damage consisted of:

- Forward section of fuselage buckled on launcher hook side of the missile approximately 20 inches aft of guidance unit.

- Guidance unit was dented two and one-half inches long, one inch wide, and three-sixteenths inches deep.
- Sealing sleeve had launcher rail indentation on launcher hook side.
- Forward stabilizers Nr 1 and 4 were separated from sealing sleeve.
- Apparent separation between forward fuselage and forward launcher hook ring.
- Stabilizer latch hook on left side of missile broken off.

Again, mishaps don't just happen — someone usually causes them. Cause? You guessed it! Someone did not follow the printed word and clear obstructions from beneath the doors. This Falcon, when extended on the launcher rail, came down on the top edge of the garbage can. Result: Best part of a \$15,778 Falcon ended up in a garbage can.

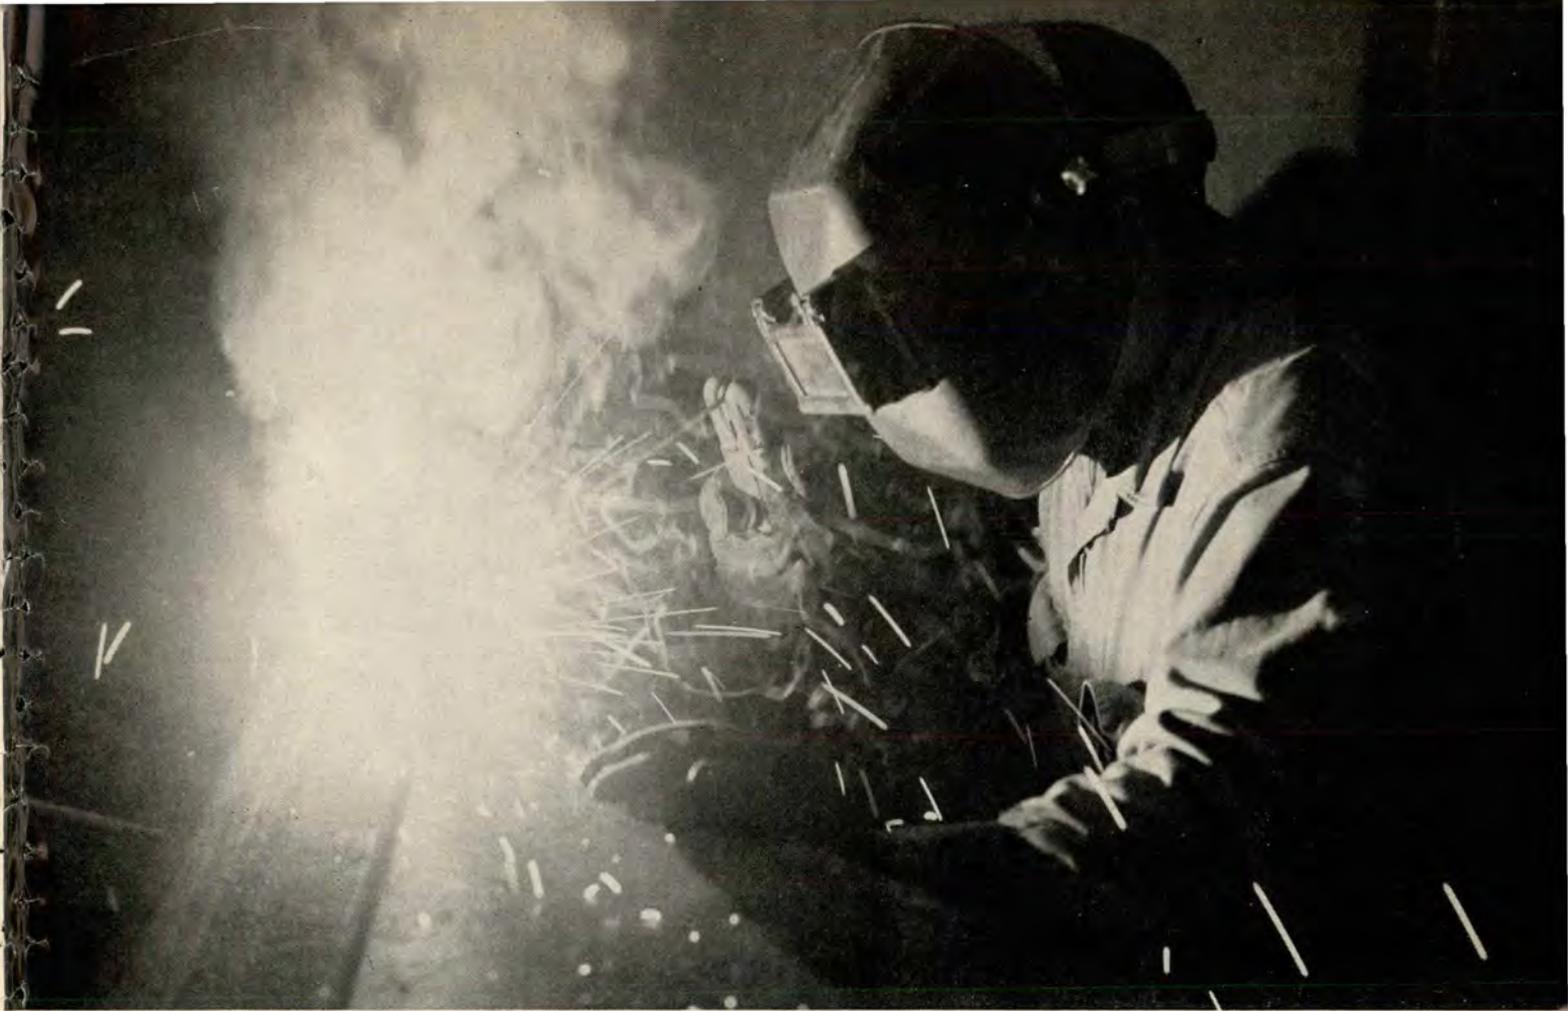
The sizes of these flames and arcs are misleading indicators of their potential hazards. An oxyacetylene flame may have a temperature as high as 5600°F; some types of welds run even hotter, as high as 11,000°F in the atomic hydrogen method. At these temperatures, materials which are generally regarded as nonflammable, will ignite, and in some cases, explode. Residues of materials which are only moderately flammable may burst into flame even when they are not immediately under the flame or arc. Although they may be some distance away, the heat conducted through the metal being welded may cause them to vaporize and raise their temperatures above the auto-ignition point. During a Titan I update program, insulation close to the area where a pipeline weld was being made was not removed. The heat caused charring and burning of the normally stable insulation.

Because of its high conductivity, metal remote from a surface being welded, but part of the object, may be dangerous to the welder. This metal may not be hot enough to glow, but still hot enough to burn the skin badly.

Hot spatter, dripping weld metal (slag), and sparks may cause burns, fires, and other damage at consider-

able distances from the welding operation. A fire in a Titan I silo started when sparks generated during electric welding ignited hydrocarbons in a sump. After update of an Atlas F silo, a small burned hole was found in the pressure balance joint (PBJ-2) in the liquid oxygen system. The hole was probably caused by slag drip from heliarc welding at a higher level.
