A E R O S P A C E

O C T O B E R 1 9 6 6

THE NEW BREED OF BIRD

As an example of some of the safety features incorporated into one of the newest aircraft scheduled for the USAF and USMC inventory, let's take a quick look at the OV-10A. This aircraft is a STOL system designed for COIN and/or FAC operations. Its multi-mission performance capabilities are impressive as evidenced by Figure 1. However, its inherent safety features are more impressive. Here are some of the more significant items of interest from a safety aspect.

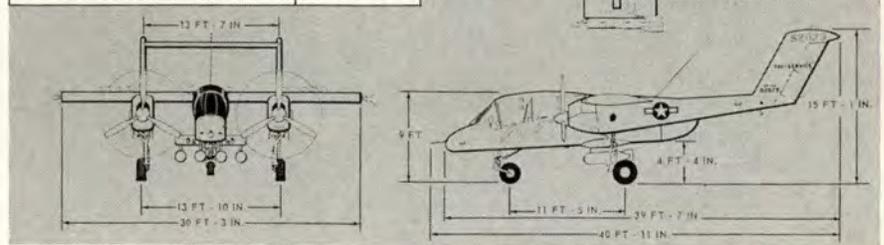
THREE-VIEW

EMPTY WEIGHT	5,267 LBS
STRUCTURAL LOAD FACTOR (LIMIT)	8.0
FLIGHT DESIGN GROSS WEIGHT	7,569 LBS
LANDING SINK RATE	20.0 FT/SEC
LANDING DESIGN WEIGHT	8,441 LBS
APPROACH SPEED	60 KNOTS
MAXIMUM SPEED (GUARANTEED) AT SEA LEVEL	265 KNOTS
SERVICE CEILING (TWO ENGINES)	27,000 FT
MAXIMUM OVERLOAD TAKE-OFF WT	13,264 LBS
MAXIMUM ORDNANCE LOAD	3,270 LBS
UTILITY BAY VOLUME	75/110 CU. FT.

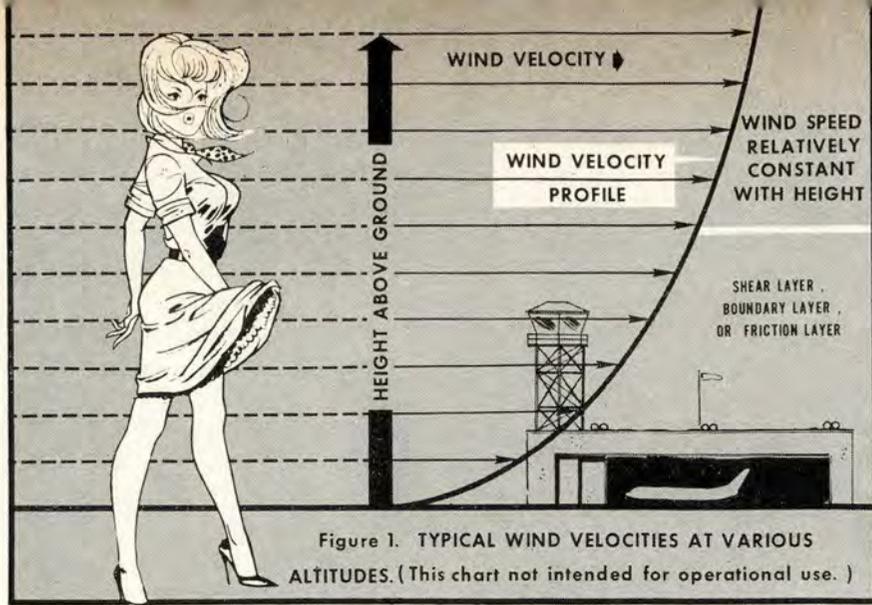
The winds aloft move under the influence of forces largely independent of ground conditions. At the surface the wind velocity is always zero with respect to the earth as shown in Figure 1. There is always a shear layer (or boundary or friction layer) at the surface. In this layer the wind velocity changes from zero to the velocity of the prevailing wind aloft. In Figure 1, the wind velocity at various heights is indicated by the horizontal arrows. The heavy line through the end of the arrows is known as the wind velocity profile. The boundary layer is thin with respect to the atmosphere but may be significantly thick with respect to aircraft operation. The height of the shear layer is usually estimated to be from 10 to 1000 feet, depending on prevailing conditions.

Since the introduction of emergency war operation downwind takeoffs, the wind velocity profile near the ground is of added significance to pilots. During climb-out on an upwind takeoff, the increase in wind velocity with altitude provides a safety factor; but during a downwind takeoff, this increase in wind speed with altitude becomes a tail wind component that must be considered when determining the airplane climbout capability.

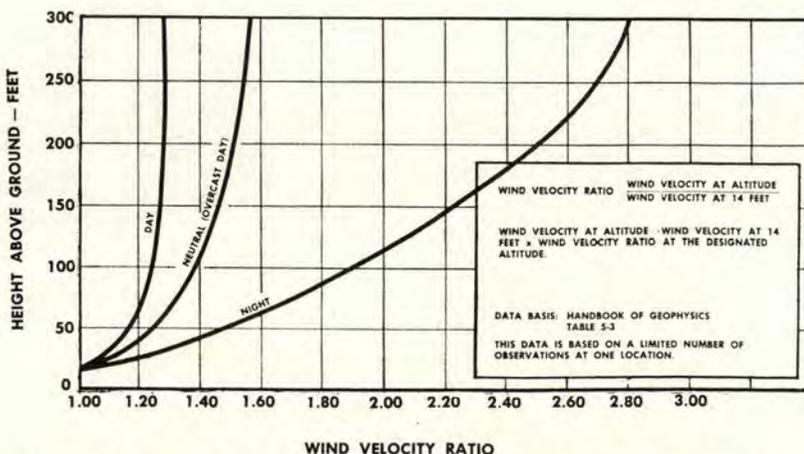
Figure 2 illustrates the large variation in the wind velocity profile which could be encountered during climbout. A typical curve is shown for day, night, and neutral conditions. In each case, the reading at the standard anemometer height (14 feet) is divided into the wind velocity at greater heights over the

The DAY curve shows a significant tailwind increase only during the first 50 to 60 feet of climb. The NEUTRAL curve shows a large change up to a height of perhaps 150 feet. The NIGHT curve shows an appreciable increase in the tailwind component right on up to 300 feet above the ground. All three curves indicate:

- An increase in tailwind can be expected on every downwind climbout.
- The greatest increase in the tailwind velocity occurs in approximately the first 100 feet of climb.
- The airspeed must be monitored very closely during the first several hundred feet of downwind climbout. ★

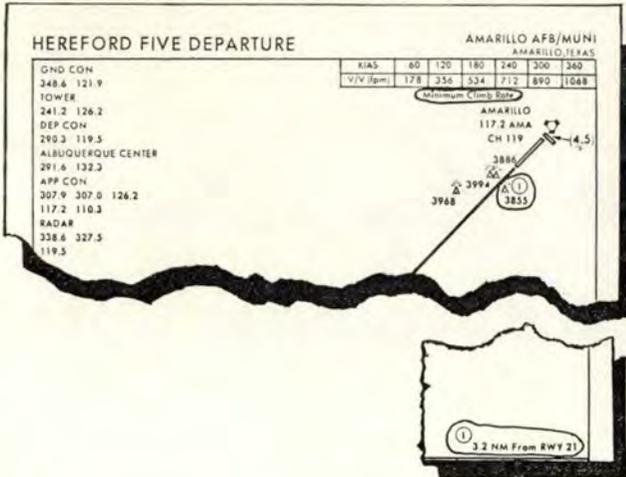
Q Concerning the above SID, what is the significance of the term "minimum climb rate," and how is it used?

The minimum climb rate is derived from a minimum climb gradient based on the location and height of a controlling obstruction. Determination of the controlling obstruction is explained in SID criteria. The minimum climb gradient provides 100 feet clearance over this obstruction for each mile it is located from the end of the runway. In the above example the controlling obstruction is noted as the 3855-foot obstacle located 3.2 NM from the departure end of the runway. The required obstruction clearance is 3.2 NM x 100 or 320 feet. 320 feet added to 3855 feet MSL totals out to 4175 MSL, or 570 feet above field elevation. Therefore, the minimum climb gradient for the "Hereford Five" SID would look like this:

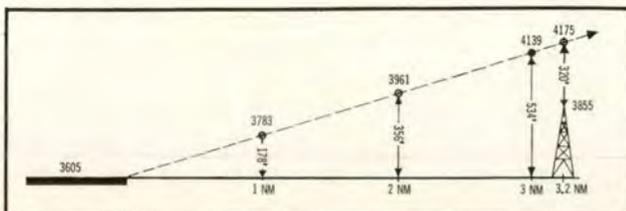
reach 570 feet above field elevation at 3.2 NM is a fairly simple matter. Dividing 570 feet by 3.2 NM results in a gradient of 178 feet per NM. Therefore, at 60 knots (1 mi/min) the vertical velocity required is 178 FPM. At 120 knots (2 mi/min) it is 356 FPM, etc. (Refer to the minimum climb rate table for the "Hereford Five" SID.)

How can you use this information in your preflight planning? Since the minimum climb gradient begins at the departure end of the runway, any altitude you have as you pass over the end of the runway on takeoff is extra margin in your favor, provided you maintain the minimum vertical velocity. Also, notice how you can compute indicated altitude "check points" as you proceed out the initial climb path. For example, at 2 NM from the departure end of the runway the minimum indicated altitude should be field elevation plus the minimum climb rate specified for 2 mi/min (or 120 KIAS) from the minimum climb rate table (3605 + 356 = 3961 at 2 NM).

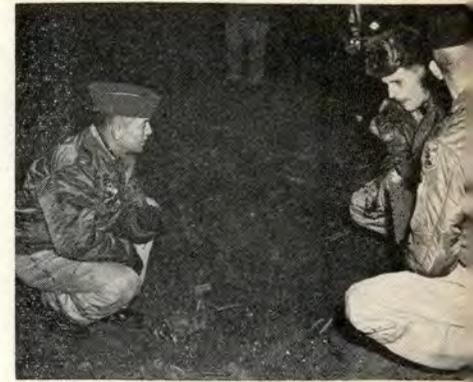
Investigators examine point of initial impact.

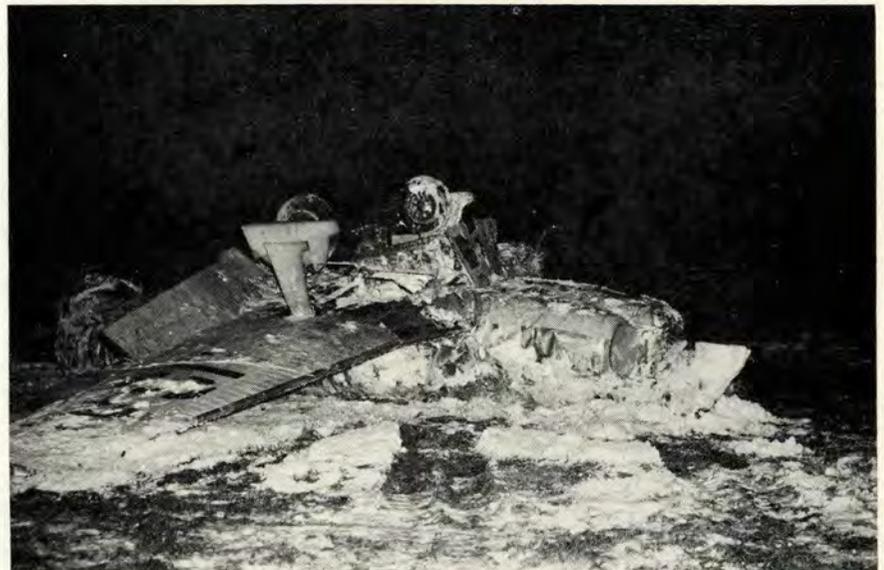
Fire was controlled almost immediately, but pilots were killed when aircraft crashed inverted.

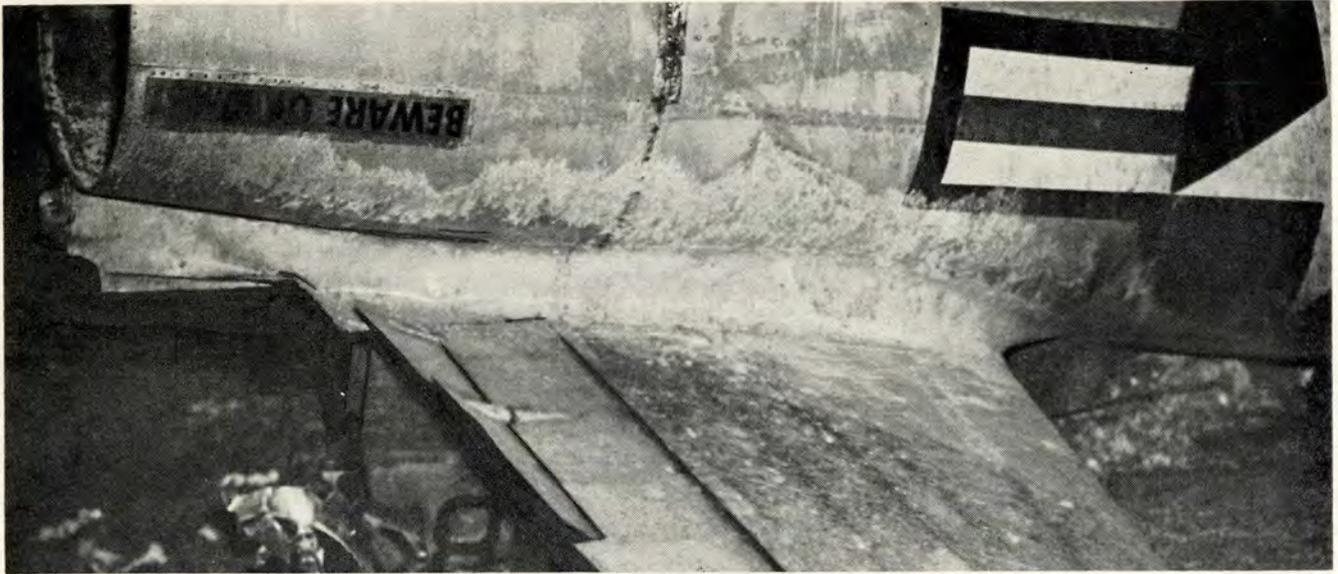
Photo shows horizontal stabilizer with elevator tab in full nose-up position.

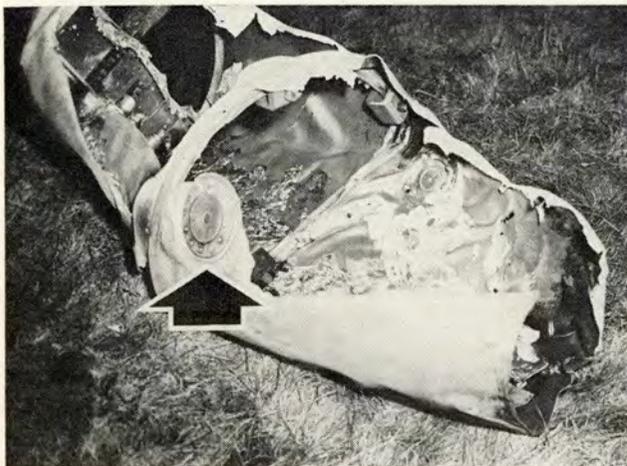
Damage in left tip tank cap area.

Another: "Tip tank caps very hard to remove." Correction: "New caps not broken in."

In summary, what can be said about this accident? First, a minor piece of defective equipment set up a situation that could result in an accident. Then the pilot, for reasons we will never know, decided the aircraft was controllable (despite precautions in the Dash One), failed to drop his tips and attempted a landing. He paid a pretty high price for a bad guess. ★

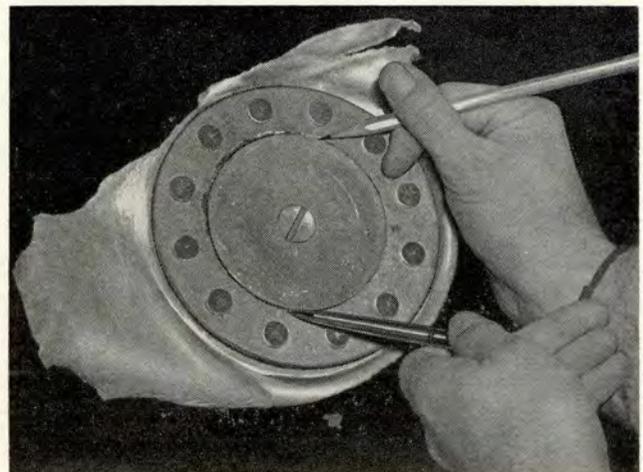
Left tank cap was not fully seated.
