# Aerospace SAFETY

February 1969

AFRP 62-1 Volume 25 Number 2

## SPECIAL FEATURES

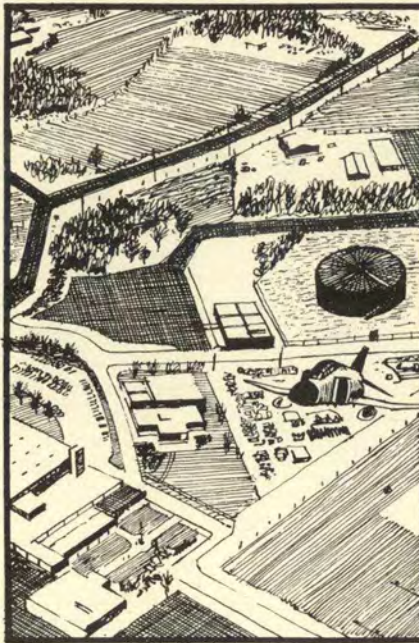
**FOCUS HERE**

This test should give you some idea of how good (poor) your peripheral vision is. Remember that your eye will be focused at the same distance as these examples and there is good contrast. Compare this to the varying conditions in flight and draw your own conclusions as to your visual limitations.

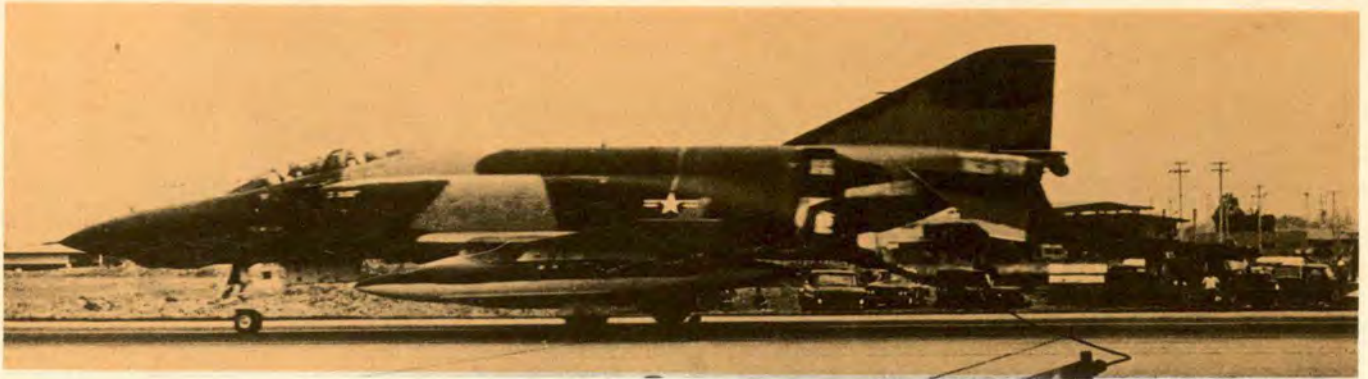
# A NEW BAK THE BAK-13

It looks a little like a BAK-12 with the tape reel lying on its side rather than vertically. It has a pendant and a tape and reel on each side of the runway like the BAK-12,

The system uses the principle of twisting water to absorb energy. The tape reel is on its side to simplify construction of the system and to provide a low profile. A water turbine rotor is connected directly to the reel shaft. The turbine assembly consists of the rotor containing a double row of nine vanes. This rotor is mounted in a liquid-filled stator housing equipped with two sets of eight vanes. Since the rotor and reel assemblies are connected on a common shaft, they are rotated together during an engagement as the tape is pulled off the reel. This hydraulic interaction between the rotor and the stator vanes provides the retarding force. It's sort of like the opposite of a fluid drive—the end product is a fluid stop.

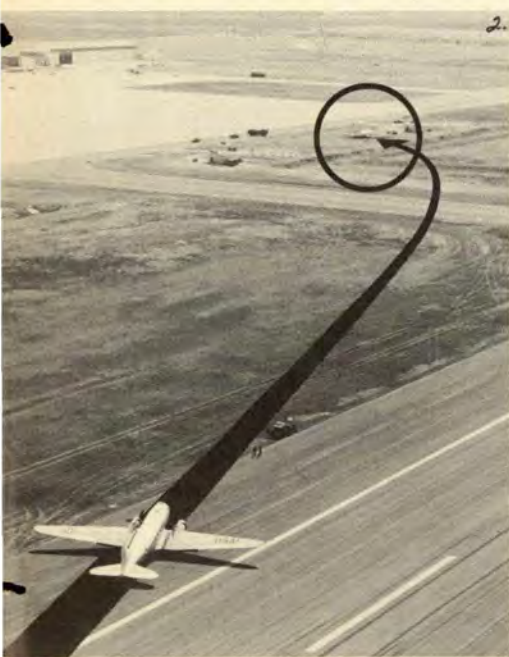
Path of aircraft after left engine failed. Fortunately, crew escaped but the aircraft was destroyed. Complacency, poor crew coordination again prevailed.

1000 feet, then made a series of bounces across some drainage ditches and finally impacted, with power still on the Nr 2 engine, at a point 8200 feet from the takeoff end and 800 feet left of the runway centerline.

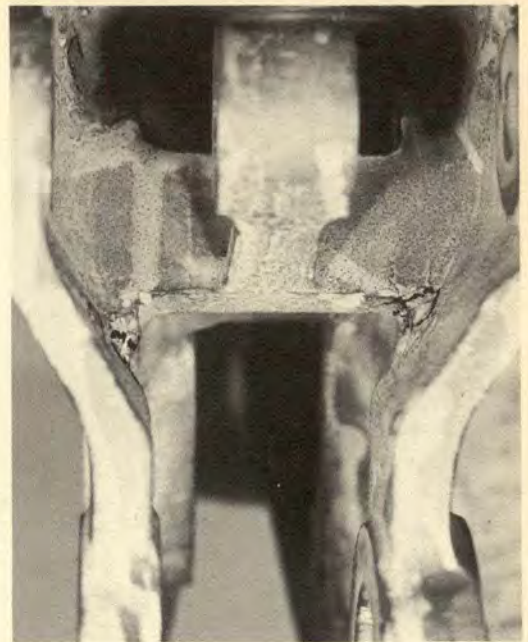
This is not a figure from the Rorschach test, but is a picture of a part sawed to reveal the results of corrosion.
