# *AEROSPACE* **SAFETY**

**FOR  
AIRCREWS,  
MAINTENANCE  
& SUPPORT  
TECHNICIANS**

April 1970

AFRP 62-1 Volume 26 Number 4

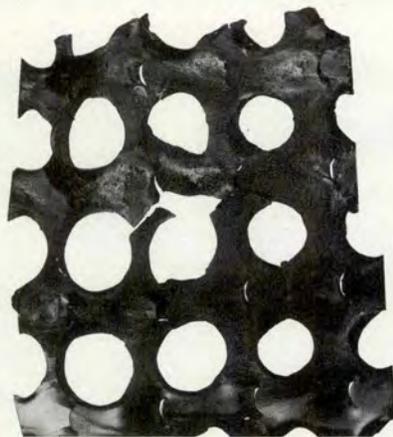
INNER COMBUSTION LINER

OUTER COMBUSTION LINER

The accompanying pictures show deteriorated parts removed from a new J85-17 engine after only 193 operating hours. Most of the damage was caused by lead compounds in the gasoline combining with the engine base metal. This creates an alloy with a low melting point, resulting in accelerated erosion of hot section parts. Increased corrosion, including the intergranular type, is also experienced.

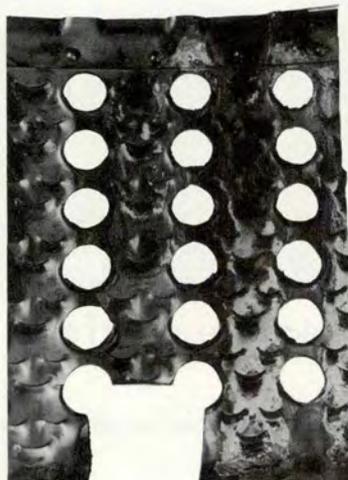
1ST STAGE TURBINE NOZZLE

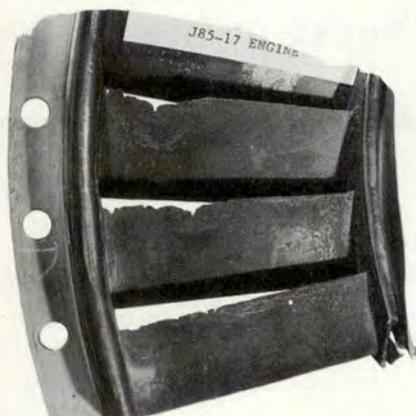
DAMAGE DUE TO AVGAS

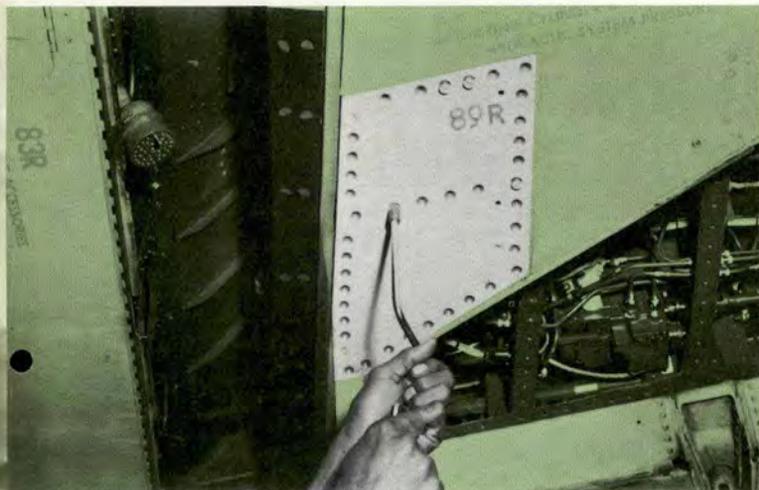
Door 89R was secured. Flight Line didn't inspect under it.

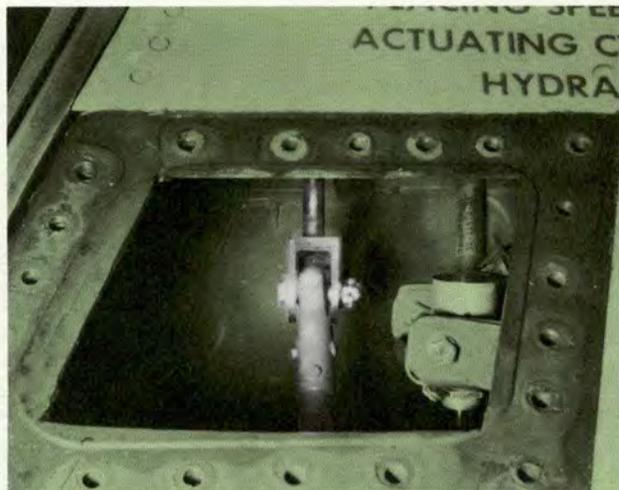
BLC rods on the left had been connected, but not on the right.

In fact, the right trailing edge valve-to-bellcrank link rod was not connected. That was why the right trailing edge BLC air did not shut off after takeoff when the flaps were raised. Normally this situation would be identified by the crew chief during the before-taxi BLC check. However, investigators found it is possible to position the trailing edge valve actuator rod in such a manner that the butterfly valve will be closed, but when

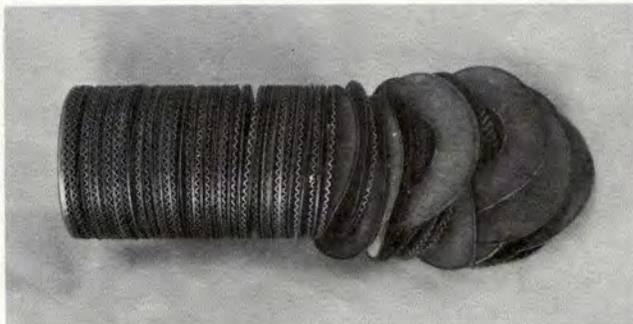
Keeping oil screen clean will allow it to function properly.

caused by chip warning lights, oil should be changed per TO directions with particular attention to cleaning oil screens. If desired, local inspection criteria may require oil change on a more frequent basis, to eliminate fuzz or dust and dirt from unprepared fields. Oil changes are cheaper than aborted missions or letting harmful deposits ruin engines. ★

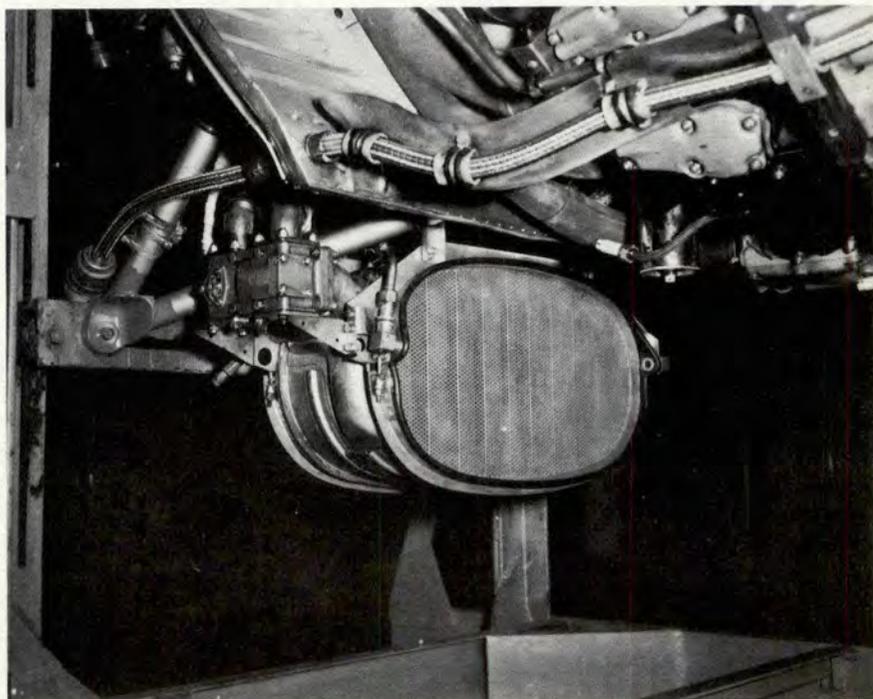
Clean, unobstructed oil cooler is essential if oil system is to perform effectively.

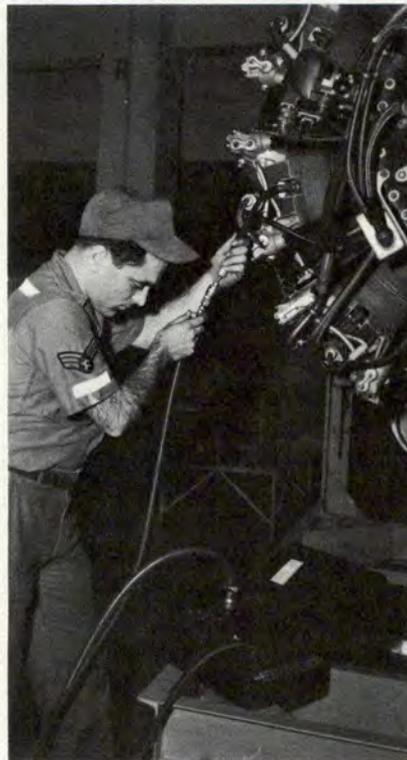
Cylinder compression tests reveal ring or valve failure.

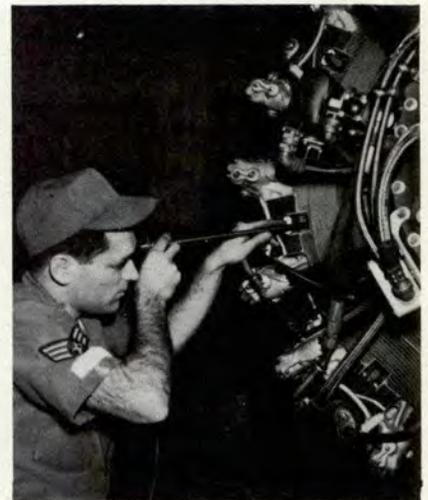
Borescoping is effective method for detecting internal failure.

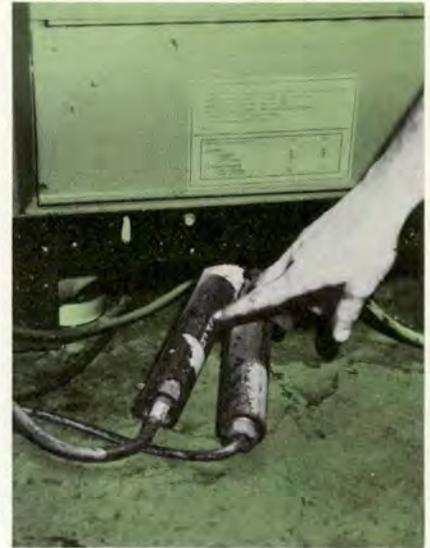
Poor example! Heliarc fuses should be properly shielded and mounted to prevent damage, assure easy access.

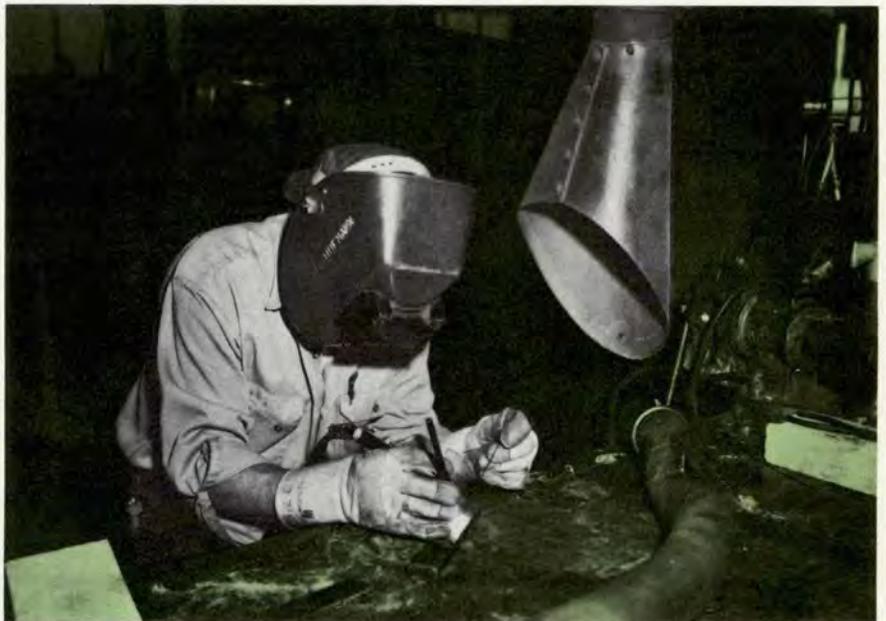
Proper venting is essential for heliarc welding in confined areas.

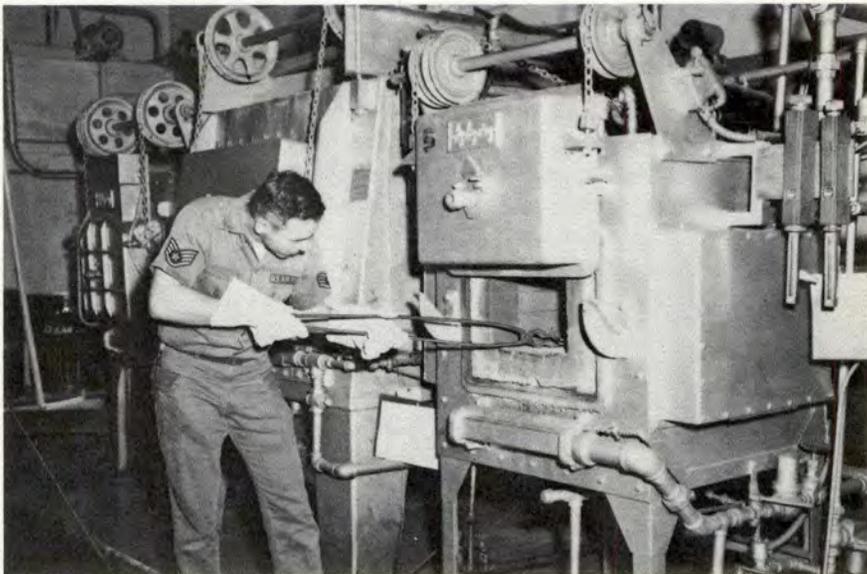
Removing item that has been heat treated from furnace. Note man in lower photo is wearing long sleeves, mask. SSgt in upper photo is unnecessarily risking injury.

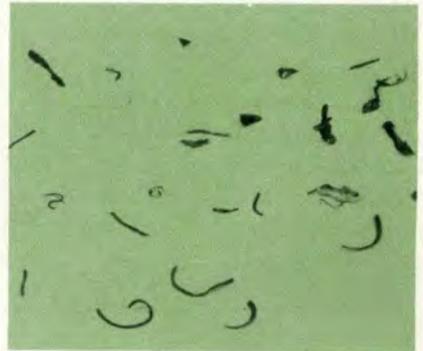
## soap is great, but ...

MOST DEFINITIONS of SOAP (Spectrometric Oil Analysis Program) include a statement similar to the following: Submicroscopic particles of metals are worn off contacting surfaces and are gathered and held in suspension by the lubricating oil. Now keep that in mind.

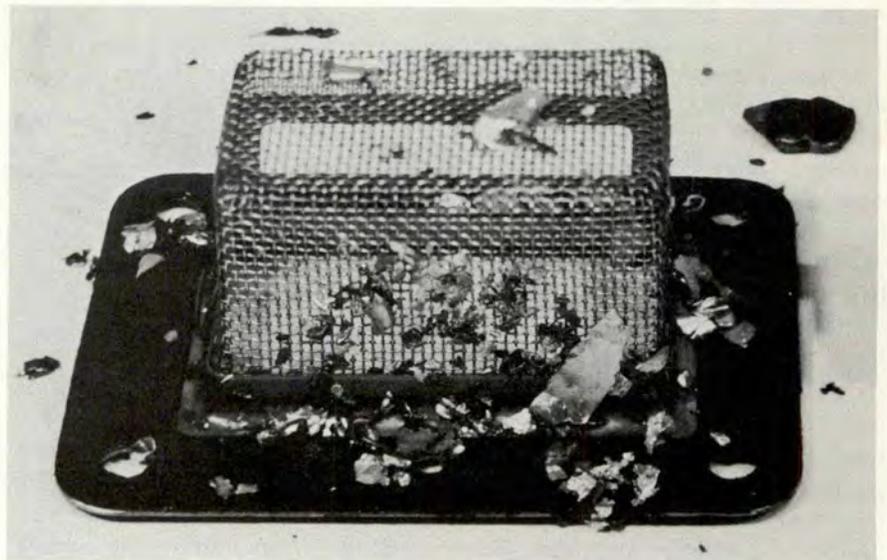
A J79 engine was removed from an airplane for P.E. The scavenge filter and the transfer gearbox magnetic plugs and screen were removed and found covered with large particles of metal. The oil jet for the Nr 3 bearing had small shavings in the orifice. The entire oil system was found to be contaminated.

Look at the pictures and remember what was said in the opening paragraph — submicroscopic particles suspended in oil. The junk in this lube system was too heavy to

be suspended. It just gathered in the filters, screens, and lube jets, and on magnetic plugs.

Note again that this was found during a P.E. The engine had apparently been running satisfactorily with no signs of any difficulty. But why was the contamination not found during the routine SOAP examinations?

Was there a way to tell that the system was contaminated? We have no way of telling for sure, but there's a good chance that oil pressure may have been higher than normal.

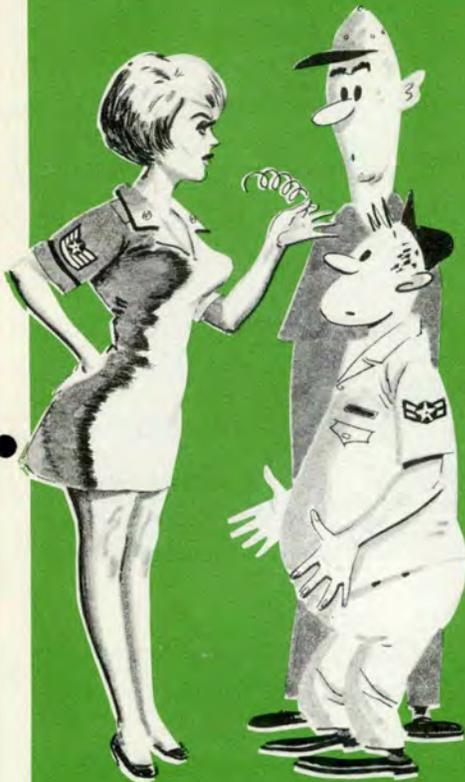
# f-4 fuel system "weirdo"

AFTER 40 MINUTES of normal flight, an F-4 aircrew was astounded by a fuel low level warning light. Fuel at this time was a healthy 4800 pounds over 5500 pounds with no indications of any malfunction. A quick feed tank check confirmed the low level light with a reading of only 900 pounds. A very wise aircrew promptly landed at an auxiliary airfield without incident.

Maintenance investigators traced the malfunction to a faulty check switch for the number six tank transfer pump. This switch is lo-

cated in the left wheel well and is spring loaded to the OFF position. Seems the spring broke and the switch remained unnoticed in the CHECK POSITION. This condition closes the number one and two transfer level control valves. The only method of obtaining fuel, then, is by gravity feed. External and internal wing fuel will transfer normally to the fuselage tanks and then by gravity to the feed tank.

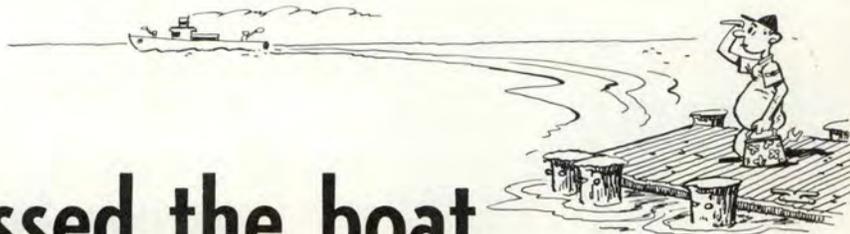
## someone missed the boat

Immediately after takeoff a C-135 crew experienced control problems. After gear and flaps had been retracted, gradually increasing right control wheel pressure was required to maintain straight and level flight. Control response to the right was very poor. At times the control wheel would have to be jerked before the pilot could get any response. The outboard spoilers were observed to be operating erratically and would occasionally stick in the up position. At times they would not extend at all. The inboard spoilers would raise only a few inches when a right turn was made and at times would not raise at all. A left turn was normal except for a slight tendency for the aircraft to roll left. The outboard spoiler switch was placed in cut-off and the outboard spoilers were observed to be working intermittently. When the

speed brakes were raised to 40 degrees and the outboard spoiler switch placed to cut-off, the outboard spoilers remained up. This procedure was followed again and the spoilers worked normally. Several additional repeats produced the same inconsistent operation.

A control check at 13,000 feet showed approximately five degrees of right control wheel deflection was required to maintain wings level at approach and touchdown speeds. The aircraft was landed with 40 degrees of flap without further incident. Investigation revealed maintenance had replaced control system cables 14, 15 and 16, due to corrosion. After replacement of the cables the spoilers had been improperly rigged. Maintenance missed the boat by not following tech data.

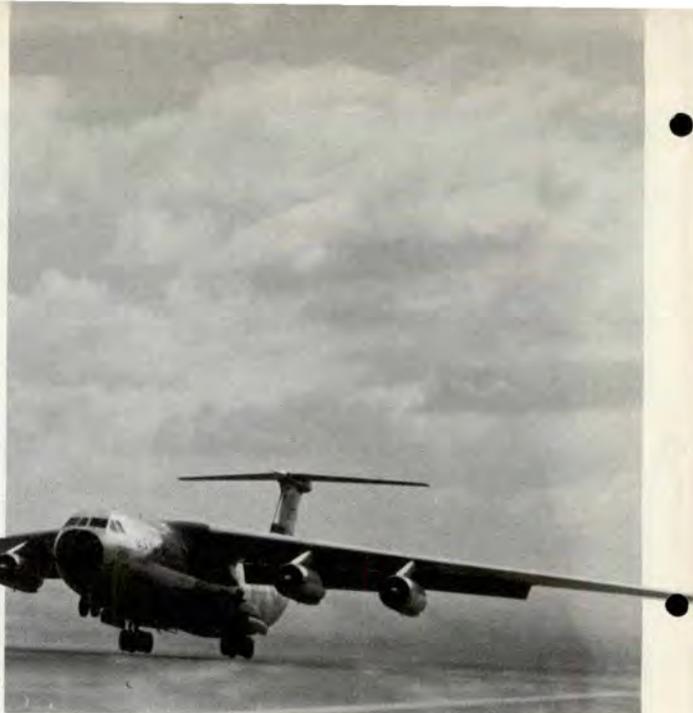
## 7/16 inch —big difference

A C-141 PILOT write-up indicated an elevator trim malfunction that required excessive back pressure to rotate during takeoff and to maintain climb to 300 feet. Normal nose down trim immediately after liftoff was not required. He landed

the big bird at his first stop, using 4.5 units nose-up trim which was considered normal. The next take-off required the same excessive back pressure for rotation and climb to 300 feet. After he landed at his next destination, Maintenance investigated the problem

and found the elevator rigged 7/16 inch down from neutral. After re-rigging, an FCF indicated the system was okay. How did the elevators get 7/16 inch out of rig? There is a maintenance man somewhere who has the answer.
