Aerospace **SAFETY**

**FOR
AIRCREWS,
MAINTENANCE
& SUPPORT
TECHNICIANS**

MAY 1970

AFRP 62-1 Volume 26 Number 5

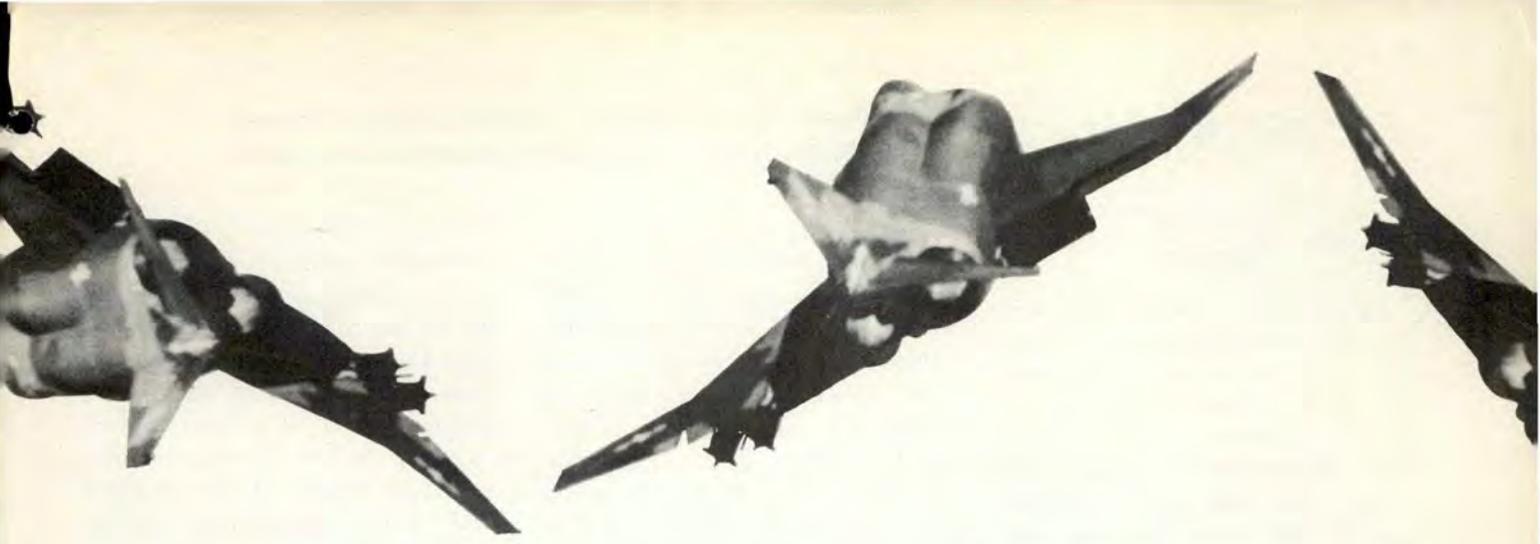
F-4s lost in out-of-control accidents

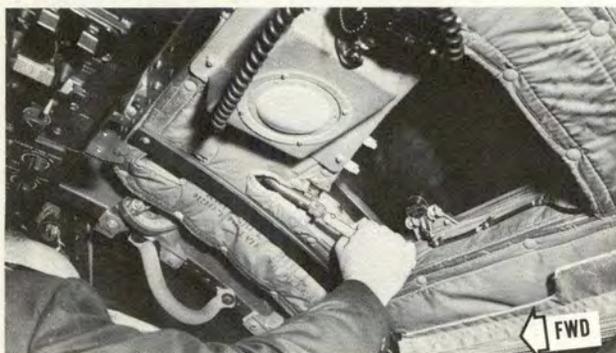
COPILOT'S HATCH (PILOT'S HATCH TYPICAL)

● Then pull downward and inboard full length of travel (approx. 80°) until locking cams release.
 ● Apply manual upward force on forward edge of hatch, rotating hatch upward and aft (approx. 95°) until it falls free of the airplane.

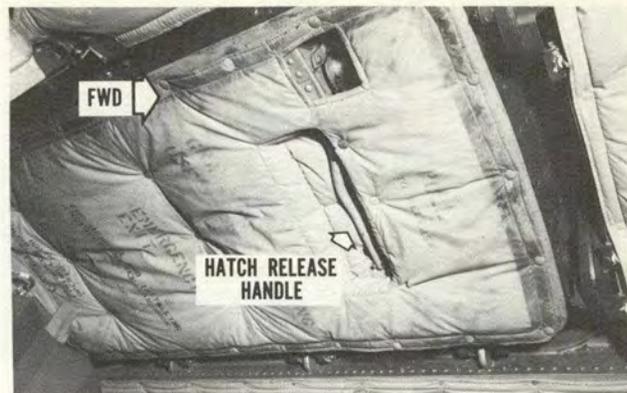
EW OFFICERS HATCH

● Pull handle downward full length of travel (approx. 80°) until locking cams release.
 ● Apply manual upward force on forward edge of hatch, rotating hatch upward and aft (approx. 95°) until it falls free of the airplane.

B-52C-F

A The hatch is hinged on the aft end and manual upward force must be applied on the forward end. The hatch weight, and the possibility of it sticking to the seal can make it nearly impossible for a man to apply enough force in any other area to lift the hatch.

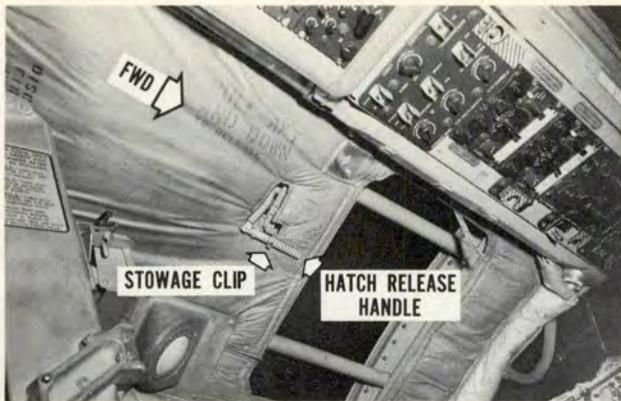
PILOT'S HATCH (COPILOT'S HATCH TYPICAL)

- On B-52G — H airplanes, rotate handle aft out of stowage clip (approx. 90°).

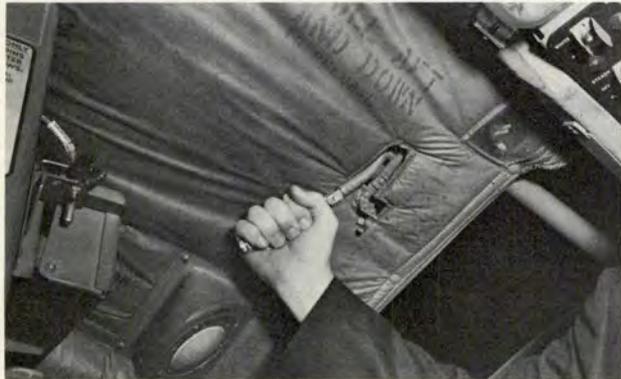
- Then pull downward and inboard full length of travel (approx. 80°) until locking cams release.
- Apply manual upward force on forward edge of hatch, rotating hatch upward and aft (approx. 95°) until it falls free of the airplane.

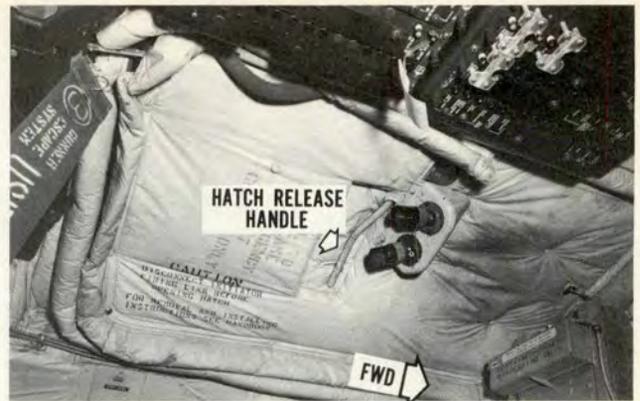
GUNNERS HATCH (EW OFFICERS HATCH TYPICAL)

- Pull handle downward full length of travel (approx. 80°) until locking cams release.
- Apply manual upward force on forward edge of hatch, rotating hatch upward and aft (approx. 95°) until it falls free of the airplane.

B-52G-H

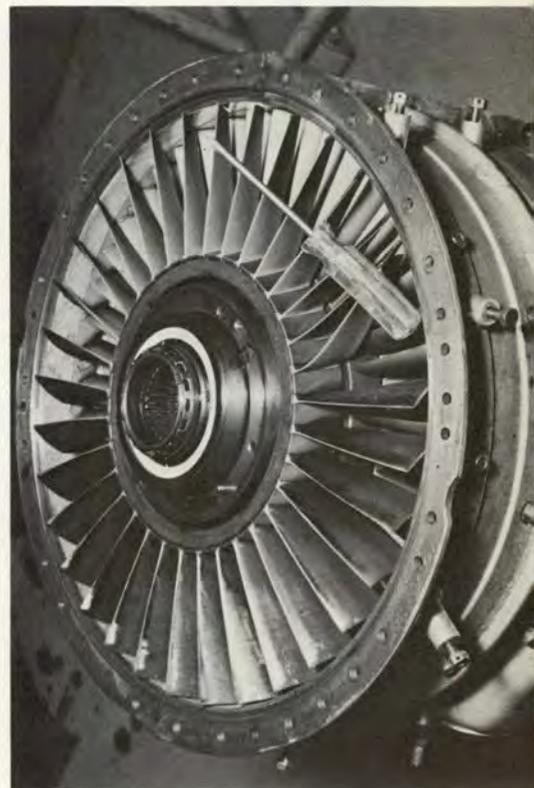
Who will lay claim to this screwdriver?

During descent the pilot of an RF-84F discovered that only a fraction of right stick movement was available. He "pounded" the stick until he got approximately 20 per cent of aileron control from neutral. After declaring an emergency he landed. A six-inch screwdriver was found wedged in the aileron control stop area. No one has claimed the screwdriver.

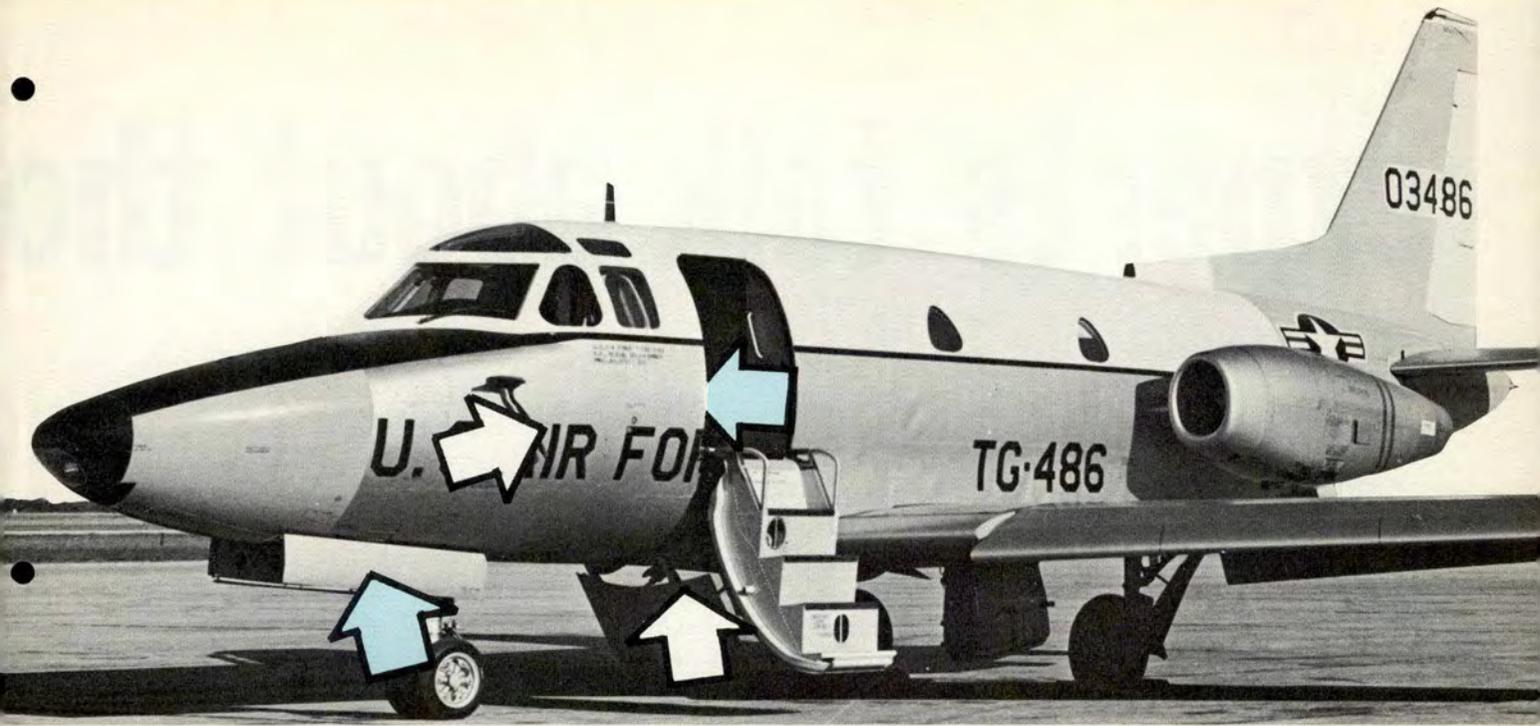
Two drains located one on either side of nose wheel well.

Maintenance personnel discovered that both the pilot's and copilot's static lines were ruptured because the two pitot static system drains located in the nose wheel well were not drained during pre-

- One plug in cockpit above the pilot's left rudder pedal.
- Two plugs on each side of the fuselage just below the pitot head.
- Two plugs in the speed brake well, right hand fuselage station 185 (On T-39A 59-2871 and later airplanes).
- Two plugs in the nose wheel well, one on each side of the aft end." ★

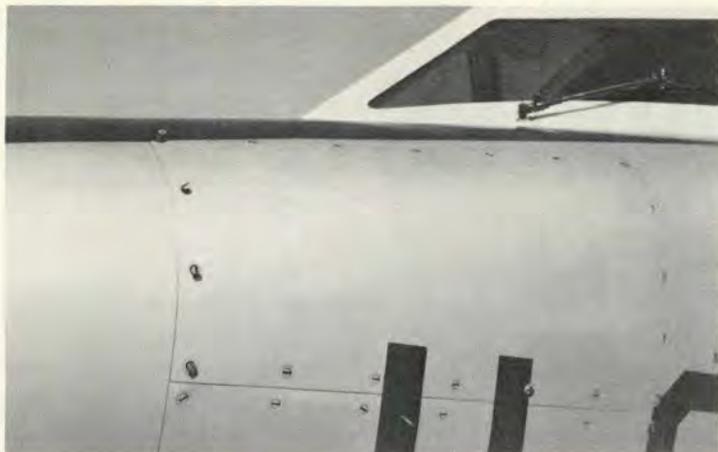
This improperly latched panel would come off in flight.
