Aerospace

SAFETY

UNITED STATES AIR FORCE • AUGUST 1970

Wake Turbulence

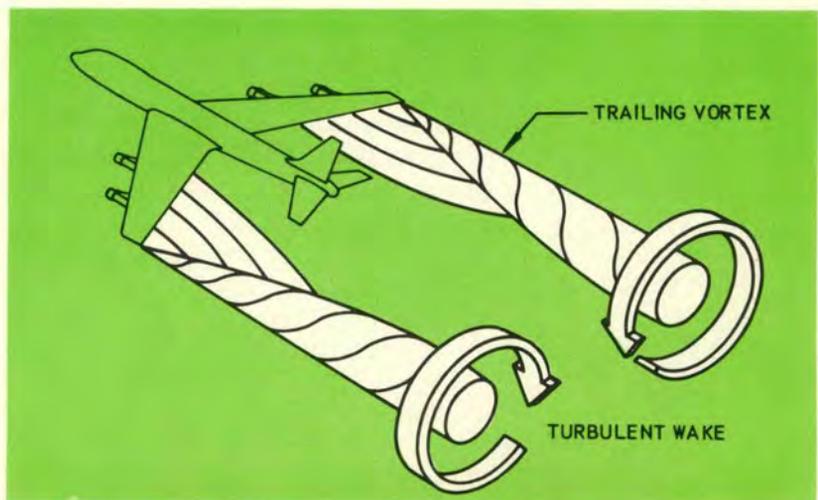
FIG. 1—Two counter rotating air masses form trailing vortices behind the airplane.

lence, on the other hand, is generated during flight when the wing is developing lift. Figure 1 shows the vortices are two counter-rotating air masses, the right wing vortex rotating counterclockwise, and the left wing vortex rotating clockwise. The region of rotating air behind the airplane comprised of the trailing vortices is the turbulent wake.

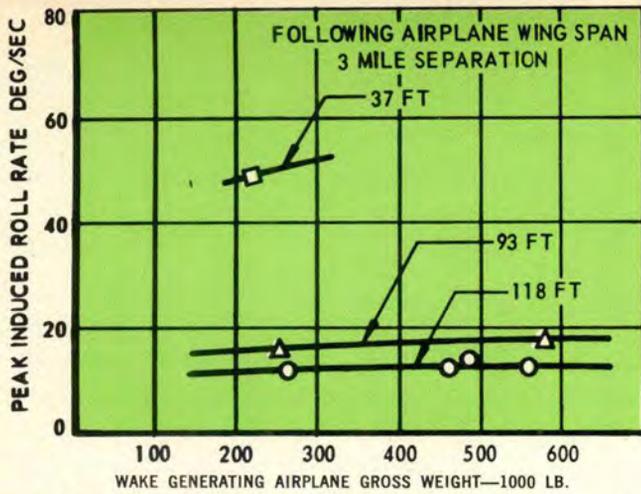
FIG. 2—Test data showing the roll experienced by airplane of a given wing span flying in wake of different weight airplanes.

The most significant result obtained from the tests was that the following aircraft (737 and NASA CV-990) could not detect any difference in the wakes generated by 747, C-5A, and 707-320B airplanes. Data from these tests and earlier NASA tests are shown in Figures 2 and 3. Figure 2 shows that the roll rate experienced by a following aircraft is approximately the same in the wake of a 200,000

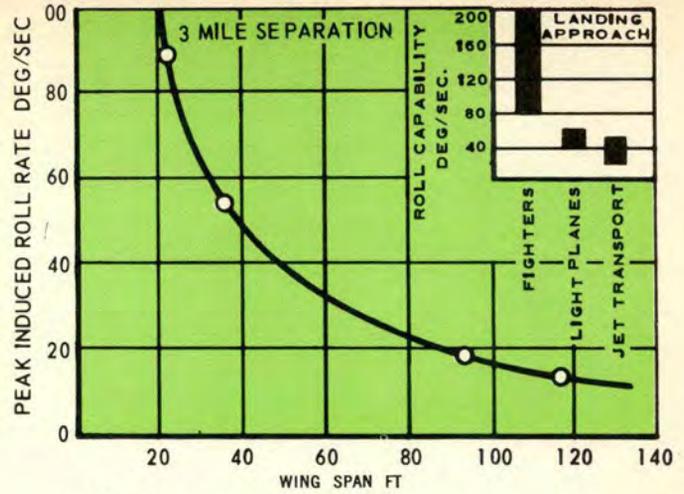
FIG. 3—Test data showing the roll experienced by airplanes of different wing span flying in wake of a 400,000 lb. airplane.

lb airplane as it is behind a 600,000 lb airplane. Figure 3 shows that the wing span of the following airplane has an important effect on the roll experienced in the wake of a jet transport.

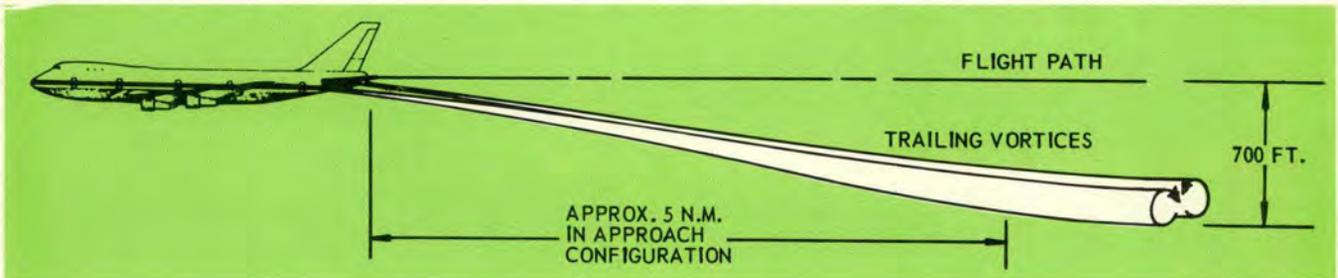
FIG. 4—(Above) Trailing vortices level off below the flight path and are never encountered more than 900 feet below the aircraft.

Another significant result obtained from the test was that the wake levels off below the generating aircraft. It was found that the wake moves down behind the generating aircraft at approximately 500 feet per minute as expected, but then levels off at approximately 700 feet below the airplane as shown in Figure 4. The wake was never found to be more than 900 feet below the flight path.

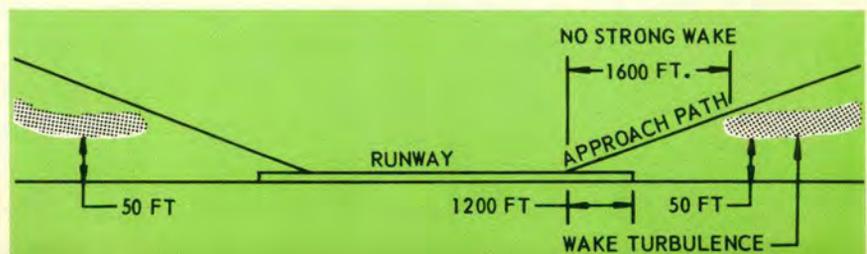
FIG. 5—(Right) The turbulent wake drops below glide path away from touchdown area.

the strength and movement of the vortices are strongly affected by the presence of the ground (ground effect). It was observed that when the generating aircraft is in ground effect, the wake does not form into concentrated vortices and turbulence in the wake is relatively weak. Thus as shown in Figure 5, there is no

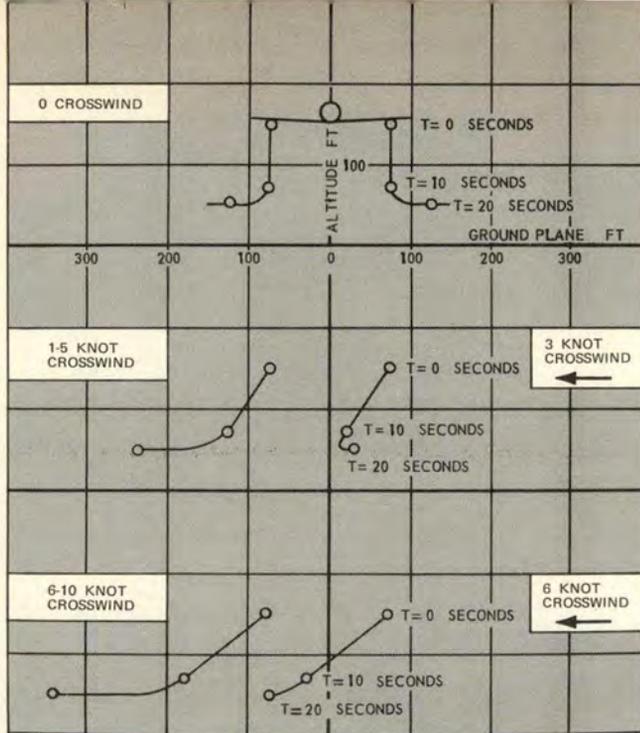
FIG. 6—Typical effect of crosswind on the movement of vortices near the ground.

strong turbulence in the touchdown area. On approach and takeoff, the wake descends below the flight path until it enters ground effect whereupon the two vortices stop their downward descent and move laterally. This behavior is illustrated in Figure 6. With no crosswind, two vortices in ground effect move apart to clear the flight path. Crosswinds of 1 to 5 knots cause one vortex to remain near the flight path while winds greater than 5 knots cause the vortices to move quickly across the flight path and to break up rapidly.

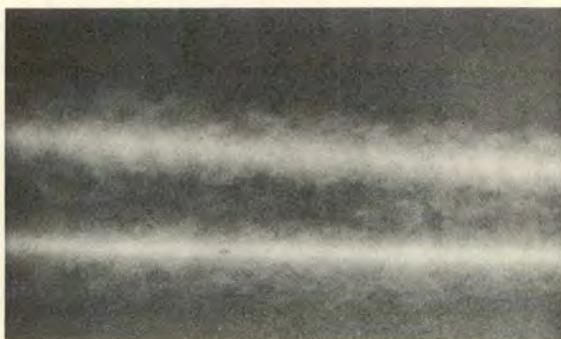
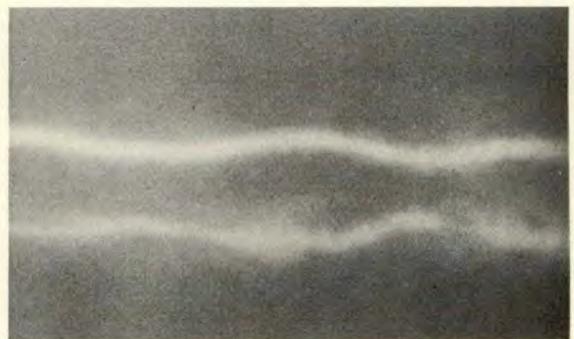
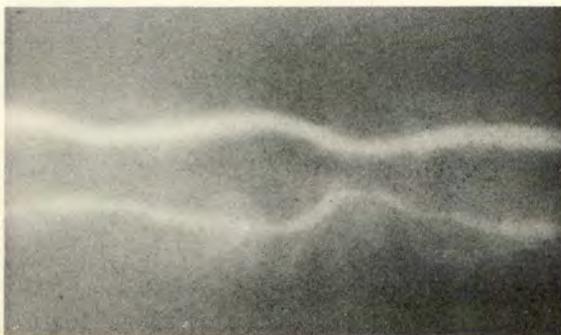
FIG. 7—Vortex breakup is shown for the trailing vortices of a 747 flying at 4900 ft. in the takeoff configuration.

A 10 SECONDS

B 90 SECONDS

C 100 SECONDS

D 130 SECONDS

Vortex breakup at altitude was also observed during these tests. In vortex breakup, the two vortices interact with each other to cause their mutual destruction. Figure 7 is a series of photographs, taken from the ground, showing breakup of the trailing vortices from a 747. The 747 was flown in takeoff configuration at 4900 feet altitude and from right to left. The photograph shown in Figure 7A was taken 10 seconds after the 747 passed overhead and shows two clearly defined vortices. Vortex breakup proceeds as shown at 90 seconds (Figure 7B) and 100 seconds (Figure 7C) until

at 130 seconds (Figure 7D), the two vortices are completely destroyed. This breakup is commonly seen in viewing contrails from the ground. Other investigators have found that breakup occurs more quickly when an aircraft has flaps down and when the atmosphere is turbulent. Within approximately 5000 feet from the ground, vortex life is directly affected by wind speed. The higher the wind speed the shorter is the vortex life (Figure 8).

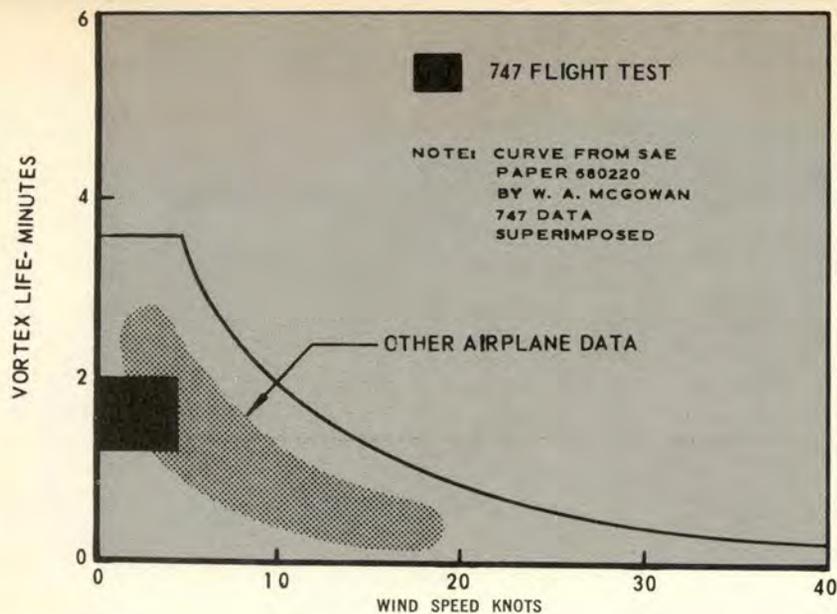
FIG. 8—Effect of wind on vortex life for vortices within 500 ft. of the ground.

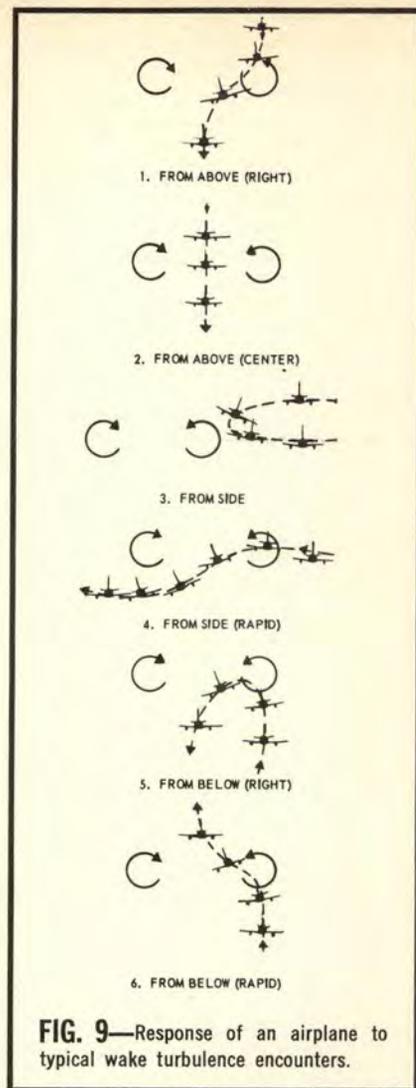
FIG. 9—Response of an airplane to typical wake turbulence encounters.

The response of an aircraft to typical vortex encounters is illustrated in Figure 9. A jet transport airplane entering wake turbulence will be quickly rolled out of the wake with maximum bank angles on the order of 30°. Yaw may also be experienced, particularly when the wake is approached from below,

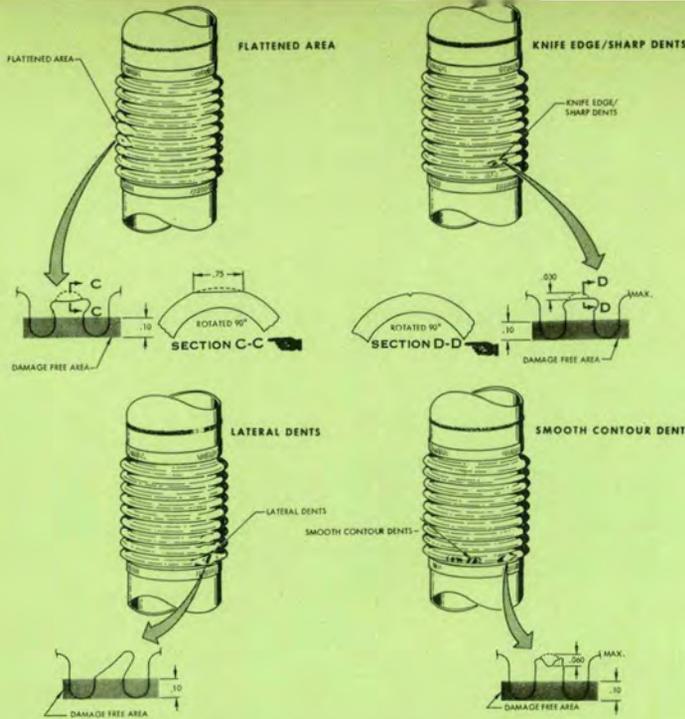
Note: The damage limits shown are intended to be typical. There is no intention to display specific damage criteria here. You must consult the applicable model technical instructions for exact information.

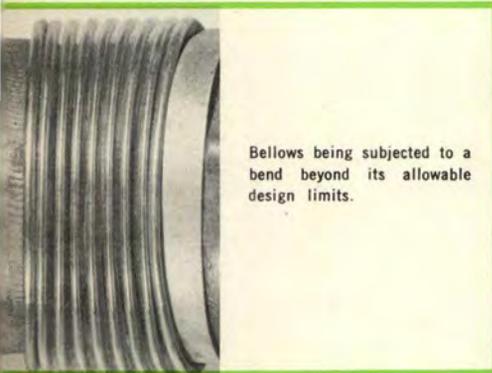
Bellows being subjected to a bend beyond its allowable design limits.

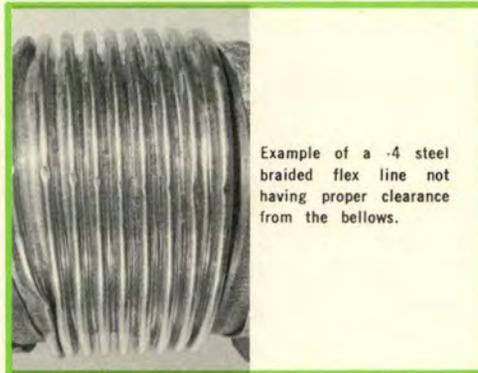
Example of a -4 steel braided flex line not having proper clearance from the bellows.

other wounds that "normal" maintenance can inflict. A dent caused by dropping a heavy tool on the corrugations is certain to produce a condition that can lead to rapid fatigue failure. Plumbing, cables or, in particular, a steel braid covered flex line that remains in contact with the bellows will literally "eat" through the thin bellows material in a time period commensurate with the vibration that is present and the contact pressure.

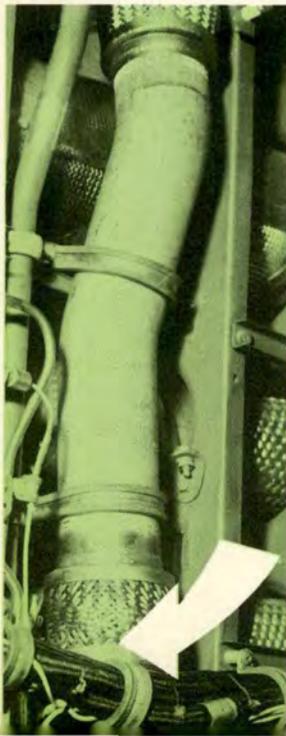
The appearance of the collapsed lower bellows and stretched upper unit could be a clue that the assembly is not installed correctly.

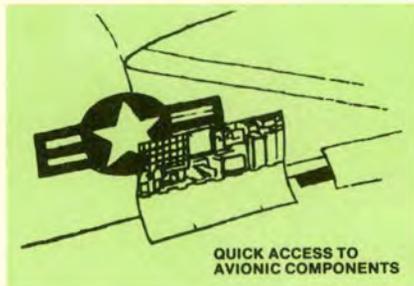
QUICK ACCESS TO AVIONIC COMPONENTS

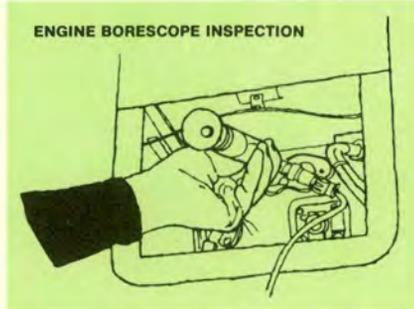
ENGINE BORESCOPE INSPECTION

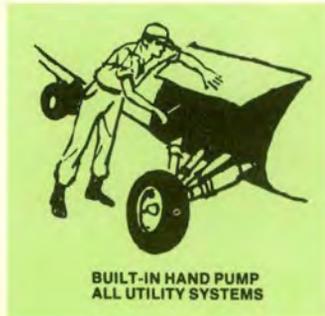
BUILT-IN HAND PUMP ALL UTILITY SYSTEMS

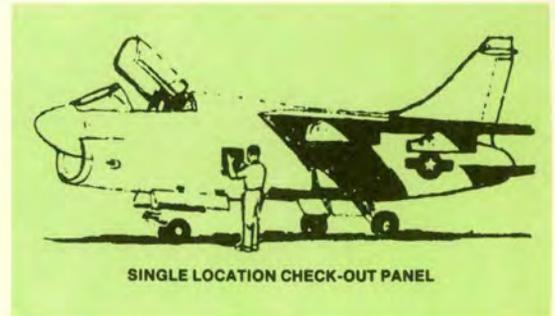
SINGLE LOCATION CHECK-OUT PANEL

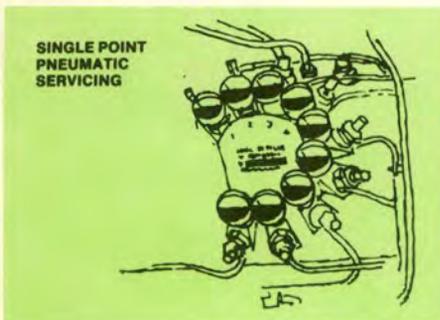
SINGLE POINT PNEUMATIC SERVICING

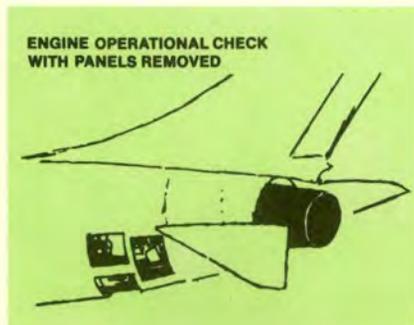
ENGINE OPERATIONAL CHECK WITH PANELS REMOVED

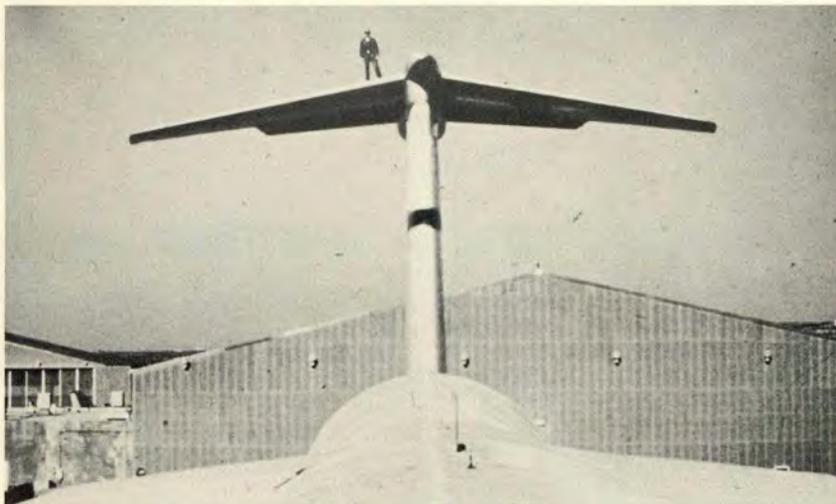
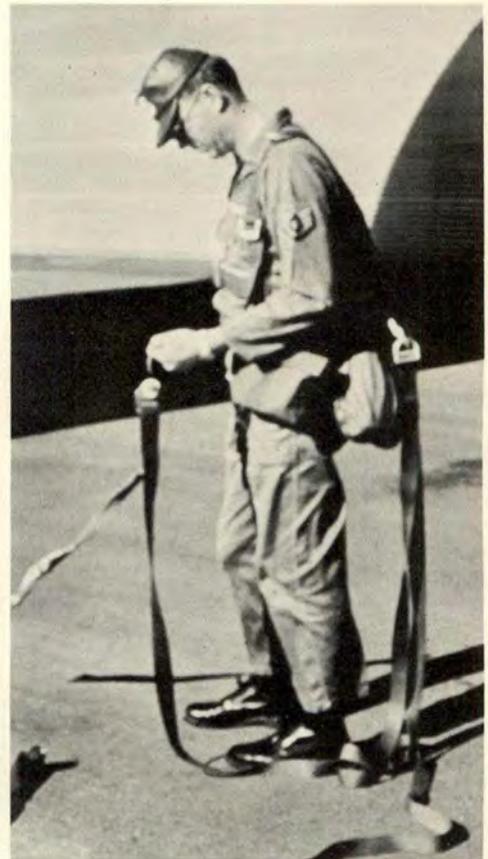
the maintenance man's life line

When standing on the C-5's horizontal stabilizer, one develops the illusion that the fuselage and wings could easily belong to some other airplane. The tail is so remote that one feels completely separated from the remainder of the aircraft and is merely standing on a large winglike platform 65 feet above the ramp. This is hardly conducive to one going calmly about his business. A slip could mean a fall and that would be disastrous.

This hazard was recognized early in the C-5A design program. Aerospace Ground Equipment Design Engineers, Safety Engineers and

Tests indicate that people working on the 65 foot high T-tail will wear the device but that they're reluctant to wear them on the upper surface of the wing. It's lower and bigger so does not seem so hazardous. Nevertheless, a fall from the wing onto concrete could be fatal.

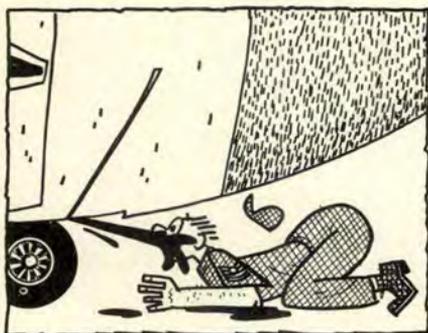
During taxi for takeoff the nosewheel steering of a C-130 failed and the engineer deplaned to inspect the steering mechanism. When he looked into the nosewheel well he was greeted with a face full of hydraulic fluid from ruptured hydraulic lines. His inspection revealed that both nosewheel steering actuators had pulled out of the fulcrum bearings and several hydraulic lines were broken.

Back on the parking ramp further inspection revealed that two keys were missing from the nosewheel steering bracket (TO 4S3-54-4, fig. 2, index 73). They had either been

The two screws are identical except that the gland nut lock screw is shorter. When it is installed in the cylinder mounting plate it does not engage the slots in the thread area of the strut. This nut became loose and allowed the steering cylinder support bracket to turn freely since it was not keyed to the strut. This also increased the dimension between the upper and lower cylinder mounts and allowed the cylinders to be forced from their mounts.

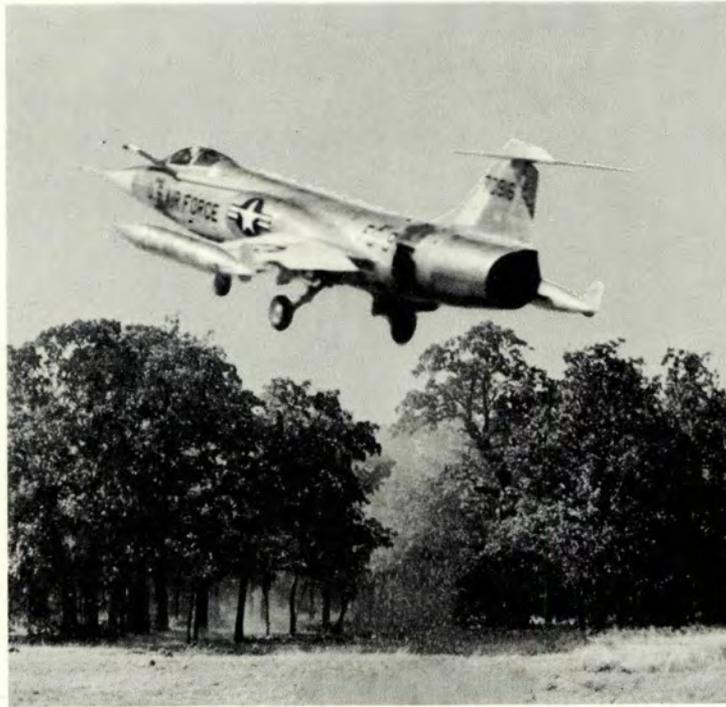
AS THE TEMPERATURE GOES **UP**
THRUST GOES **DOWN**
