AEROSPACE SAFETY

Aerospace

SAFETY

NUMBER 10

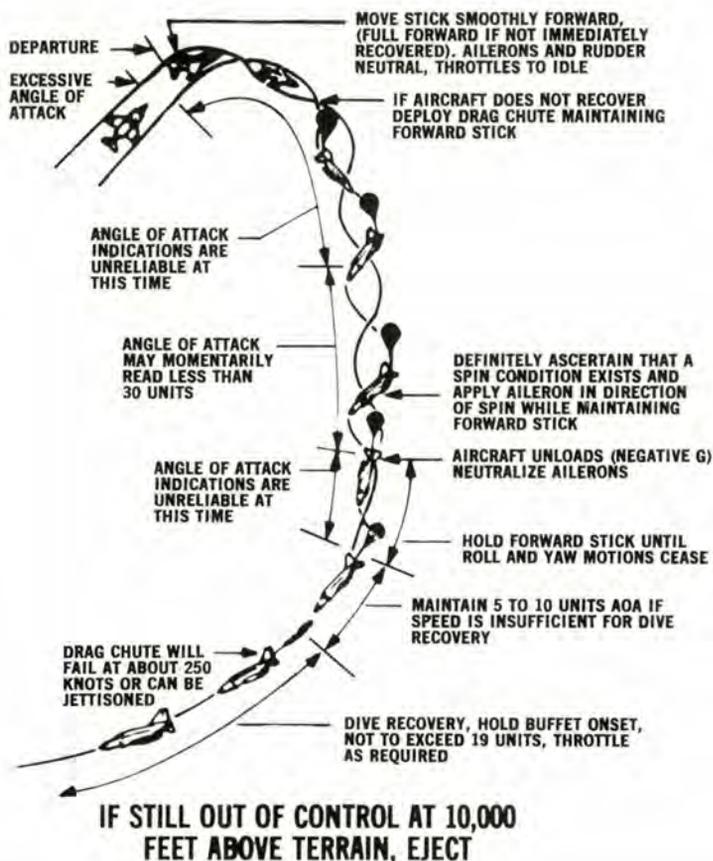
FIGURE 1.

SPIN RECOVERY

A comparison of the previous and recommended Out-of-Control and Spin Recovery procedures is shown on page 4. The emphasis now is on "unloading" the aircraft rather than obtaining "5-10 units." This, of course, is because of the AOA indicator errors mentioned above and because unloading will insure a positive recovery. The Upright Spin procedure is merely an extension of the Out-of-Control procedure. In all probability, the Out-of-Control procedures will recover the aircraft from most spins. The new procedures are pictorially presented in Figures 1 and 2.

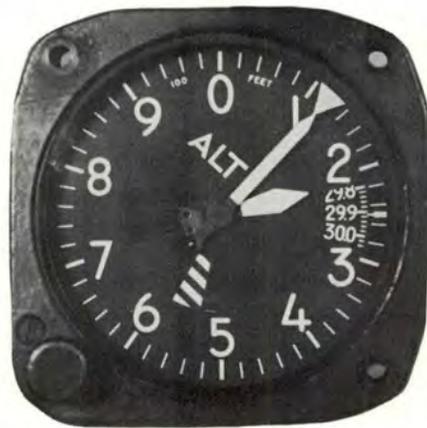
FIGURE 1
 THREE POINTER (3P)

HOW MANY TIMES have you misread your altimeter? Never? Only once? What would have happened if the situation had been slightly different—the weather worse, or perhaps the terrain slightly higher? Try reading the four altimeters on this page and check your answers with those at the end of the article.

Unfortunately, a recent accident points out the need to reemphasize the proper methods of reading the altimeter. The Air Force presently uses the four types of altimeters shown in Figures 1-4, of which the three-pointer (Fig 1) is the most commonly used. Two variations of the three-pointer (Figures 5 and 6) are shown below:

Figure 1	12,120'
Figure 2	2,960'
Figure 3	7,960'
Figure 4	40,000'

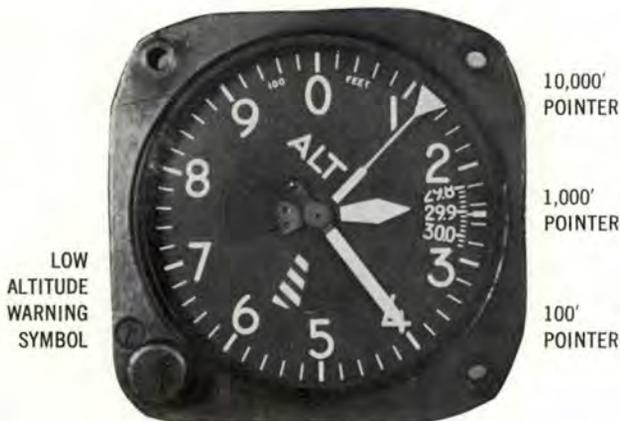
FIGURE 5

THE THREE-POINTER on the right (Fig 6) was designed with the white stripe to make the 10,000' pointer more noticeable. Both have the low altitude warning symbol which warns the pilot when he is below 16,000'. This symbol as shown in Figures 7-10 is fully in view at 0', $\frac{3}{4}$ at 4,000', $\frac{1}{2}$ at 8,000', and $\frac{1}{4}$ at 12,000'.

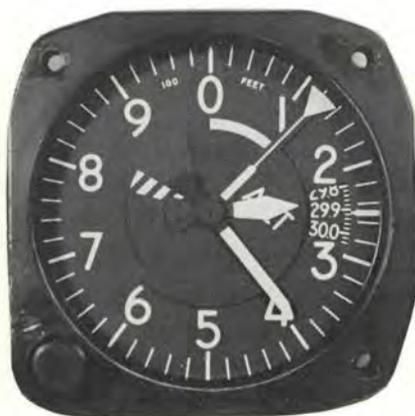
FIGURE 11

- 1 READ THE 10,000' POINTER
- 2 READ THE 1,000' POINTER
- 3 READ THE 100' POINTER

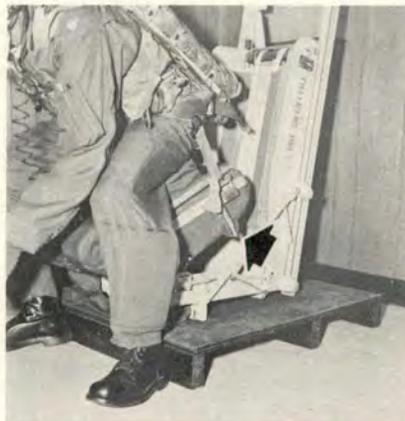
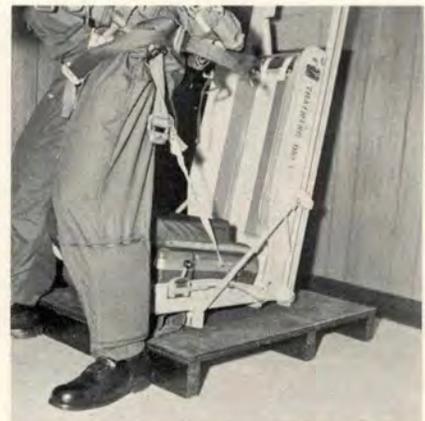
Plunger (arrow) is key to separation from survival kit. If it's extended when you pull secondary escape handle, you remain attached to raft (right).

Separation from the seat survival kit is a very frequent delay-causing problem. In many airplanes, a single handle deploys the kit once you are suspended beneath the chute. You use the same handle to separate from the heavy and cumbersome kit for emergency ground escape. Trouble comes when you start up out of the seat before you actuate this handle. In delaying until your weight is off the kit, you de-

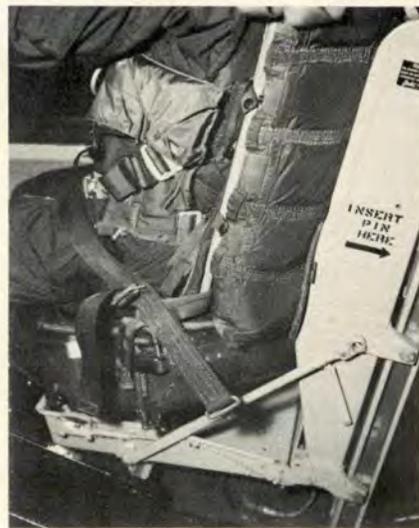
Parachute and survival kit attached, pilot has difficulty climbing out of A-1E/G seat.

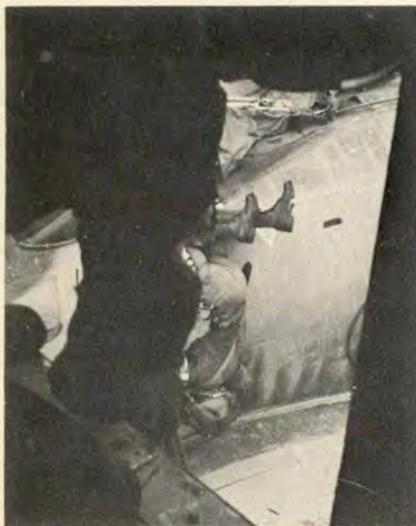
Photo from rescue helicopter shows pilot suspended over the side of A-1H by lap belt.

Habit is strong and unpredictable; several A-1H pilots have found themselves struggling to get out of the cockpit after unfastening only one side of the lap belt. One hapless pilot, after aborting takeoff, running off the end, collapsing the gear and bursting into flames, did this. But he got out of the cockpit—and found himself hanging head

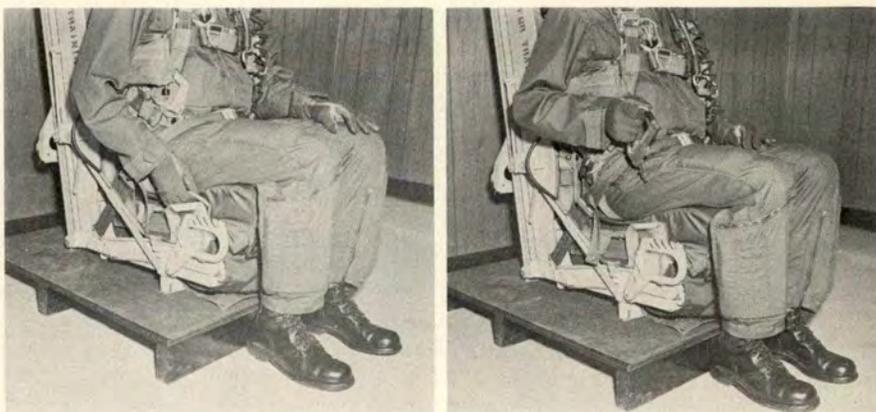
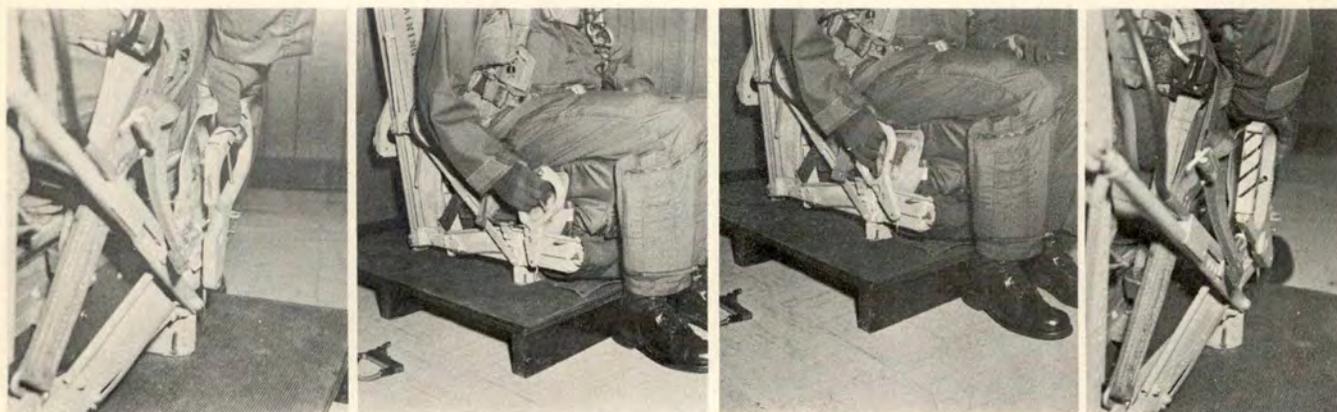
SECONDARY ESCAPE HANDLE—SQUEEZE AND PULL UP.

This handle must be moved through its full 110-degree arc of travel. Pull force required is 80 pounds. In right seat of A-1E/G there may not be sufficient room to place your hand around the handle. Learn to initially grasp it backhand. In A-1H/J, should handle fail to release you from lap belt and shoulder har-

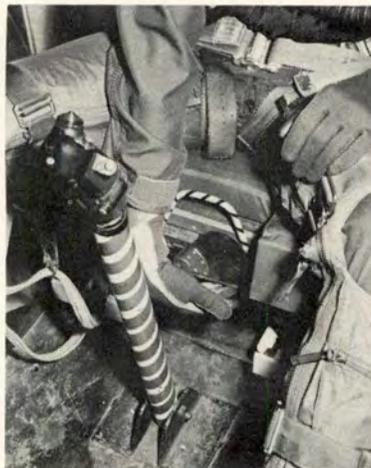
LOWER EJECTION HANDLE GUARD-UP.

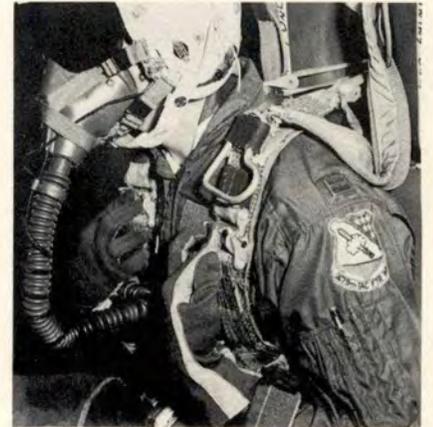
SHOULDER HARNESS—RELEASE.

Leave the parachute in the bird, it can catch on something on your way out.

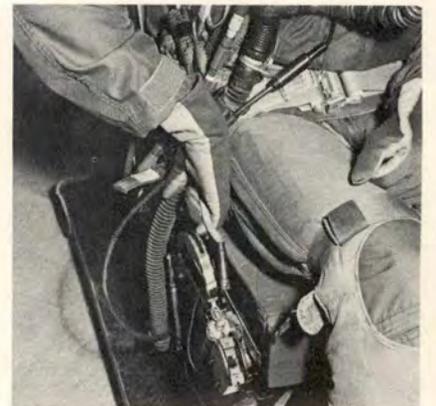
SURVIVAL KIT RELEASE HANDLE—ROTATE AFT.

Inside handle first, then—

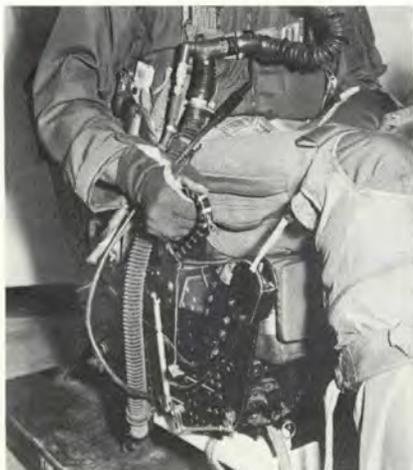
EMERGENCY HARNESS RELEASE HANDLE—LOCK UP.

If you allow the handle to return to the down position, it may re-lock your leg restraints. This has happened too often!

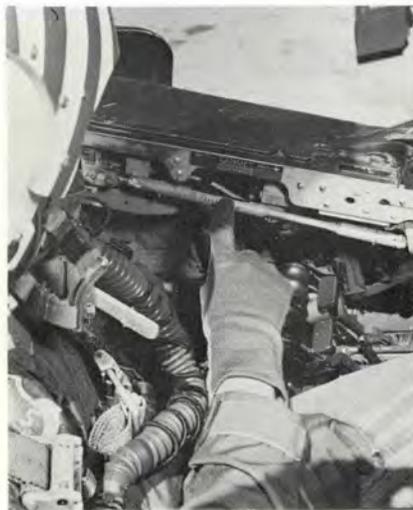
Try the normal canopy open switch first to avoid possibility of inadvertent ejection.

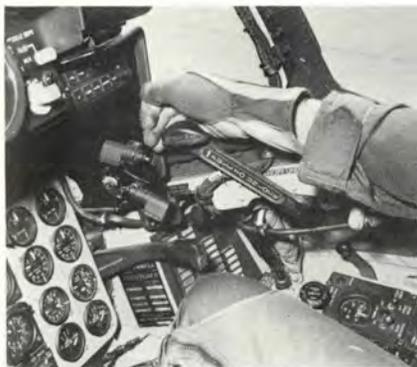
Then the manual canopy unlock handle, but remember you must hold the canopy open—there's no air pressure to hold it up.

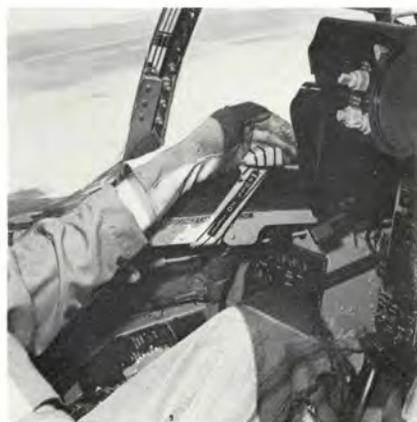
Next go to emergency jettison handle on the left.

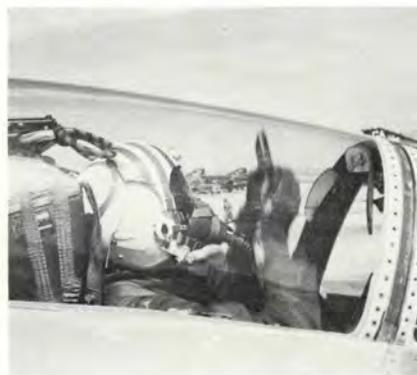
Finally, if you must, bust out with your canopy breaker tool. Start at a forward corner of the canopy and **KEEP HITTING IT IN THE SAME PLACE!!** Don't bang away at random all over the place.

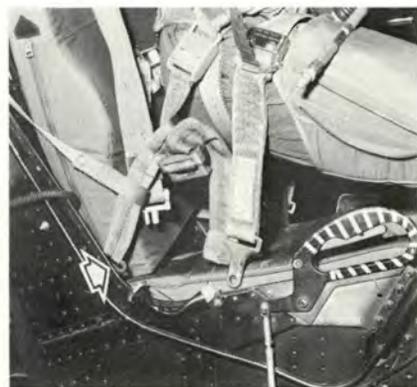
With the canopy open (or removed), grasp the windshield bow and pull yourself up. You must use sufficient force to release the sticker clips (arrow) from the seat.

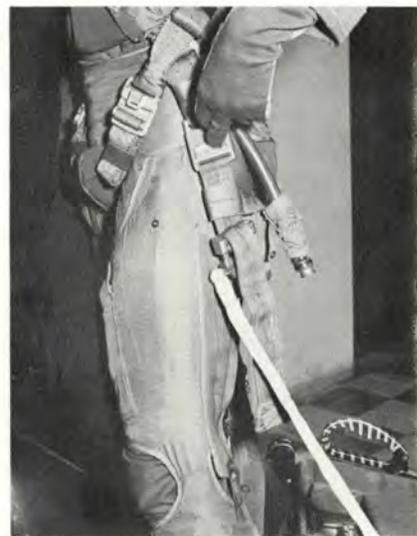
Should you find that you are still attached to the survival kit by the raft lanyard, you don't have to wait for it to burn through—or for someone to cut you loose. Just punch the survival kit quick release where it attaches to your harness at your left hip. ★

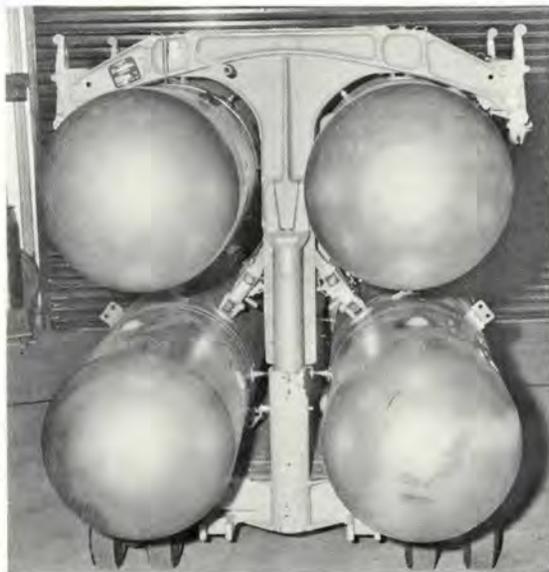
PINTLE HOOK BENDS BOMB

A loaded MHU-20/C clip-in had been transported from storage to the Maintenance Bay on an MHU-19/E for demating. During demating, the team chief noted a dent in the fuze section of one weapon. The unit was rejected and an investigation conducted. The towing operation had been accomplished with a farm tractor equipped with more than one pintle hook. It was determined that the hook on the left side of the tractor had contacted the bomb during a left turn. Neither the driver nor the team chief had observed the incident. Safety consciousness and motivation seem to be lacking in a situation like this one. The possibility of such an incident should have been apparent to the people involved and additional care should have been taken. "Should have" sounds like a Monday morning quarterback, but the need for constant safety vigilance is definitely illustrated.
