UNITED STATES AIR FORCE • JANUARY 1971

AEROSPACE

SAFETY

FOR AIRCREWS, MAINTENANCE & SUPPORT TECHNICIANS

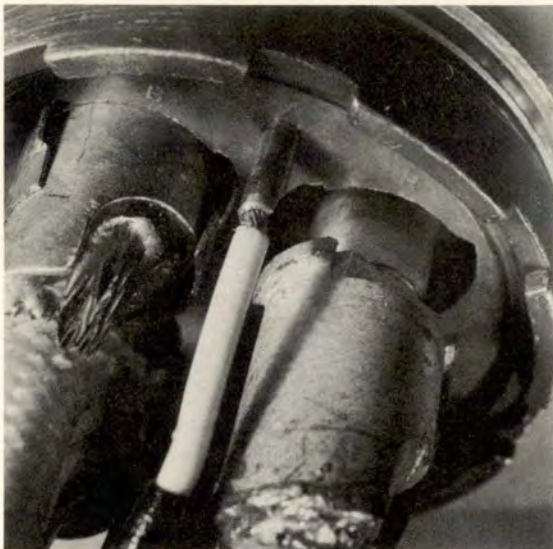
FIGURE 1

applied. The booster refused, but after a 165 second scheduled time delay, the payload decided to go anyway. It went 30 yards down-range. Investigation revealed that a pushed back pin in the male portion of a connector had caused a fault in the system. Figure 1 is a photo of a connector showing it can happen.

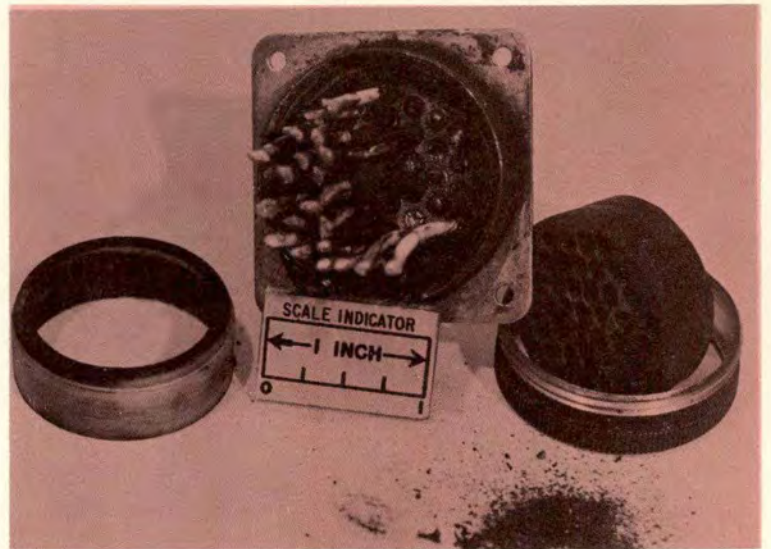
FIGURE 2

Now ask this crew what they think of depot level assembly of connector plugs. The little beauty that caused their problems is shown in Figure 2, the aircraft in Figure 3. The depot level quality control people plus others assumed that the connector was put together correctly.

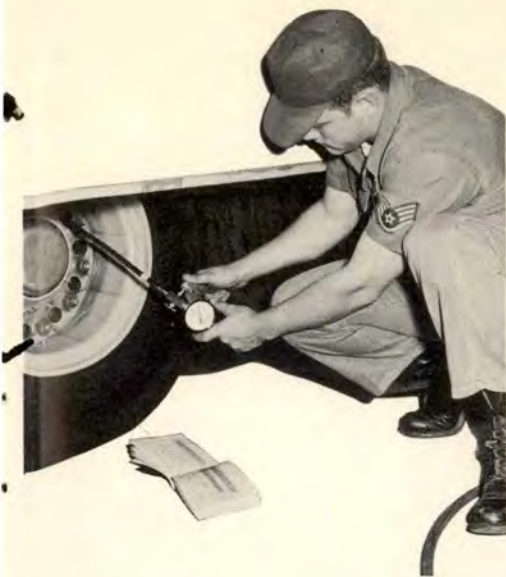
OPPOSITE PAGE: Connecting gage is difficult and time consuming.

LEFT: If used properly service through gages will save time.

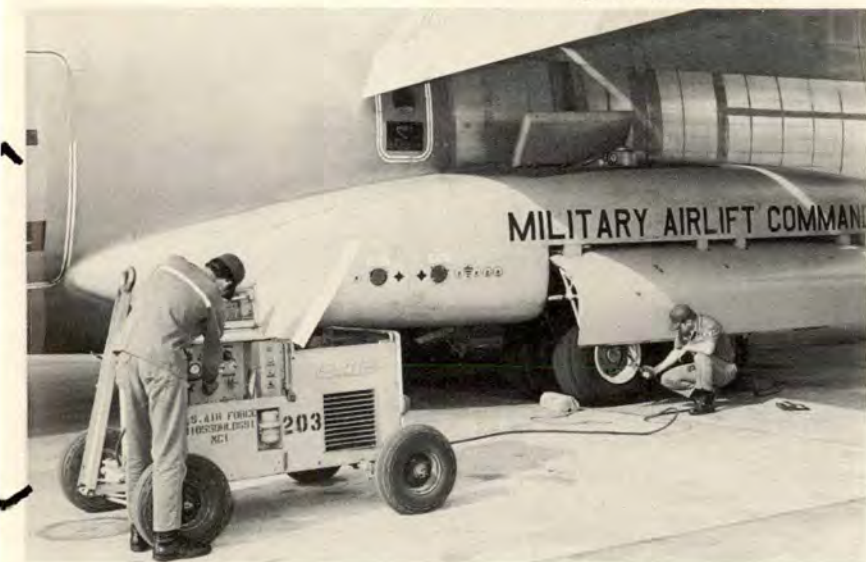
BELOW: If everything works perfectly they'll finish before the flight crew arrives.

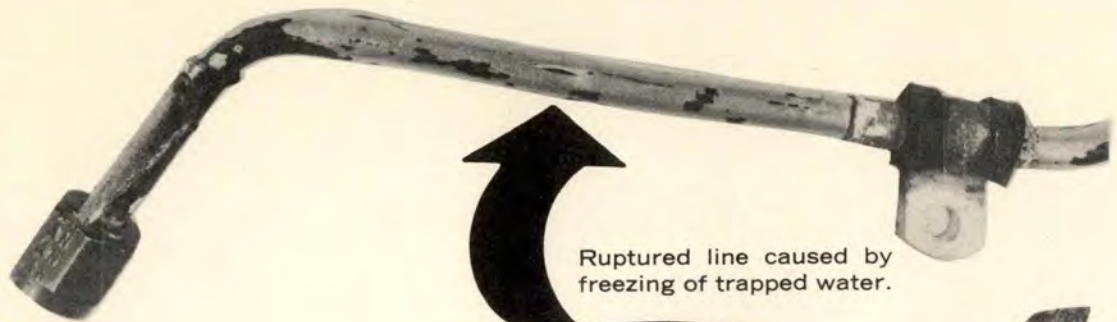
Ruptured line caused by freezing of trapped water.

There is no substitute for using technical orders. They were published in the first place to aid the mechanic in solving the problems that are encountered with today's complex weapon systems. In this specific instance, the mechanic was negligent in not checking TO 1F-100D(I)-2-1, pages 3-40 and 3-41, Figure 3-21—the pitot-static system section of the airplane general technical order for organizational maintenance.

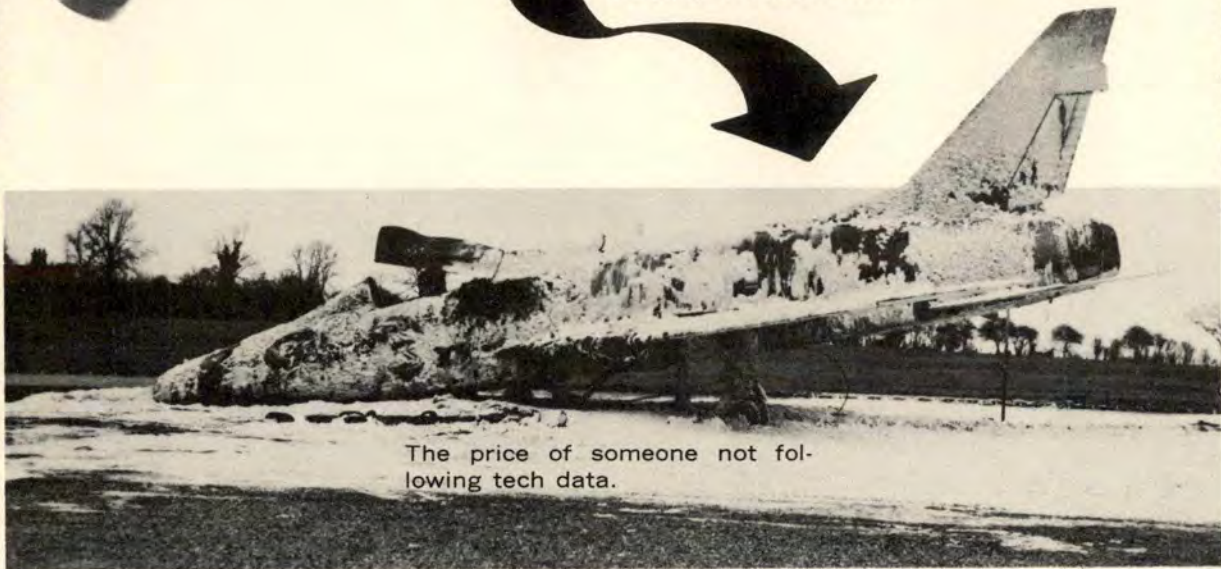
The price of someone not following tech data.

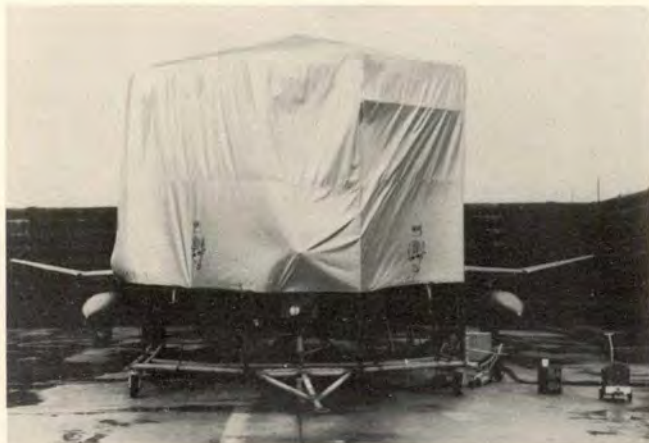
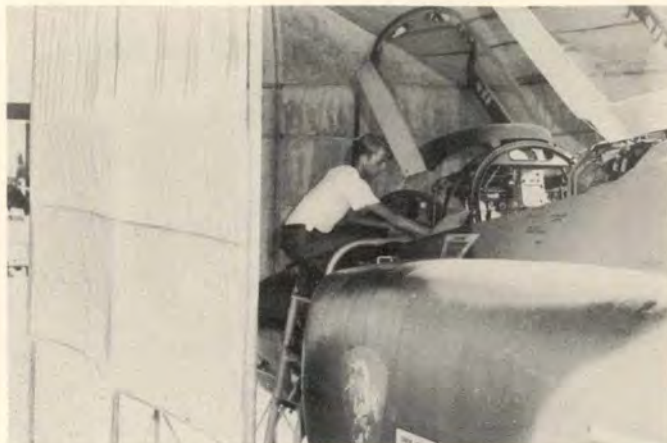
PORTABLE DOCKS

It gets hot in Thailand—and wet, conditions that are a way of life for maintenance men assigned to Southeast Asia. At Ubon RTAFB, Thailand, somebody decided to do something about it, so the welding

and fabric shops of the 8th FMS got busy and turned out some neat portable shelters.

and reflects heat. Wheels make the shelters easily movable from one aircraft to another. ★

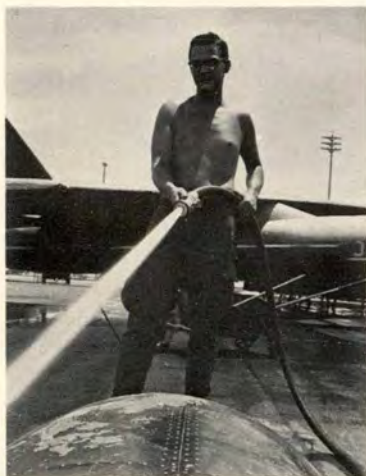
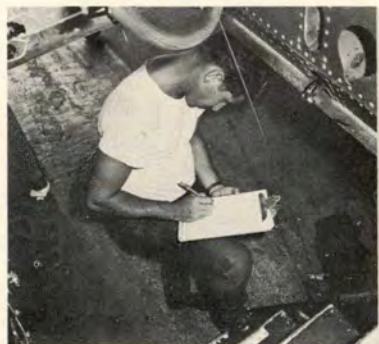
PROJECT CLEANSWEEP

Sgt Richard Davis, 307 FMS, operates high powered stream of water to flake paint off a B-52 engine cowling.

Part of the Project Cleansweep operation is the repainting of the aircraft. Sgt Lawrence J. Smith, 307 FMS, sprays a B-52 with camouflage paint.

TSgt Ray A. Gant, a 307th Headquarters Squadron Section Quality Control & Evaluation inspector, administers a "follow-up" inspection on corrosion control maintenance performed on one of the Cleansweep B-52s.

Selected aircraft receive a concentrated maintenance attack over a five-day period. Not only are all discrepancies cleared, the aircraft are painted inside and out, new decals are installed and even new light bulbs. Sixteen men from the 307th Maintenance Squadrons are assigned to the program, 12 working the day shift and 4 at night. ★
