Aerospace SAFETY

UNITED STATES AIR FORCE • MARCH 1971

FOR AIRCREWS, MAINTENANCE & SUPPORT TECHNICIANS

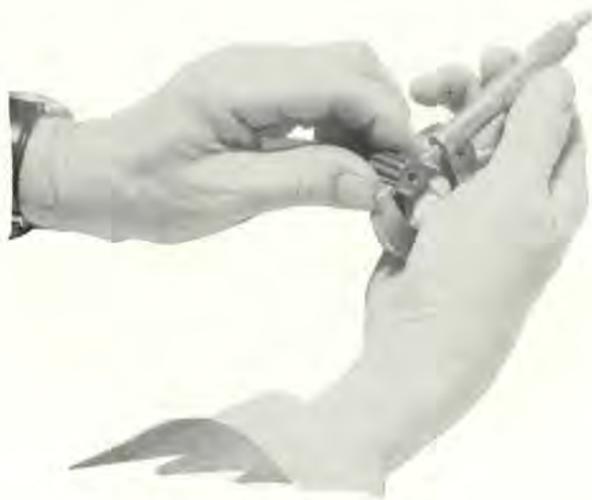
See Specification NAS 881 for Additional Data

found in a factory or overhaul agency. The typical field method, "mike and wires", should be accomplished by a machinist using the proper NAS 581 measuring criteria. You must clean both the male and female spline parts and inspect visually. If there appears to be wear, measure to determine if the parts are airworthy and relube as directed in the installation technical order.

There are two methods of checking spline wear. One is by use of special go-no-go gages, usually
