AEROSPACE

SAFETY

UNITED STATES AIR FORCE
APRIL 1971

FOR AIRCREWS, MAINTENANCE & SUPPORT TECHNICIANS

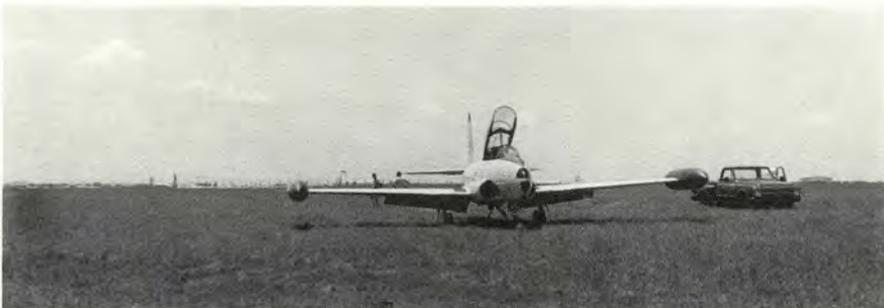
3. 1970—T-33 Brake failure.

found one of these five-foot ditches. The mishaps shown in photos 1 through 3 proved our hypothesis to be correct.

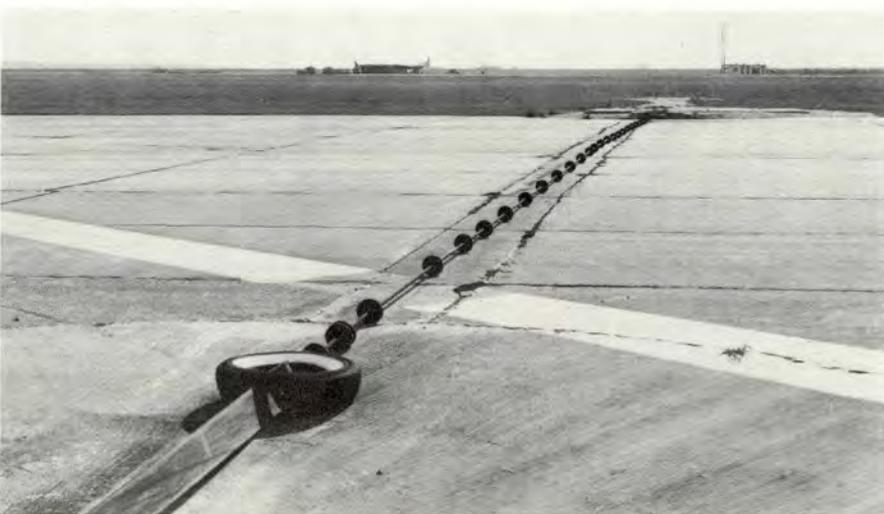
4. BAK-9 aircraft arresting barrier.

tems on runway 04/22. None was equipped to accommodate non-tail-hook aircraft. Only one arresting system, the BAK-9 on the approach end of runway 04, was capable of approach end engagement, and its capability was marginal, due to sur-

face irregularities on both sides of the hook cable and the fact that the cable was in a depression caused by a cut made across the runway when the BAK-9 arresting gear was installed. One look at photo 4 should prove convincing.

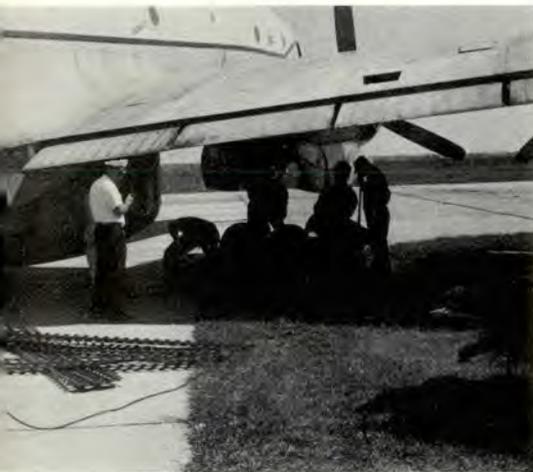
5. CY 1969—WV-1 stuck.

Night operations, especially during inclement weather, were positively unsafe on the parking aprons, due to no lighting and poorly defined guidelines. The fact that mishaps were infrequent attests to the professional skill of the pilots. Some visiting aviators were not so fortunate, as depicted by photos 5 through 7. The edges of aprons, taxiways (except the southeast) and runways were not stabilized with macadam or concrete. At night it was difficult to tell the difference between the paved surface and the mud.

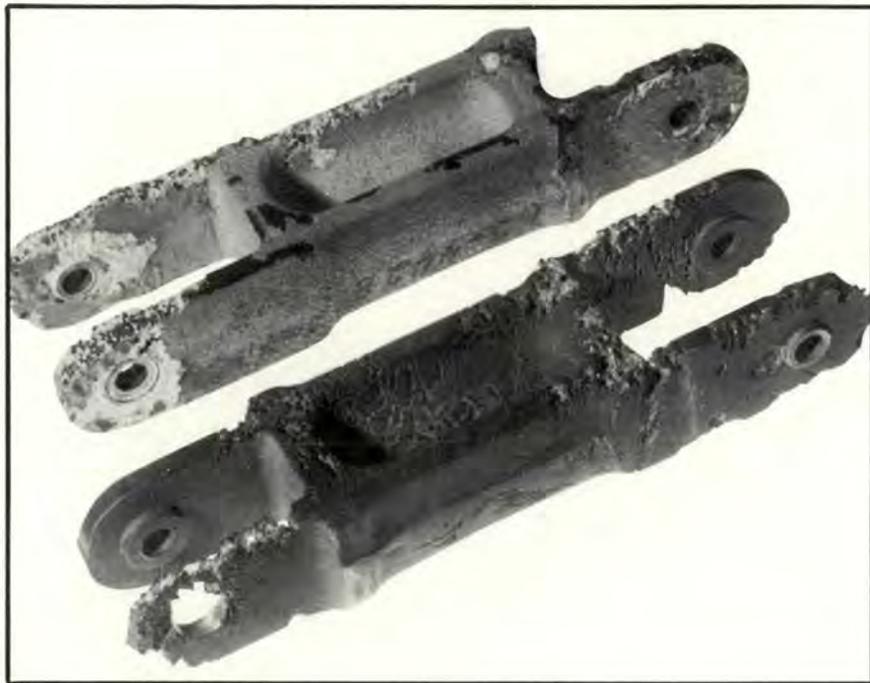
F-105 Flight Control Stick Link Rod Corrosion PN 79F340012-1

How would you like to fly the airplane the part above came from? The part is a pitch control link rod from an F-105. As the result of two separate instances of such severe corrosion of F-105 pitch control link rods, SMAMA, prime AMA for the '105, initiated an urgent TCTO.

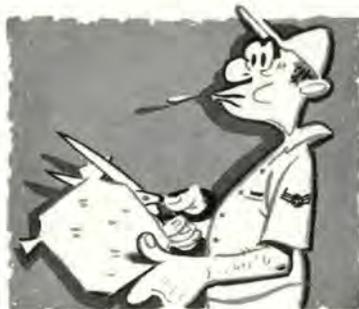
spit run

If you are not a recip engine mechanic, you most likely do not know what the term *spit run* means. If you are a recip engine mechanic, you know the term and the associated dangers if it is not done properly. The following incident is a prime example of what can happen when you try to cut corners.

The newly installed number two engine on a T-29 had been prepared for a depreservation run. Tech data had been followed with the exception of installing the depreservation drain plug hoses. It is impossible to install the drain hoses with the lower cowling installed. The engine was started, using the primer, and ran for 10-15 seconds, when a fire was noted. The operator attempted to blow out the fire by advancing the throttle; however, 700 RPM was all he could attain, so he re-

The fire was caused by an accumulation of fuel and corrosion preventive compound that puddled in the lower cowling from the lower cylinders. It probably ignited from a spark plug lead, even though the leads had plastic covers. It is believed that the spark jumped around the plastic to the ground. This outfit has decided to remove the lower cowling and install the drain hoses before spit running any more engines. In addition, they recommend metal caps on the loose spark plug leads rather than plastic. This would prevent any spark from jumping. Following tech data is still the best way to prevent such mishaps.

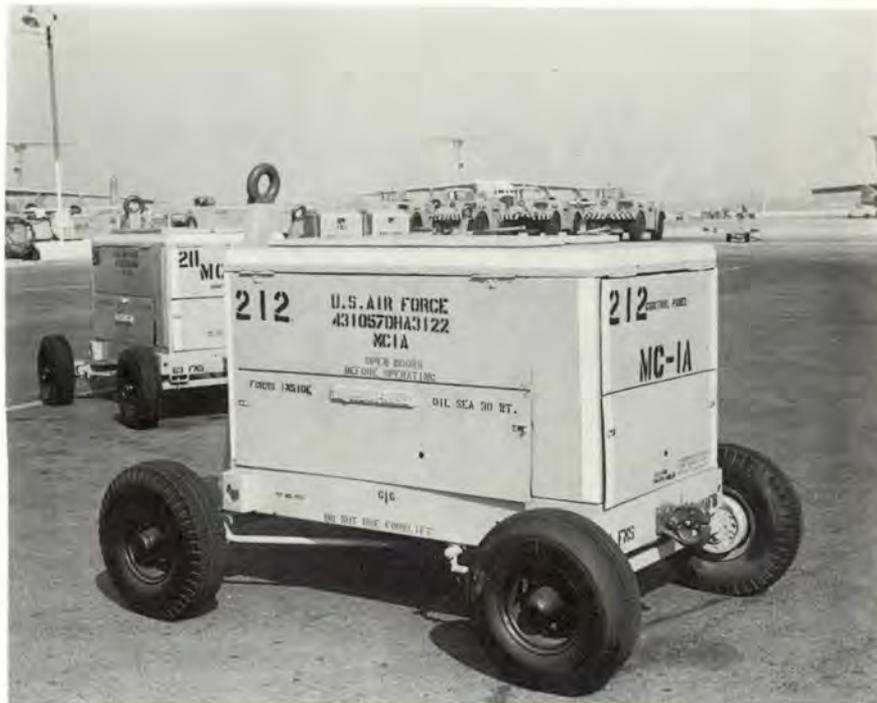
Charts similar to this are used by each AMA to compute repair expenditure limits.

- High dollar aerospace ground equipment which costs \$2,500 or more. These items are assigned maximum allowable one-time repair expenditure limits and estimated service life. They are listed in TOs 35-1-24, 35-1-25 and 35-1-26 by FSC, P/N and Noun in a convenient table citing the repair expenditure limit for each year of the estimated service life of each item.

When the repair cost estimate for AGE in this cost category exceeds the maximum allowable one-time repair expenditure limit, the owner must submit to the FSC IM a detailed description of the deficiencies
