UNITED STATES AIR FORCE • MAY 1971

Aerospace

SAFETY

A SALTY SITUATION

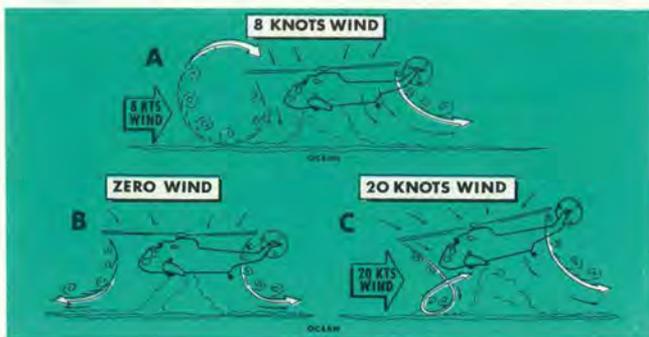
aircraft attitude. As the figure above illustrates, wind conditions are particularly significant. At zero wind, most of the spray is blown away from the aircraft. At 20 knots the spray blows aft, beneath the aircraft. With an 8-10 knot headwind (and a low hover height), conditions approach the intolerable—the engine inlet is engulfed in salt spray.

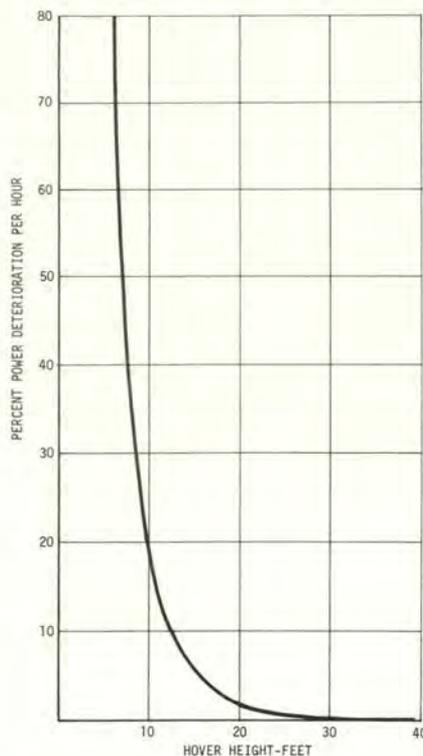
FIGURE 1

POWER DETERIORATION RATES VS HOVER HEIGHT ABOVE SALT WATER*
RATES STRONGLY INFLUENCED BY PREVAILING WIND AND SEA STATE CONDITIONS.

*DATA FOR COMPARATIVE PURPOSES ONLY - NOT TO BE USED AS LIMITS FOR DETERMINING SAFE TIME IN HOVER CONDITION.

Hover height is particularly critical in determining the salt deposit rate. Figure 1 defines power deterioration rate versus hover height under adverse wind and sea state conditions. Below ten feet, a very tall chart is required to contain the data points on the paper. For T-58 powered helicopters the rotor downwash ceases to be a major factor above 40 feet. With larger rotor systems such as exist on the H-53, the equivalent level might occur at approximately 70 feet.

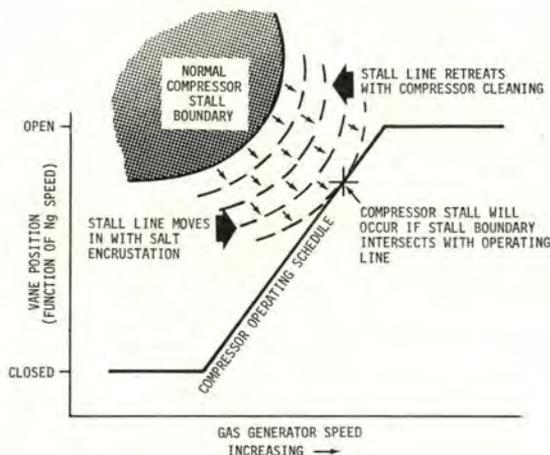
EFFECT OF SALT INGESTION ON LOSS OF COMPRESSOR STALL MARGIN

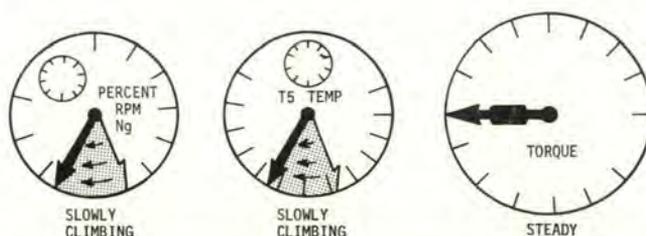
ENGINE CHARACTERISTICS IN A SUSTAINED HOVER OVER SALT WATER

The pilot is equipped with adequate instrumentation and the engine provides sufficient symptoms to allow recognition of excessive power degradation. At a fixed torque, N_g and T_5 will continue to rise as the salt build-up process continues. Armed with this information, the pilot can exercise effective precautions.

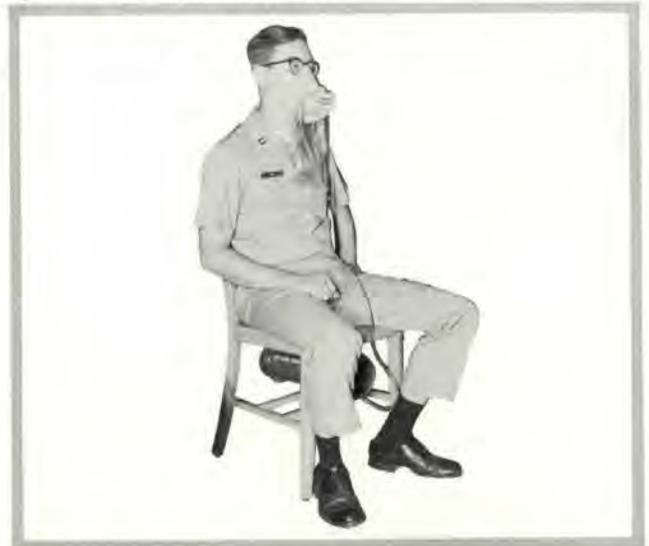
Engineer demonstrates chlorate candle oxygen system now in use on the C-141. System eliminates pressurized walk-around bottles.

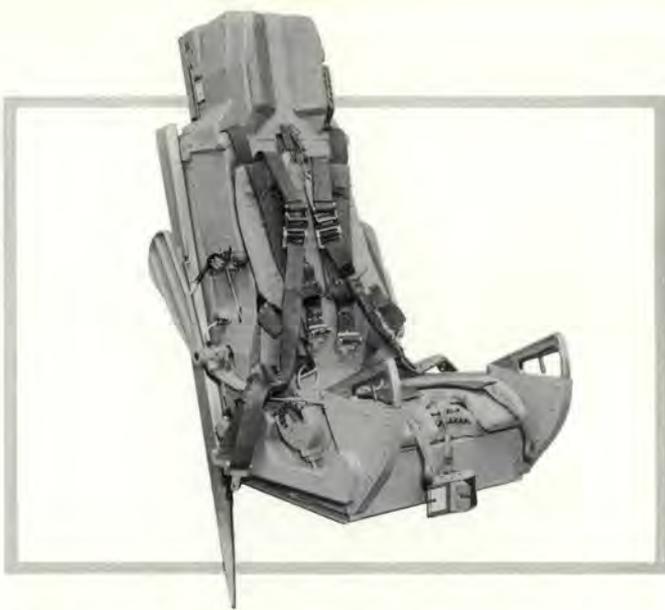
Mockup of ACES now under development by the contractor and Life Support SPO.

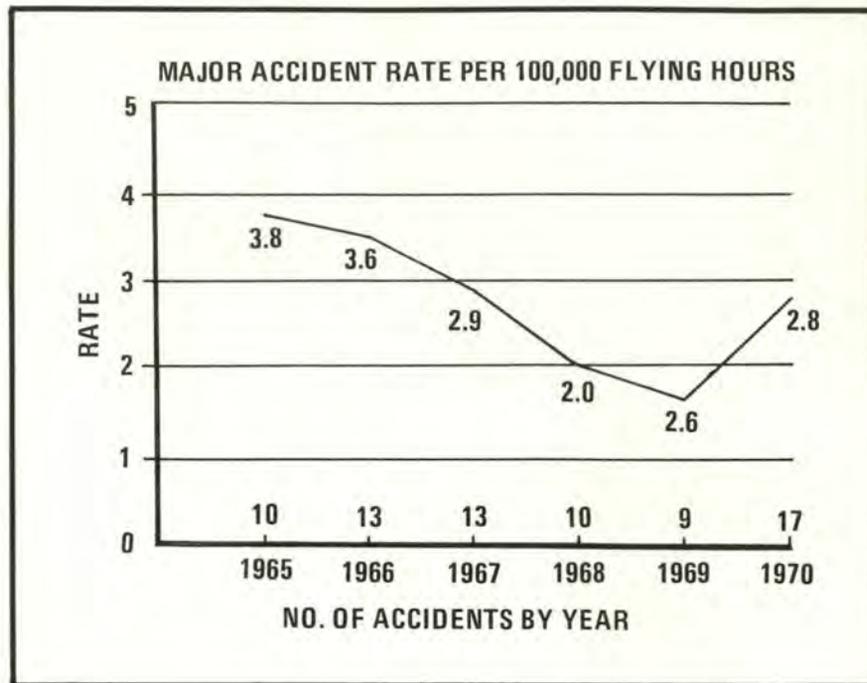
This graph illustrates the favorable trend enjoyed by the T-38 since 1965 and the sudden reversal in 1970.

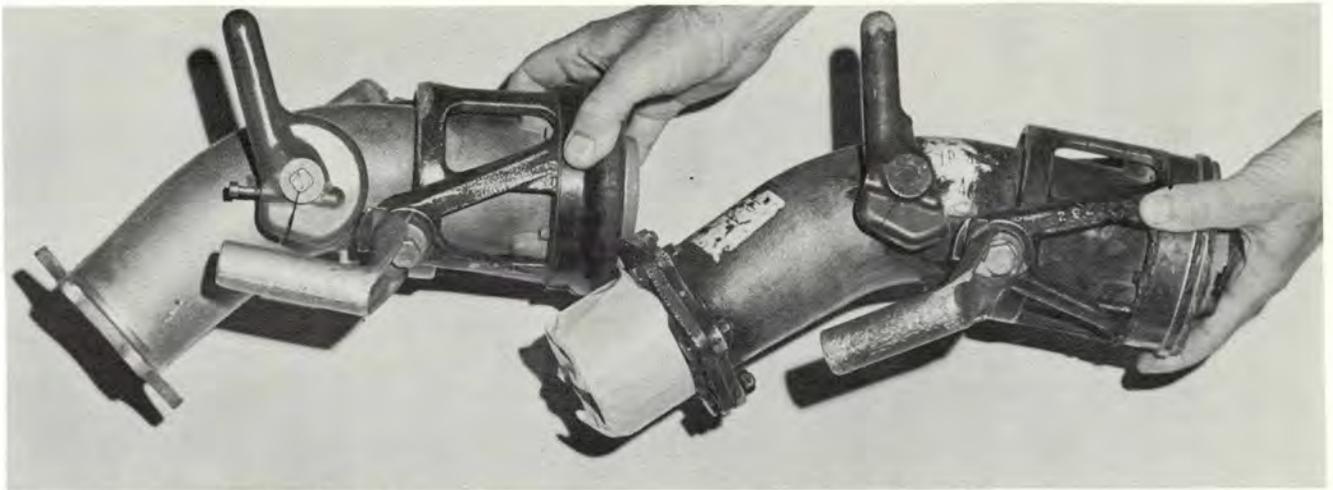
CAM INTACT

BROKEN CAM

This cannot be denied. The handle was broken and it did fail. Would you have used this nozzle with the broken handle? Someone did. All of the broken handles in

the above picture were removed from nozzles at one base. Good maintenance practices would have replaced all of the broken handles.

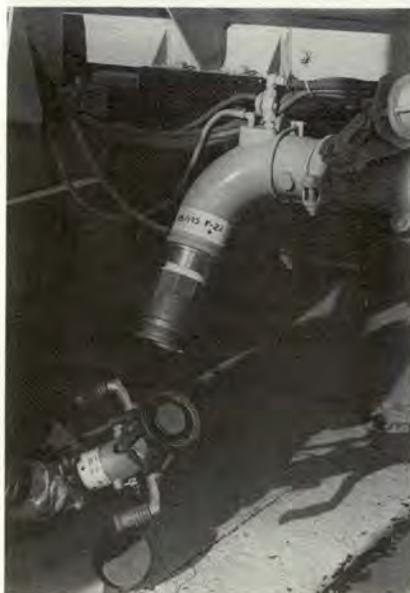
Note the standard single point nozzle will not fit the dry break type coupling.

for JP-4 and a dry break type coupling valve with adapter for avgas. *With these two different systems it will be virtually impossible to bottom load the wrong grade of fuel into a refueling unit.*

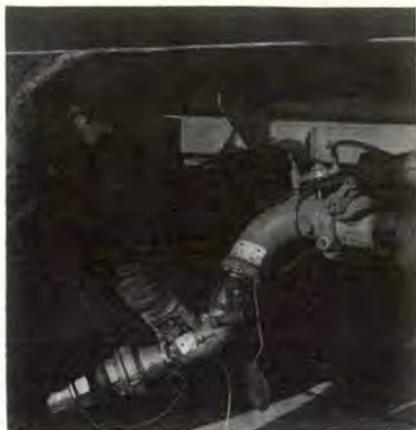
Bottom load hook-up for JP-4.

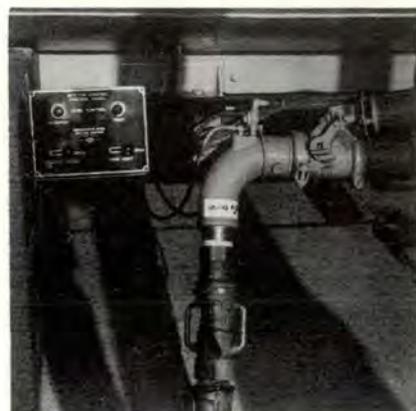
Bottom load hook-up for avgas.
