UNITED STATES AIR FORCE • JUNE 1971

Aerospace

SAFETY

FOR AIRCREWS, MAINTENANCE & SUPPORT TECHNICIANS

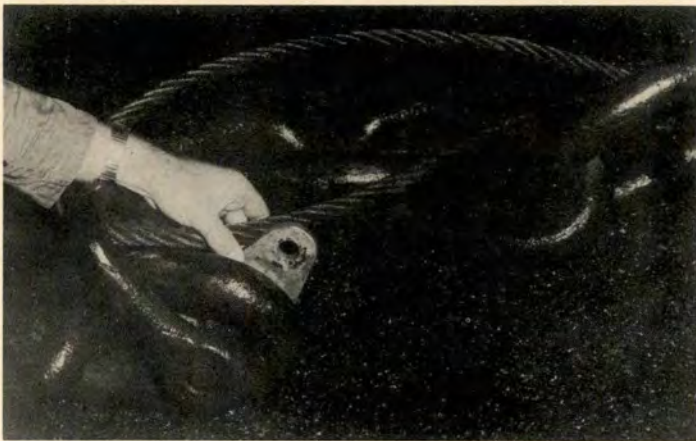
The accident investigation board concluded that the groove under the cable contributed to the unsuccessful BAK-12 engagement. The fact that the cable was rigged 1/16 inch below the minimum runway clear-

ance required was considered a minor factor. The most probable cause was that as the aircraft wheels passed over the BAK-12 cable, fluctuations were induced and the cable was almost below the level of the runway as the hook arrived. Under this condition, with the cable partially within the groove, the accident aircraft hook deflected the cable down and under the hook.

Although the groove under the cable had been repaired two months earlier, the BAK-12 cable had worn a new groove about ten inches wide and $1 \frac{7}{16}$ inches deep at the runway centerline. These measurements were determined during a grooving inspection made by the barrier crew three days prior to the accident. By coincidence, the cable clearing above the runway was also measured as $1 \frac{7}{16}$ inches during this inspection. This is $\frac{1}{16}$ inch less

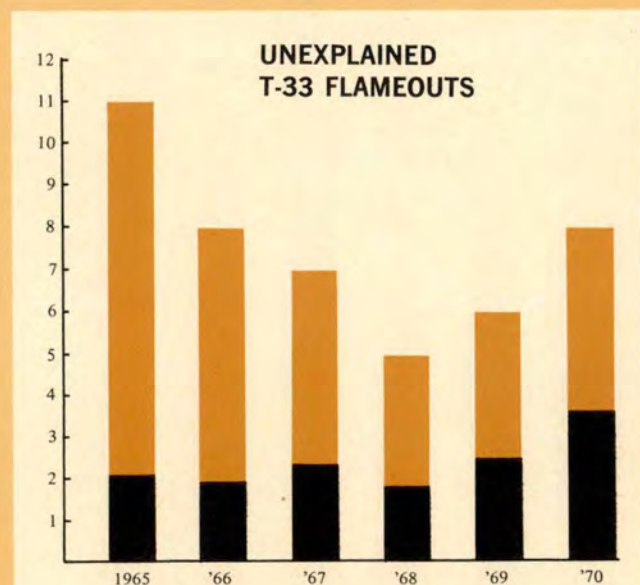
The legend on the chart, page 19, April issue was somewhat garbled. For you folks concerned with the T-33, we have redrawn the chart and corrected the legend. Sorry about that.—ED.

Color bars indicate number of unexplained flameouts. Black portion indicates rate per 100,000 flying hours.
