UNITED STATES AIR FORCE • NOVEMBER 1971

# AEROSPACE

# Aerospace SAFETY

**FOR AIRCREWS, MAINTENANCE & SUPPORT TECHNICIANS**

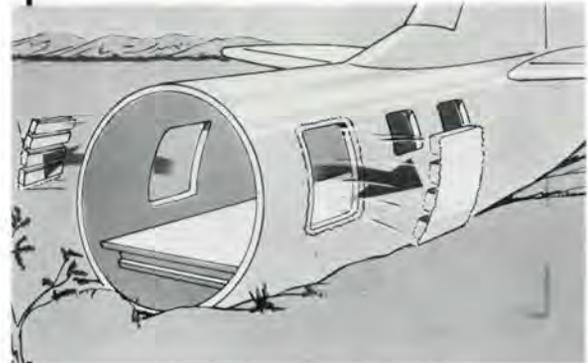
Schematic of ELSIE System

an AC-130 where no opening in the aircraft structure exists prior to actuation of the system. The other is a door within a door which is being installed in an ASD Flight Test C-131.

ELSIE resulted from studies of the causes of death in survivable accidents. The studies showed that, in commercial aviation, approximately half of the persons involved in survivable crashes perish and half of the deaths are attributed to post-crash fire. The Air Force, likewise, has experienced fatalities from post-crash fire, due to the inability of crew and passengers to open jammed

Currently two applications of the system are in operation. One is in

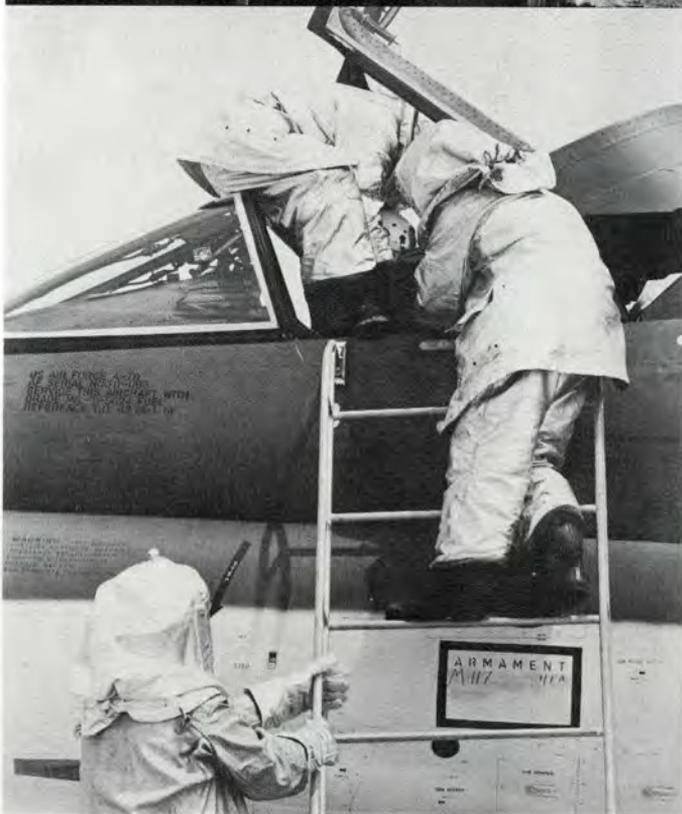
## RESCUE LADDER (A-7)

mally stored in the fuselage. Rescue operation using this ladder would be severely hampered, so a special lightweight ladder with protective "feet" and "pads" was developed to allow two or more rescuers access to the cockpit. The canopy locking and opening mechanism is intricate and finely balanced, so special instruction was required. A friction cutting saw (K-12) is required to enter the cockpit if the interdependent canopy downlock system becomes jammed. Seat safing instructions in the TO, while adequate for normal maintenance in a hangar, were deemed inadequate for aircrew extraction practice. A new checklist was devised and submitted for inclusion in the TO. This checklist insures that no "Murphyism" will cause an inadvertent canopy jettison or seat ejection.

During exercises, protective mats for the sensitive canopy rails are used. A special non-skid "bathtub" mat precludes windscreen damage, and pilots are physically lifted only to the edge of the canopy rail. They then climb down the ladder, are placed on a fracture board, and carried a safe distance from the simulated crash site while receiving mouth-to-mouth resuscitation and heart massage. A resuscitator is available and used until the flight surgeon's arrival.

The first problem encountered involved aircraft design. With the cockpit located well forward and higher than most fighters, the A-7 has a telescoping access ladder nor-
