UNITED STATES AIR FORCE • DECEMBER 1971

Aerospace SAFETY

FOR AIRCREWS, MAINTENANCE & SUPPORT TECHNICIANS

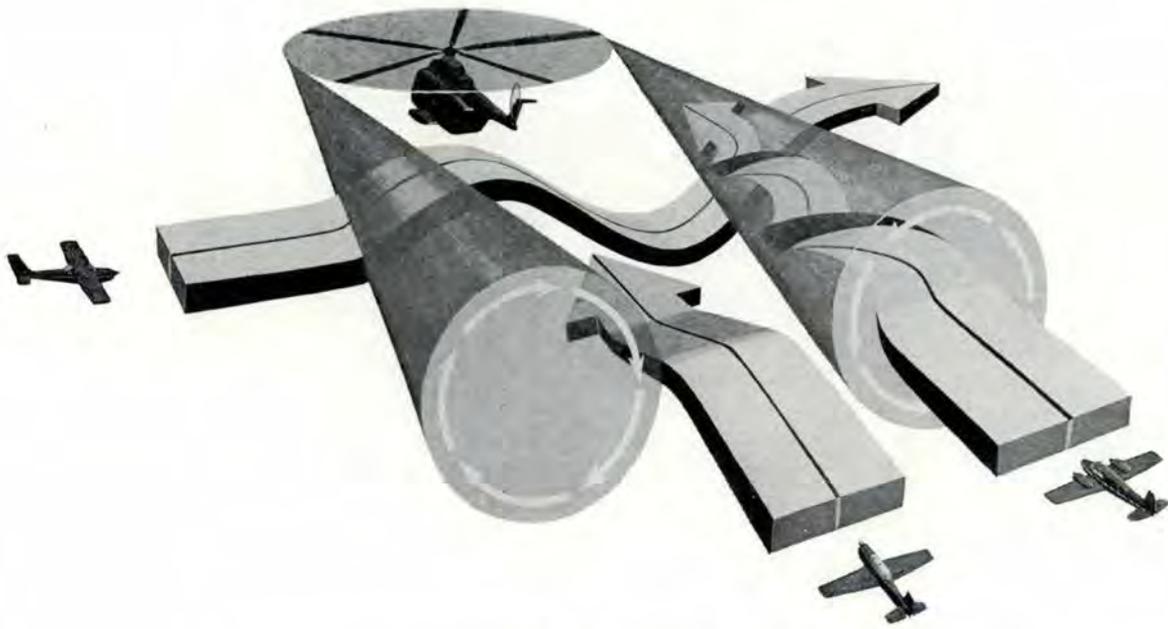
Penetration modes: cross track, along track between vortices, along track through vortex center. Each mode presents certain hazards to penetrating aircraft.

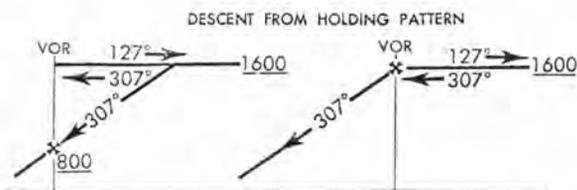
Descent from the minimum holding altitude is depicted in two ways—descent at the holding fix and descent on the inbound leg.

All maneuvering depicted with a heavy blue line is considered an integral part of the approach procedure. This applies to the heavy blue holding pattern depiction and differentiates it from an arrival holding pattern which is not part of the approach procedure.

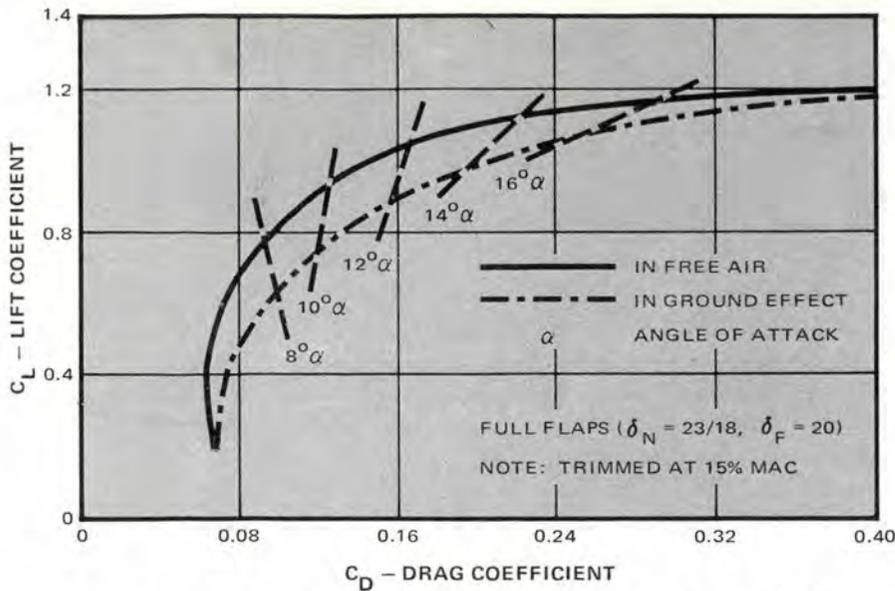
Figure 1. Lift and Drag Characteristics with Landing Gear Down (F-5)

a smaller angle of attack and less induced drag, all illustrated in Fig. 1.

ground effect area. You should keep in mind that the aircraft must have excess thrust available to climb out after it becomes airborne. If the aircraft is airborne at too low a velocity it may be so far back in the area of reversed command that no excess thrust will exist upon leaving the ground effect benefits.

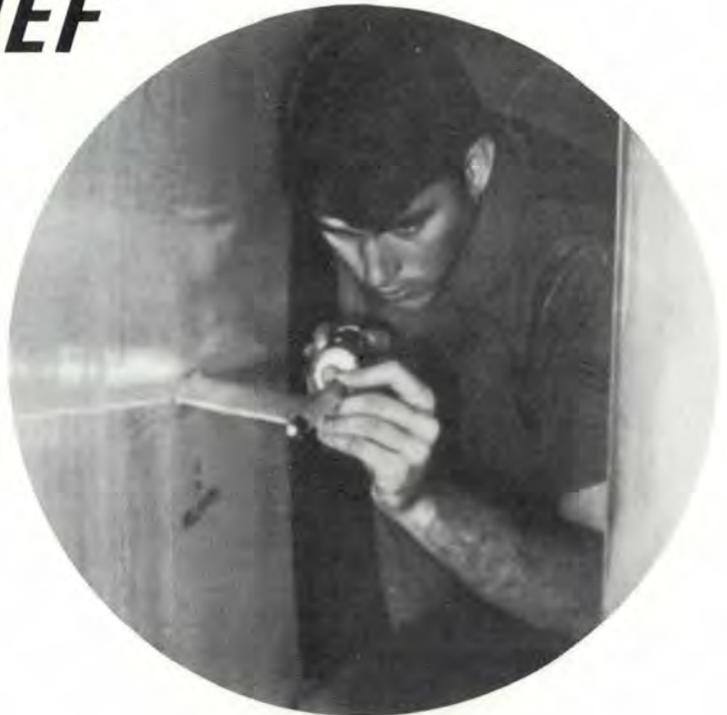
The work begins . . . a hundred little things on paper. Screws fussed over, rivets pecked, dials tapped, connections checked and rechecked. Shoeless and armed with a flashlight, he injects himself up into the narrow cave of aluminum, the intake. On the way he stops to check a pencil-sized tube that measures air pressure to the engine.

He crawls farther, looking for foreign objects that could damage

... NOTHING MISSED.

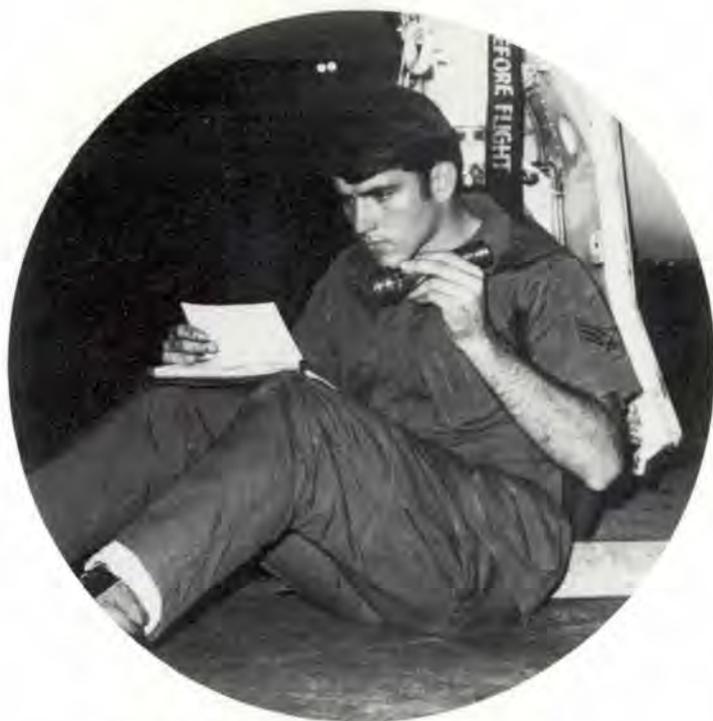
CHECKLIST—CREW CHIEF'S BEST FRIEND.

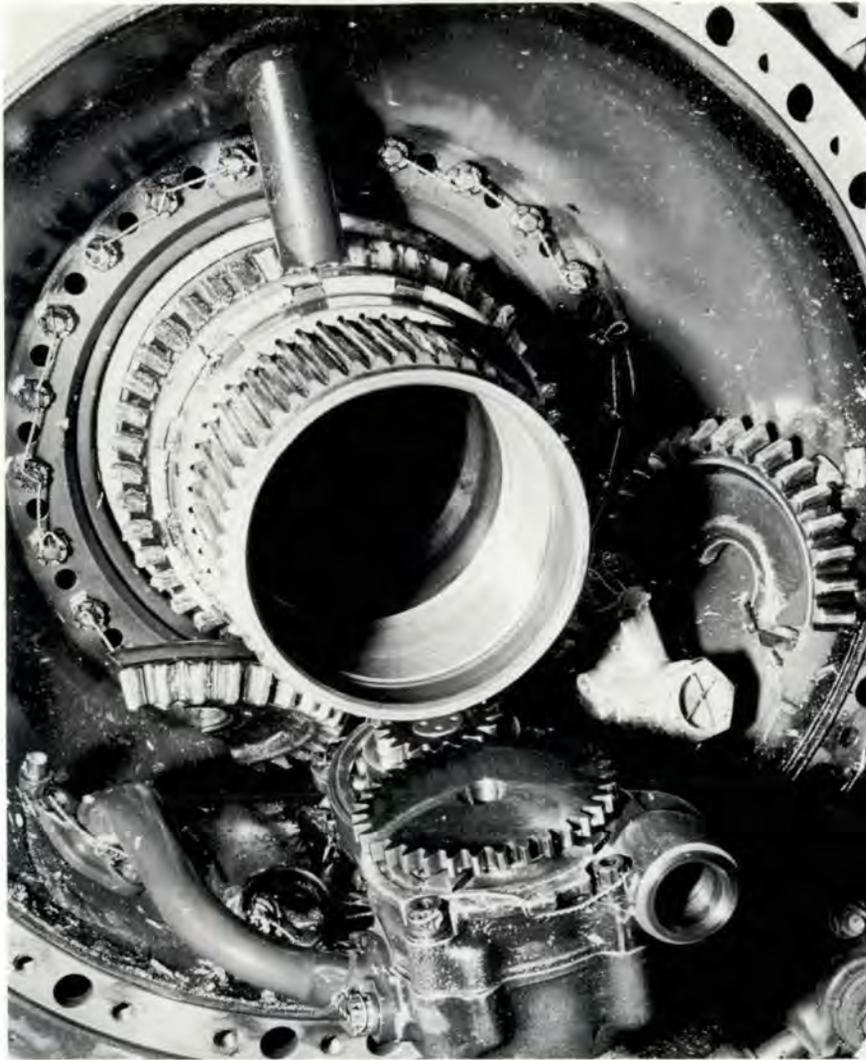
• two wrongs make an accident

The F-102 pilot was closing on the target when the radar scope went blank and the aircraft yawed to the left. A quick glance at engine instruments confirmed engine flameout. After all attempts failed to restart the engine, the pilot flew to the closest airport; however, the field was obscured by clouds so the pilot elected to eject, which was successful.

The primary cause of the accident was maintenance. Improper stacking of the accessory drive (bull) gear with insufficient clear-

ance (backlash) between the accessory drive gear and the mating bevel gear shaft caused an overload condition leading to progressive wear, metal fatigue, and subsequent failure, as pictured above.
