UNITED STATES AIR FORCE • JANUARY 1972

AEROSPACE SAFETY

FOR AIRCREWS, MAINTENANCE & SUPPORT TECHNICIANS

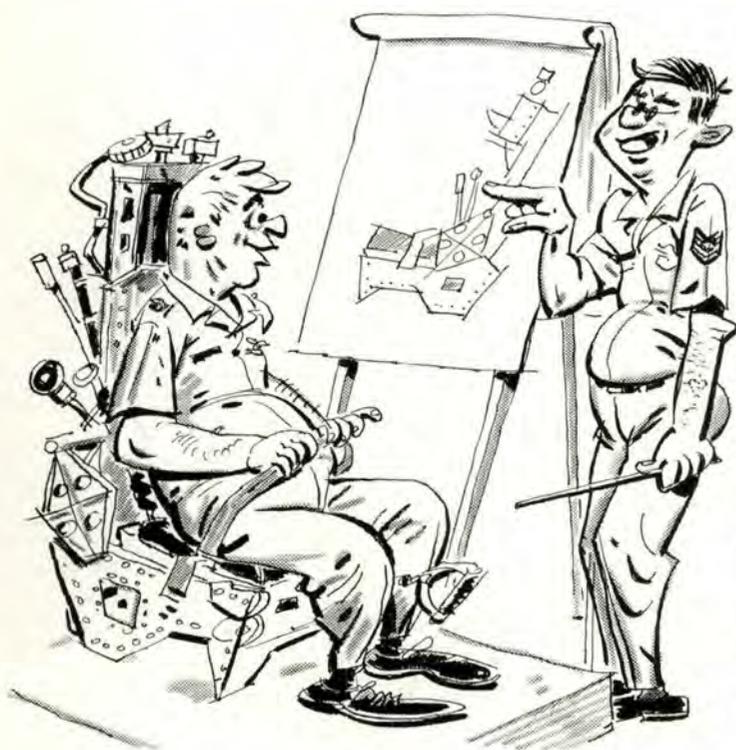
WOW!! IT WORKS!

The prospective passenger arrived at flight operations for his first orientation ride in the OV-10, and was sent to the Life Support section to pick up survival gear. There he was briefed on the operation of life support equipment and the OV-10 egress system.

The passenger and the pilot then walked to the aircraft, where the pilot personally strapped the passenger into the rear seat, reviewing with him the briefing on the egress system. Specifically, he cautioned the passenger not to pull the D ring unless told to do so.

he directed the passenger to do the same. The passenger stated that the pin was a little snug but with a little jiggling he was able to remove it. He took the pin and the attached strap and was reaching for the thruster safety pin on top of the instrument panel. Suddenly he smelled something burning, heard a hissing noise and was ejected out of the cockpit! The ejection was successful, and the passenger landed 48 feet away, with no serious injury.

The conclusion of investigators was that the passenger pulled the D ring and S.I.E.'d (self-induced-ejection). Examination of the seat showed that both initiators in the dual system had fired with the activating pins pulled. The graduated metal flanges on the seat-activating D ring handle were bent and broken in such a way as to indicate that the D ring was UP at the time of impact.

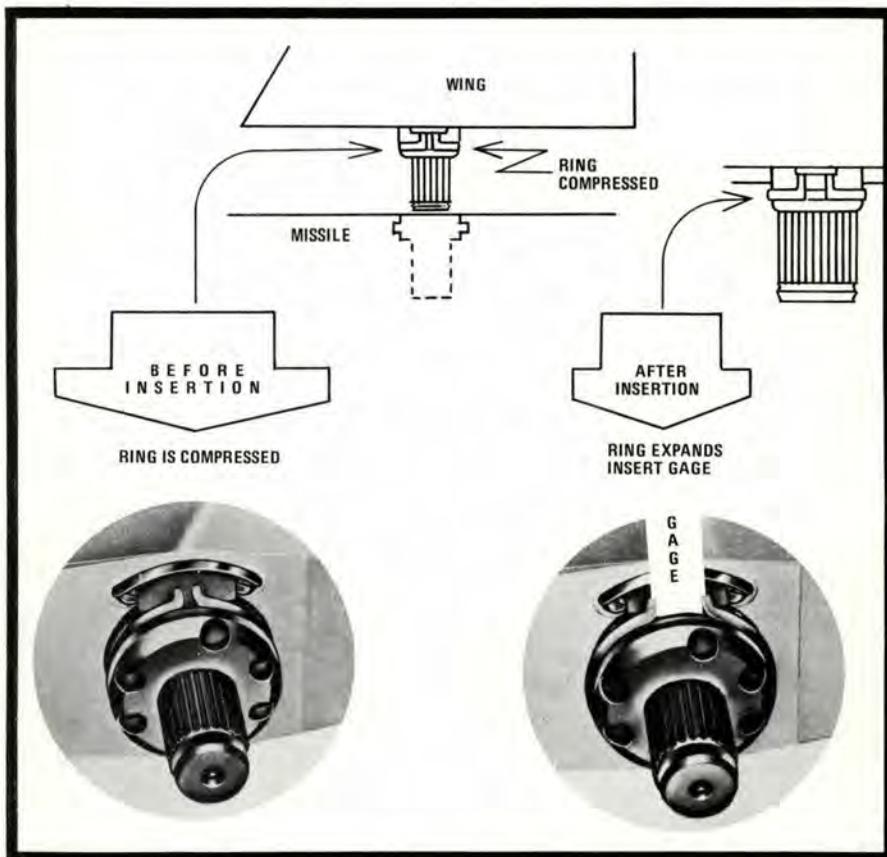
History repeats itself, and once again we have wing problems—this time AIM-7 missile wing losses. Supposedly, we have come a long way from those days of mythological tales, but a look at the facts makes one wonder. In mid-1970, a GO-NO-GO gage was devised that, if used properly, could prevent AIM-7 wing losses. However, the number of wing

losses has remained constant, and most of these incidents have been attributed to personnel error on the part of the user. Some bases have been three and four time repeat offenders.
