UNITED STATES AIR FORCE • FEBRUARY 1972

Aerospace SAFETY

whoa woes

One sure way to cause the hair to stand up on the back of your neck is to apply your brakes and have your machine pick up speed. Here are some guidelines that may help avoid this nasty situation.

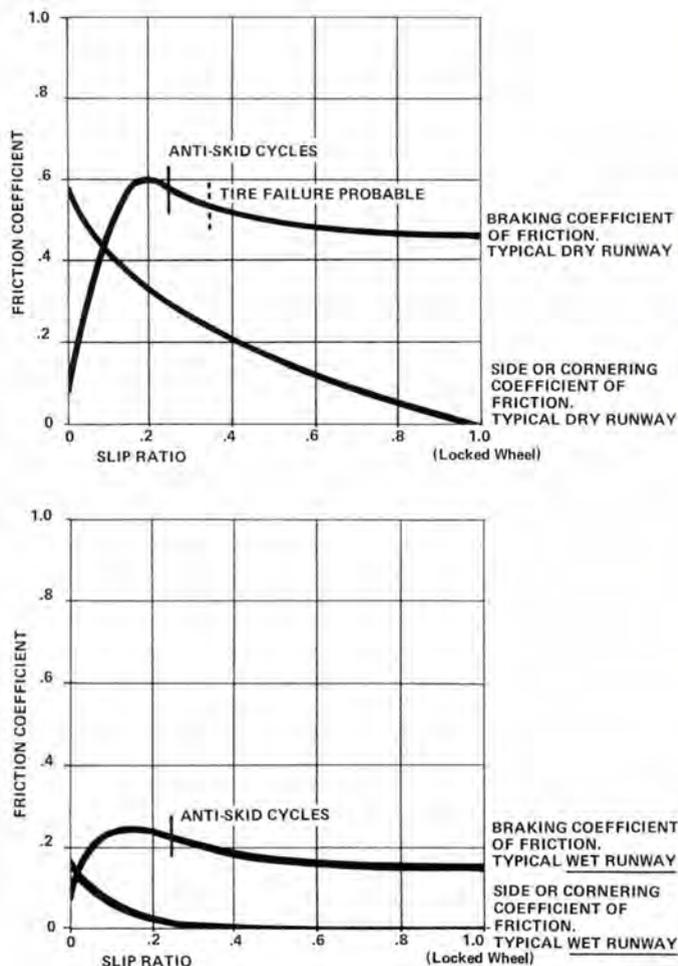
FIGURE 1

When an aircraft tire is totally skidded (slip ratio of 1) on a dry surface, tire failure is complete and immediate. Figure 1 shows that, as you increase the slip ratio, the side force capability of the tire drops, and as you reach a 1.0 slip ratio (total skid) the side force coefficient of friction drops to zero, whereas the braking coefficient of friction levels at somewhere around 0.4. You've probably experienced this phenomenon of loss of directional control during a panic wheels-locked stop in your automobile.

Anti-skid braking systems are designed to prevent total skidding and thus loss of directional control and tire failure. Some very slight skidding is required, however, to develop the most effective coefficient of friction. From Figure 1 you can see that the coefficient changes as the slip ratio changes. The most effective frictional values are developed with approximately 0.20 slip ratio or 20 percent of a total skid. Based on this, most anti-skid systems cycle at 0.15 to 0.25 slip ratios.

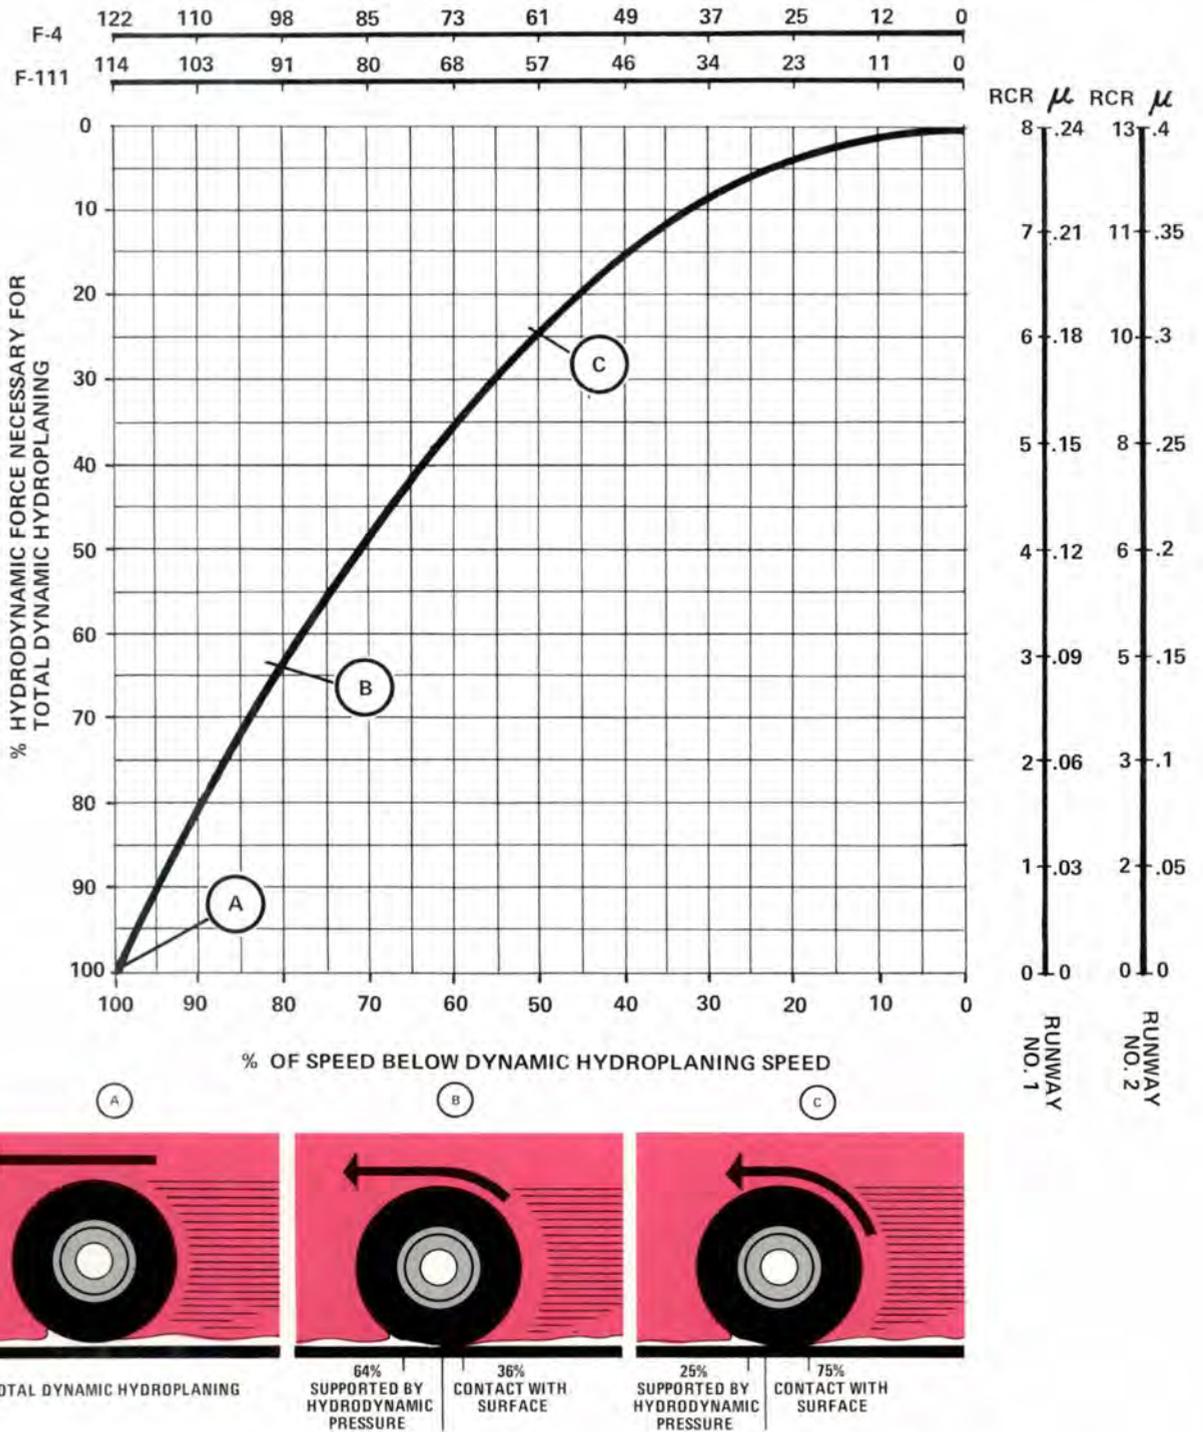
Figure 2 explains the effect of partial hydroplaning on braking performance on a slippery wet runway. Across the bottom of the chart is the percentage of speed below total dynamic hydroplaning speed. Across the top are the corresponding speeds of the F-4 and the F-111. In the F-4 your total hydroplaning speed is 122. At 92 knots you would be 56 percent hydroplaning. Move to the right side of the chart to runway 1 with a total coefficient of friction capability, when wet, of 0.24 (or an RCR of 8). Under the partial dynamic hydroplaning condition above, the total coefficient of friction capability at that speed would be only 0.10, (an RCR of 3). As the aircraft slows down, the effective RCR or coefficient of friction would increase but never exceed the total capability of the runway, which in this case is 0.24 (RCR of 8).

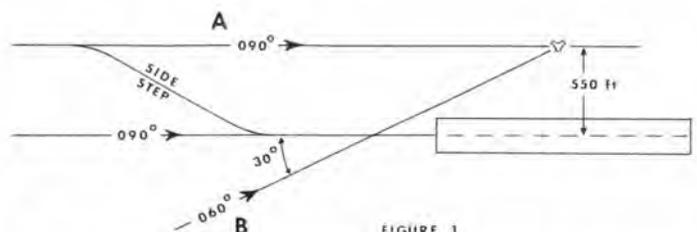
FIGURE 1

Consider an on-airport TACAN placed 550 feet from the runway centerline. If the final approach radial exactly parallels the runway centerline (090 degrees in Figure 1, Example A), a side-step maneuver of more than 500 feet is required. If you sight the runway some distance out, the side-step maneuver would hardly be noticed. However, only circling minimums could be published even though the maneuver will appear to be a straight-in approach.

A different final approach radial may be selected by the approach designer which will eliminate the side-step maneuver. In Example B, the final approach course of 060° requires a 30 degree turn to align the aircraft with the runway. This is within the criteria for a straight-in approach and straight-in minimums would be published.

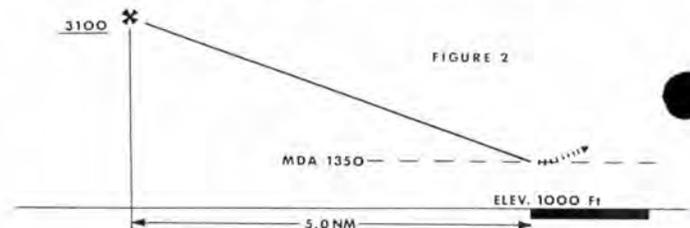
FIGURE 2

A less common problem is the descent gradient in the final approach segment. Straight-in minimums can be published only when this descent gradient does not exceed 400 feet per mile. The example in Figure 2 shows descent of 2100 feet in 5.0 nautical miles, or 420 feet per mile. Note that descent gradient is computed to the runway elevation and NOT to the MDA. While straight-in minimums cannot be published, the actual landing maneuver may, for all practical purposes, be a straight-in approach. ★
