UNITED STATES AIR FORCE • MARCH 1972

# AEROSPACE

SAFETY

**FOR AIRCREWS, MAINTENANCE & SUPPORT TECHNICIANS**

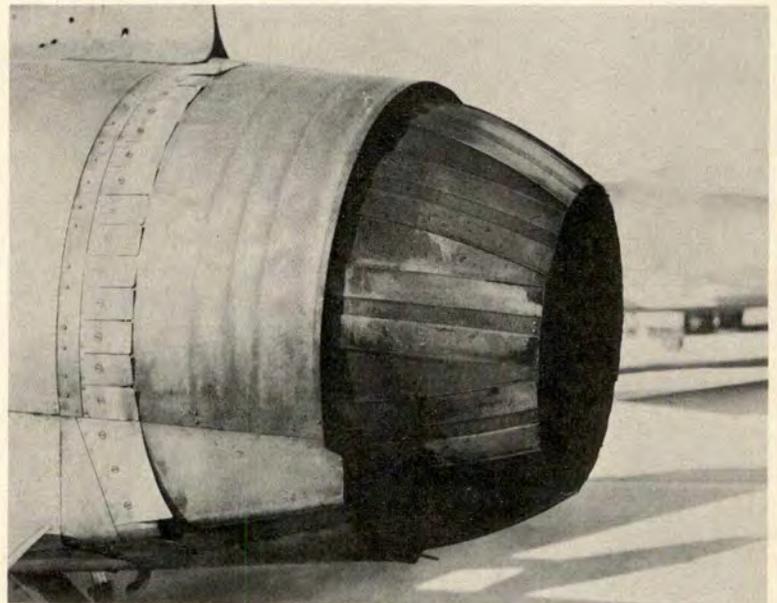
F-100 -21 afterburner "before" transplant.

Results were continuous good lights at three-second intervals under all flight, altitude and G loading conditions for which the F-100 is operationally qualified. More than 200 lights were accomplished without a single hard light or compressor stall. With the -23 afterburner installed, a small thrust and fuel consumption increase was realized; however, this increase regained some of the performance loss the F-100 had experienced over the years. Also, temperatures in the aft section ran cooler than with the -21AB. Drag chute operations were normal with no cable hangups on the AB during crosswinds. At the end of the test, the engine was checked for trim, AB growth, heat damage, vibration and drag chute heating. All results were negative.

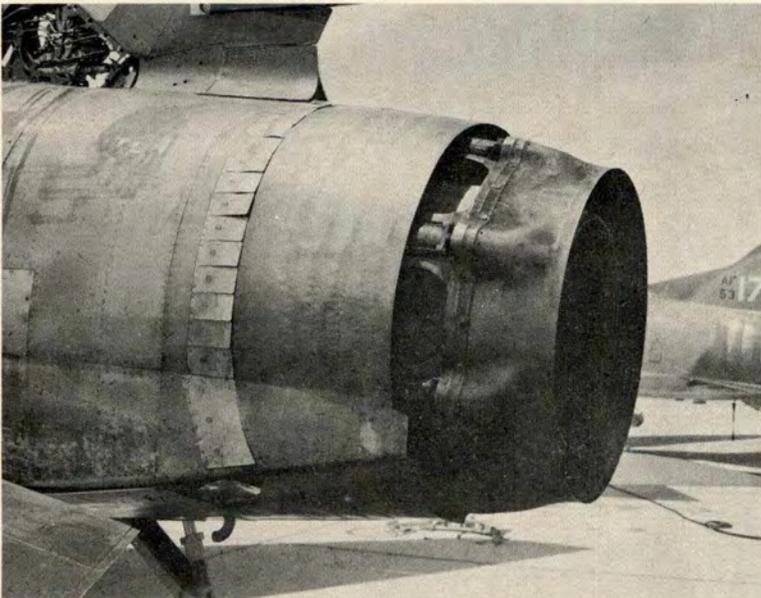
F-100 -23 afterburner "after" transplant.

one of the finest things to happen to the old bird." Sergeant Suzich also says that the -23 afterburner provides satisfactory service for up to 600 hours. The average time between major maintenance on the -21 AB is 150 hours. And the in-commission rate of the -23 is four times better than the -21.

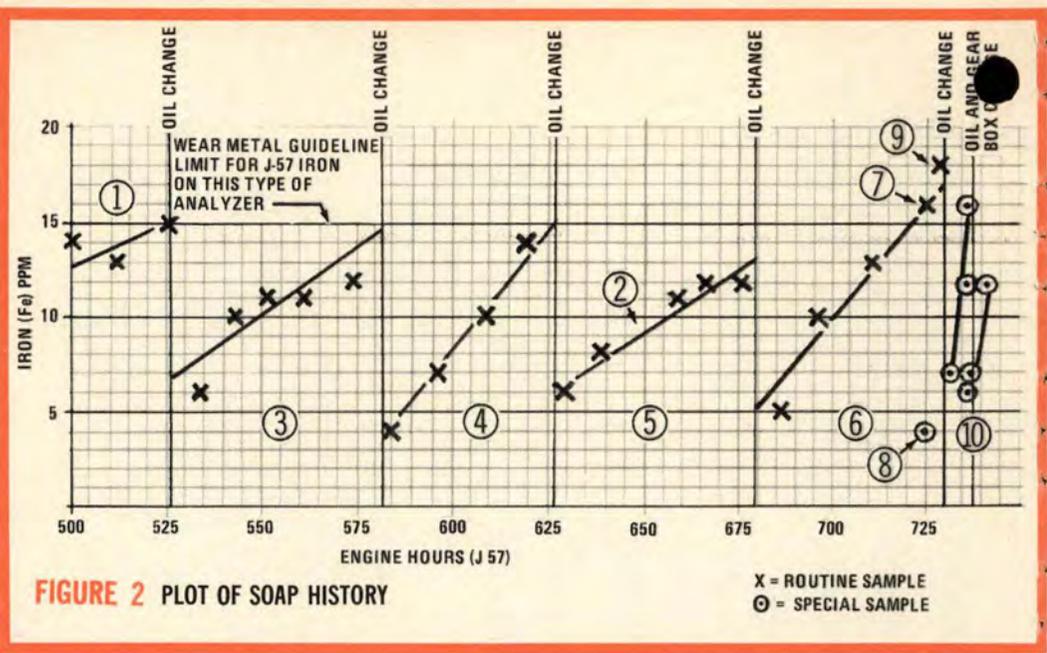
**FIGURE 2** PLOT OF SOAP HISTORY

To do this, we've analyzed about 250 hours of the SOAP history of a J57 engine. This particular engine was transferred to a new unit and its oil analysis responsibility assumed by a new laboratory. For some reason, the old SOAP records did not go with the engine, so the new lab started from scratch, so to speak.

To construct Figure 2, we plotted engine hours against FE readings in parts per million. The guideline limit for FE in this engine tested on this analyzer is 15 ppm. We've also plotted oil changes as vertical lines at the appropriate engine times. We've elected to treat each oil change as a separate graph and to examine the trend developing in that oil.

The SOAP Tech Orders suggest this method, but don't provide much information on exactly how to do it. We've selected one method that might be of some use in an investigation (Figure 2).

Figure 1 shows some of the SOAP data available to the accident board. For clarity, we've included only the FE readings. This same data has been plotted on the graph in Figure 2.

Now we're ready to analyze. The paragraphs numbered below correspond to the circled numbers on Figure 2.

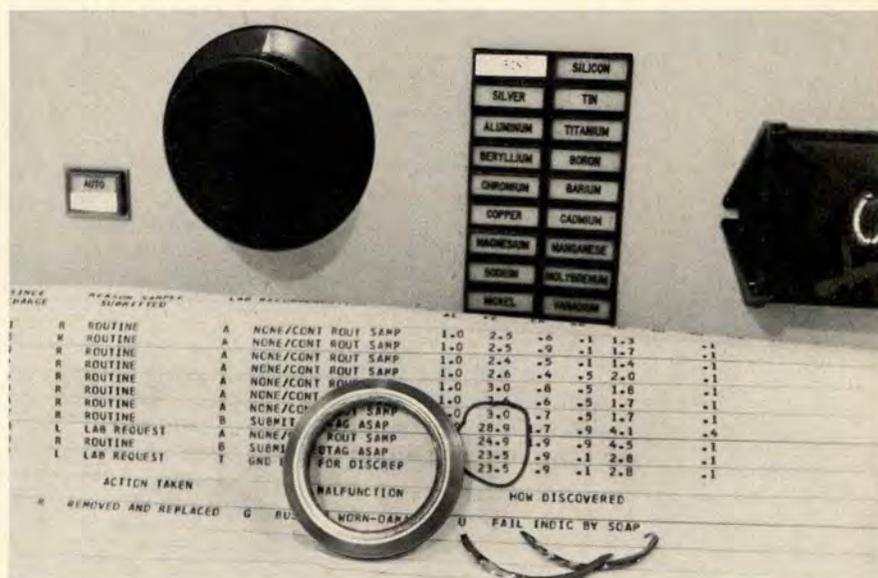
Experts say any engine oil-wetted part will tell us when it's about to fail, if properly analyzed. This one did!

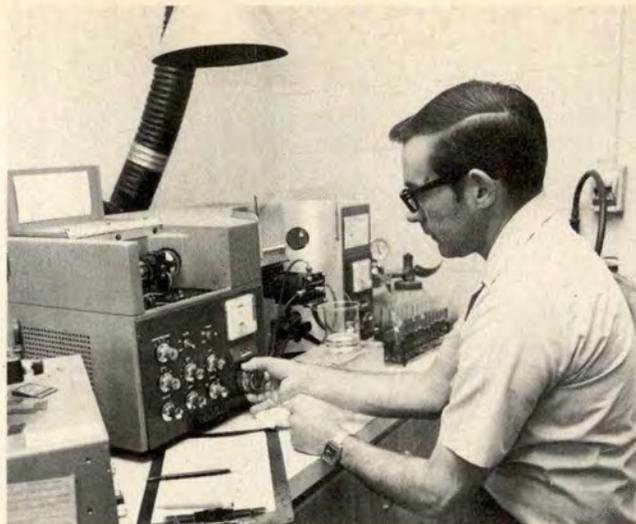
479 FMS SOAP laboratory supervisor, William C. Moffat, calibrates Perkins-Elmer 303 unit in preparation for the day's analysis.

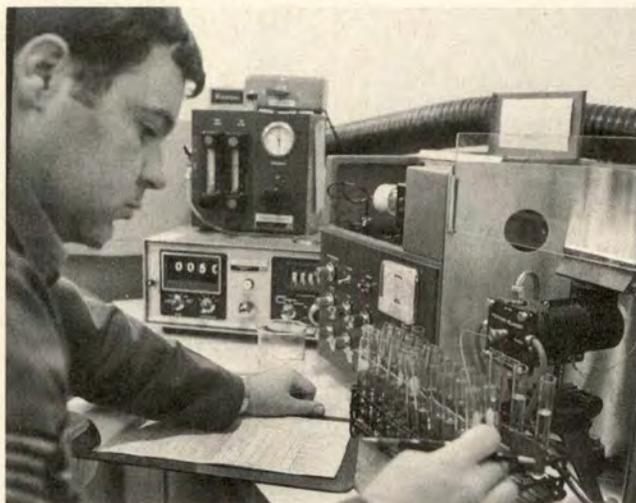
J79 engine oil samples are tested for iron content by SSgt Raymond B. Borm.

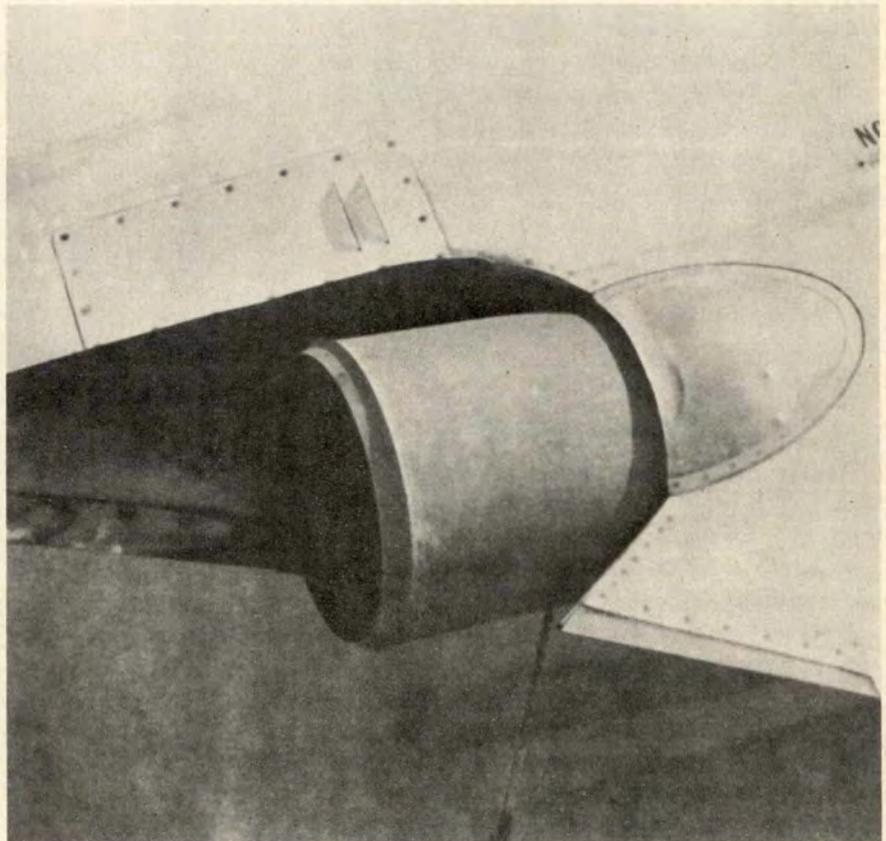
Turned out the tailpipe had come loose and was forced back against the interior of the nacelle. Closer examination revealed that the tailpipe clamp had been installed with its edge caught on the tailpipe flange. The clamp worked loose in flight and the tailpipe was forced aft by the exhaust gases, as shown in the accompanying photo.

During go-around from a low approach, the IP and student in a T-37 heard an explosion in the right engine. The IP retarded the throttle to idle as smoke entered the cockpit and the overheat light illuminated. The fuel shut off "T" handle was pulled, the overheat light went out in approximately 20 seconds, and the IP made a single engine landing.
