UNITED STATES AIR FORCE • APRIL 1972

# AEROSPACE

SAFETY

**FOR AIRCREWS, MAINTENANCE & SUPPORT TECHNICIANS**

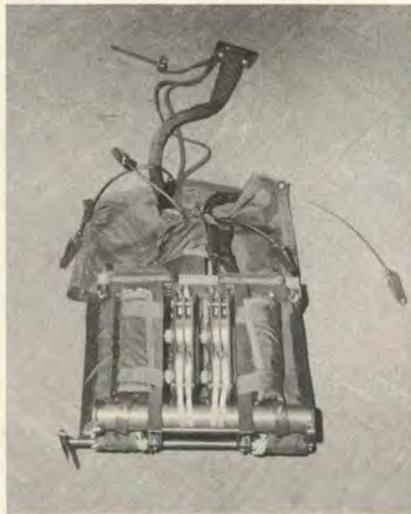
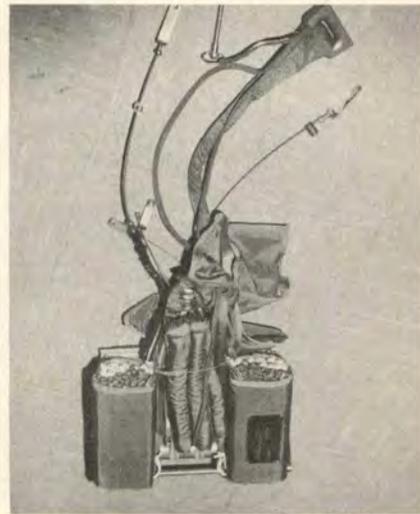
**Left above, DART brake system on underside of seat. Right, stowage of snubber lines on each side of underside of seat.**

What makes this system unique are the methods employed to accomplish these features. Stabilization during rocket burn is accomplished by nylon sliplines attached to the aircraft and connected to the seat through brakes fitted to the underside of the seat.

seat stabilization. As the lines play out through the brake during rocket burn, the lines sense seat movement in pitch and roll. Any adverse movement of the seat, when sensed, causes the DART to force the seat back to the upright position by changing the point of tension application. Meanwhile, the snubbing lines are also playing out. These are two high strength nylon cords whose function is to stop the seat's upward motion and positively separate the seat from the man. This will effectively eliminate the age-old problem of the seat catching up to and striking the pilot or becoming entangled with the chute.

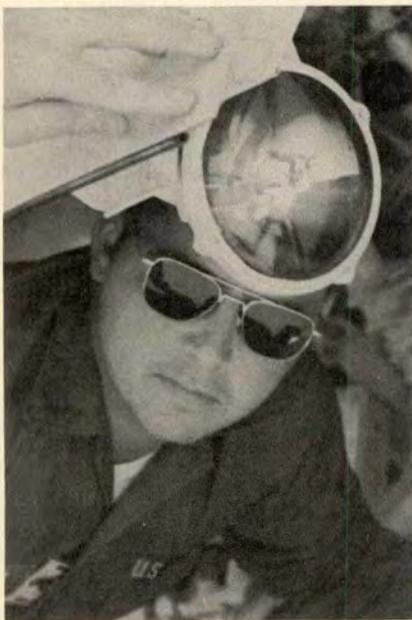
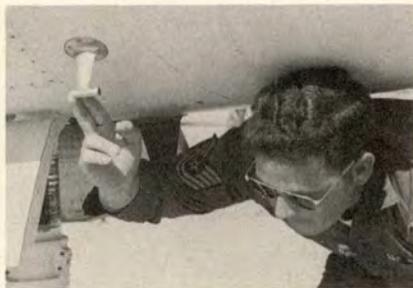
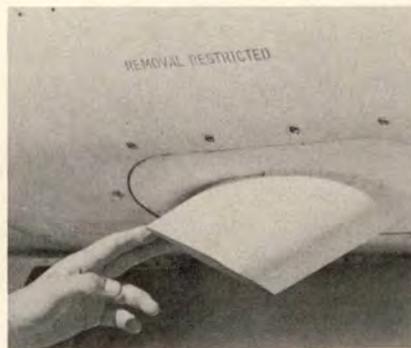
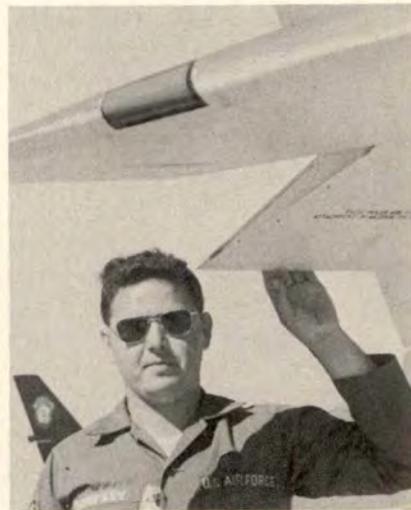
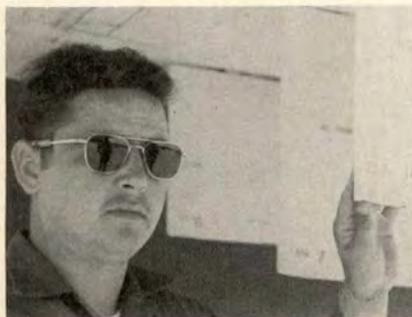
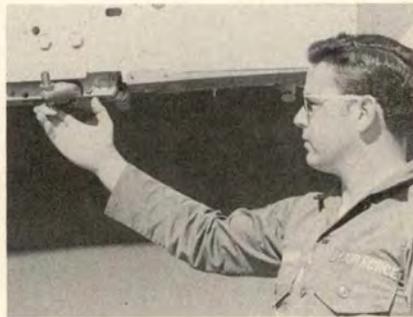
The A-7D has been in the Air Force inventory now for two years. It has reached operational status, and will be seen throughout the United States. As in any new aircraft, the A-7D design features pose certain safety hazards, especially for transient maintenance people who are not familiar with the aircraft. Some of these hazards are shown in the accompanying photographs.

The primary hazard areas during servicing or launching are in the wheel well areas. Due to their position, entry and exit to these areas

require "ducking" or stooping. The sharp corners of the upper main landing gear doors can cause lacerations while the landing/taxi light in the right well could cause painful bruises (photo #1).

With the engine running, it is important that launch personnel stay near the nose gear when crossing under the aircraft intake to avoid the intake suction. In doing so, one can strike the aircraft's total temperature probe (photo #2) causing injury to the person and damage to the aircraft.

On the right side of the nose gear well, another danger exists. The ram air cooling duct (photo #3) exhausts hot bleed air during ground operation. This air heats the duct surface to 240+°F.

The aircraft's pylons and wing tips can also cause injuries. The pylons have two danger areas; the sharp trailing edge and the sway braces (photos #4 and #5). A drooping wing tip or aileron (photo #6) is low enough to cause head injuries. (Photo subjects are 5'8" and 6'0" tall respectively.) ★

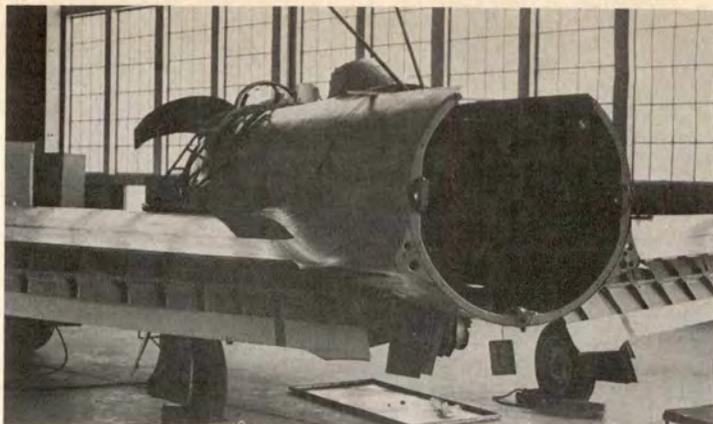
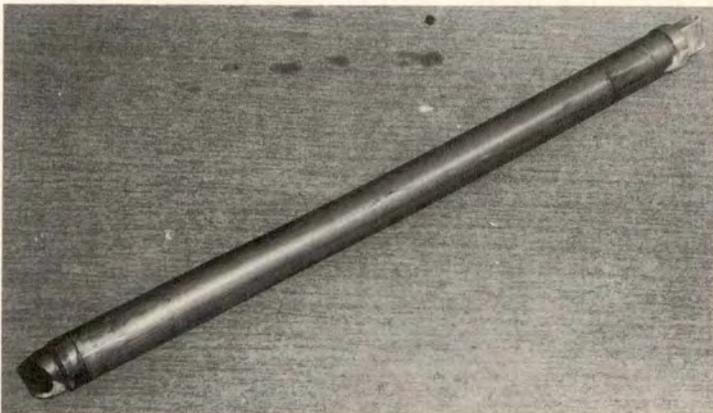
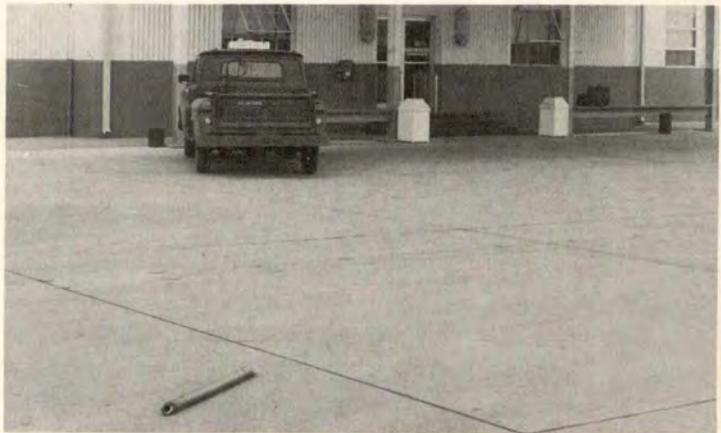
This is the bird

that fired the rocket catapult

that went through the roof

and landed on the ramp in front of the house that Jack built.

With a man as experienced as this, and the TO on hand, how could such a thing happen? The answer is simple and all too familiar: **failure to adhere to the tech data**. The technician did not disconnect the seat catapult hose as called for by item 6, Figure 4-20M, page 456W of the TO.

Photos at right show the sequence of events and illustrate the potential hazard of such flying projectiles.
