UNITED STATES AIR FORCE • MAY 1972

# AEROSPACE

SAFETY

**FOR AIRCREWS, MAINTENANCE & SUPPORT TECHNICIANS**

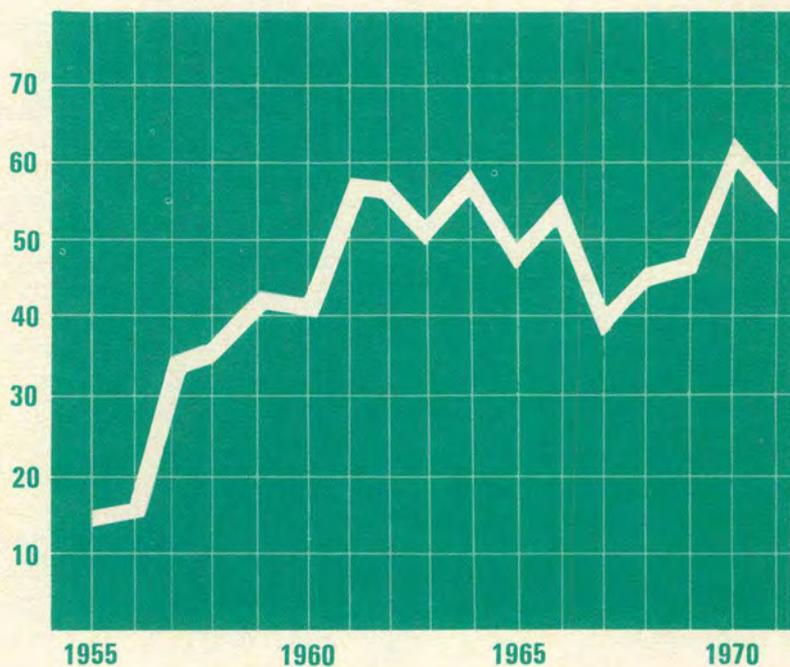
Figure 1. The percentage of patients successfully returned to flying status, following evaluation by the Aeromedical Consultation Service, is presented for fiscal years, 1955-1971.

Figure 1 depicts the return-to-

flying rate for patients evaluated by the Consultation Service during the past 17 years. During the early years of the service, one-third or fewer of the patients were returned to flying duties. During recent years, a return rate of almost two-thirds has been achieved. Efforts are continuing to study borderline medical conditions to determine criteria by

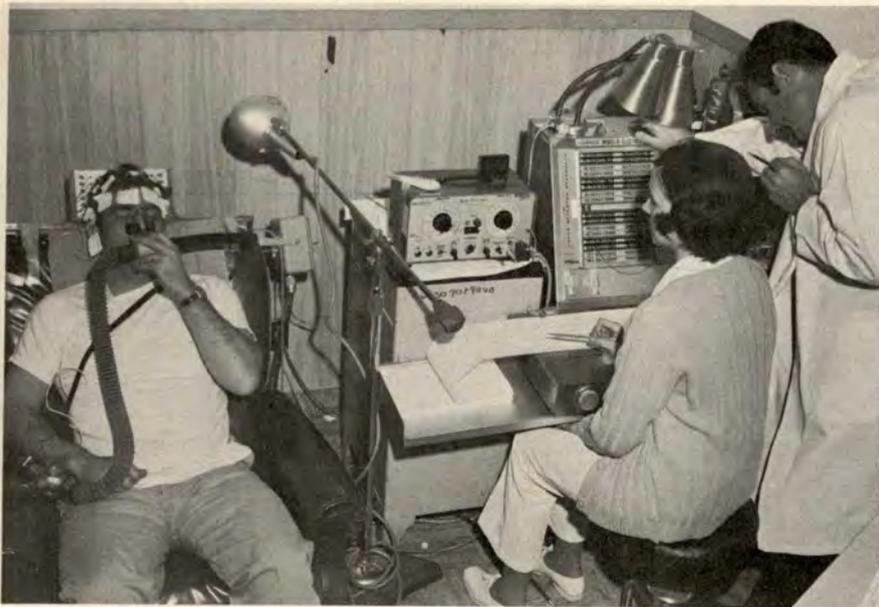
A baseline EEG is routine for all pilots and navigators evaluated at SAM. Here technician Sue Matthews and Dr Ed Liske, Chief of the Neurology Function, monitor the patient's response to mild hypoxia.

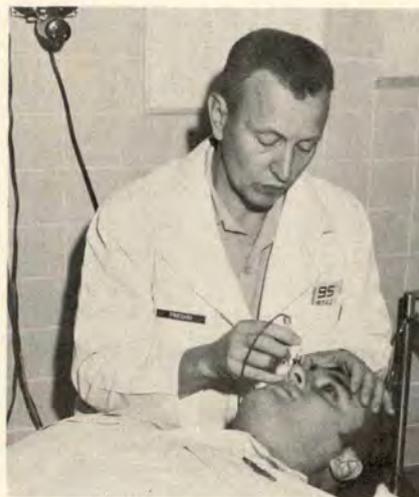
A complete evaluation of the patient's visual and ocular stratus includes a check of intraocular pressures, here demonstrated by Col (Dr) Thomas Tredici, Chief of the Ophthalmology Branch.

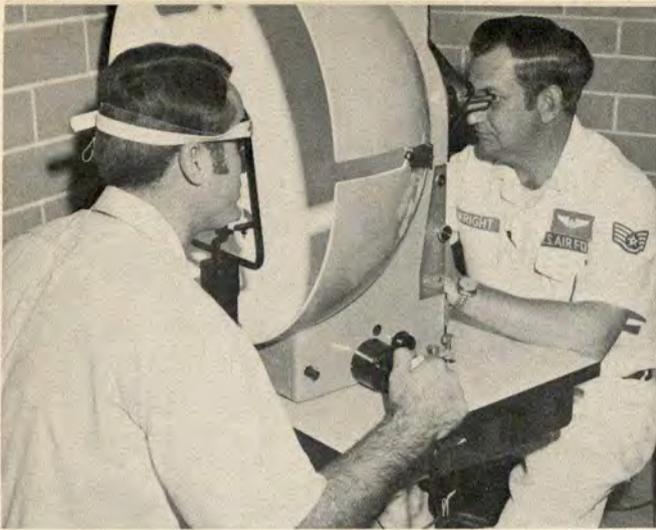
A special piece of equipment at USAFSAM is the Goldmann perimeter for the detection of any impairment in a pilot's field of vision. This study is being conducted by SSgt Dean Wright of the Ophthalmology Branch.
