UNITED STATES AIR FORCE • JULY 1972

# AEROSPACE

## SAFETY

# AEROSPACE SAFETY

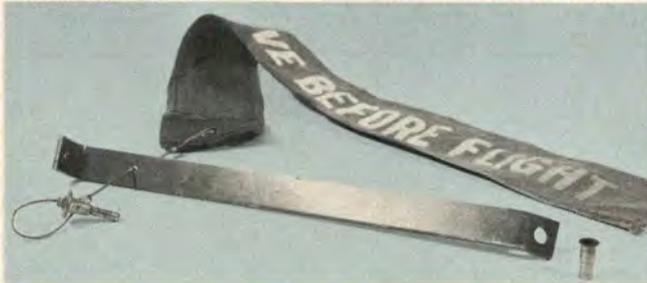
TSgt Snuffer has devised a door support bracket which will support these doors in the intermediate position, clear of the stabilizer travel and allow access to the engine area. Sergeant Snuffer's suggestion has been approved by TAC and SMAMA and will eventually be picked up in the Air Force Technical Order System.

Width	1"
Length overall	12"
Hole in 90° end	1/4"
Hole in 45° end	3/8"
Hole for cable	5/64"

Quick release pin P/N C1398C2C06D or any suitable substitute with a 1/4" shank no longer than 1".
