UNITED STATES AIR FORCE • AUGUST 1972

AEROSPACE

SAFETY

FOR AIRCREWS, MAINTENANCE & SUPPORT TECHNICIANS

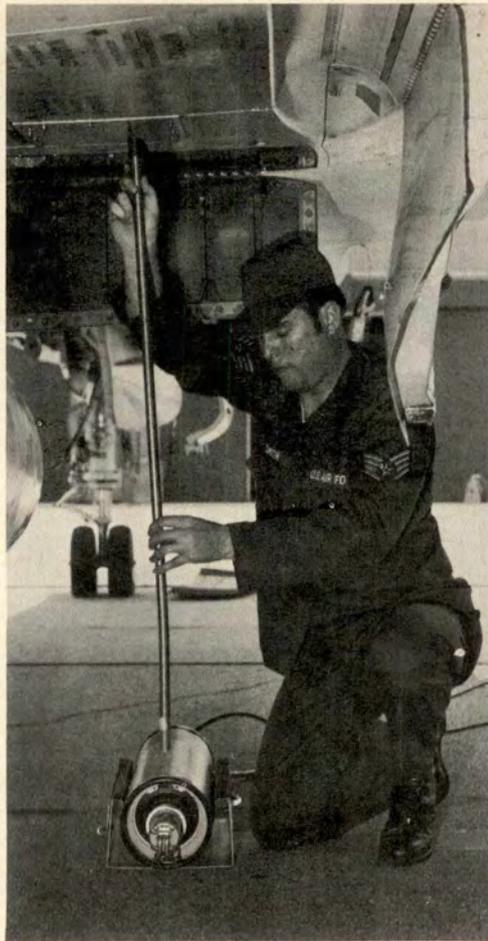
1

bay. Photo #1 shows SSgt Richard Smith aligning X-ray tube head for shooting bottom of engine bay. X-rays from different aircraft revealed a washer, nut and heavy safety wire under hydraulic lines (Photo 1a) and a hidden brake pin and heavy safety wire (Photo 1b). Photo #2 shows SSgt Ernest R. Brothers placing the X-ray film and TSgt James K. McDonald aligning the tube head prior to exposure. The exposure, Photo 2a, revealed a loose Jo bolt.
