SEPTEMBER-OCTOBER 1972

UNITED STATES AIR FORCE

AEROSPACE SAFETY

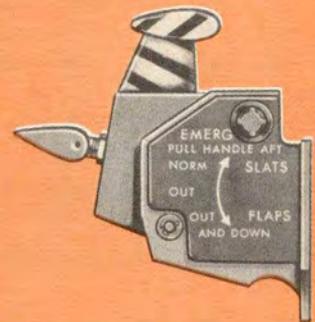
SWITCHOLOGY

A few items have been changed in the cockpit to accommodate this new "toy." The heart of the slats control is the old FLAPS switch which still has three positions but is relabeled from top to bottom as NORM, OUT, and OUT AND DOWN. NORM applies to almost all flying between the takeoff and landing phases. In this position, you have a slat system which is auto-

atically positioned as a function of angle of attack. No thinking is required—when alpha exceeds 10 units, the slats move out; when it decreases below eight units, they come back in. Two units hysteresis is built in, of course, to keep them from chattering in and out around cruise. Okay? Auto slats in NORM.

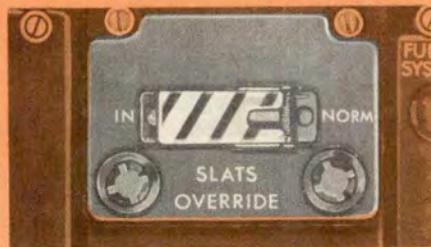
Earlier I mentioned the SLATS OVERRIDE switch. This is a new addition to the cockpit: a two-position switch guarded to the NORM position with the other selection being IN. If it, in fact, is positioned to NORM,

the functions I've ascribed to the FLAP/SLAT switch will prevail. However, if you move it to IN, all other slat selections are overridden, and the slats should come in. The logic here was to provide a capability to retract everything rather than have an asymmetric slat extension due to battle damage or malfunction.

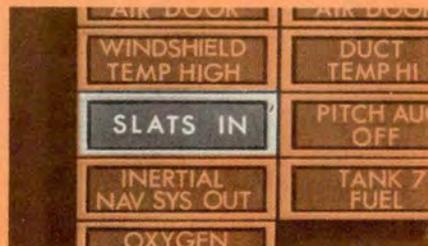
NEW INDICATORS

In our slats-equipped F-4Es some new and different indications are presented. The old leading-edge flap

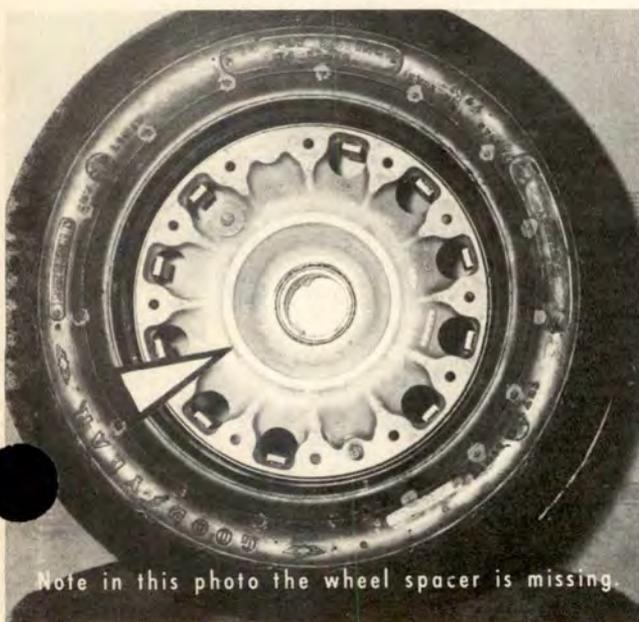
Note in this photo the wheel spacer is missing.

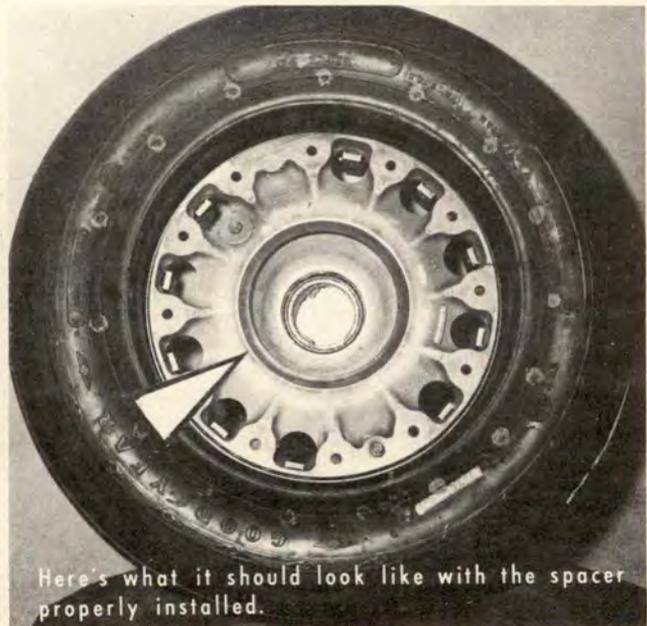
Here's what it should look like with the spacer properly installed.
