UNITED STATES AIR FORCE • DECEMBER 1972

Aerospace

SAFETY

AEROSPACE SAFETY

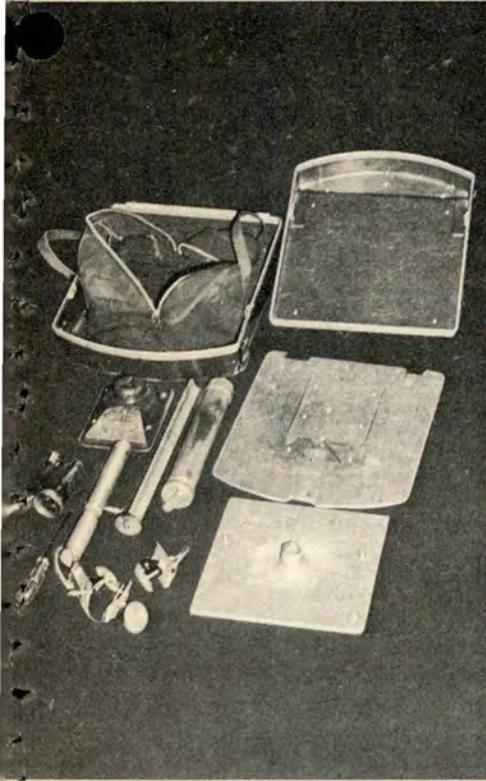
Pieces Unstowed.

About two or three weeks later, the same mechanic walks into the office of the Chief of Maintenance carrying a survival kit container. He opens the lid and says, "Sir, I'd like you to consider a safer way to change a gearbox when we don't have the authorized AGE gear and sometimes not any help." The mechanic picks up the canvas bag from the container, zips it open, and proceeds to build up a flyaway gearbox adapter—jack, plate, base on rollers—the whole works! He says, "Sir, we can stow this as you saw and fly it anywhere. We can remove and replace the gearbox with one man and

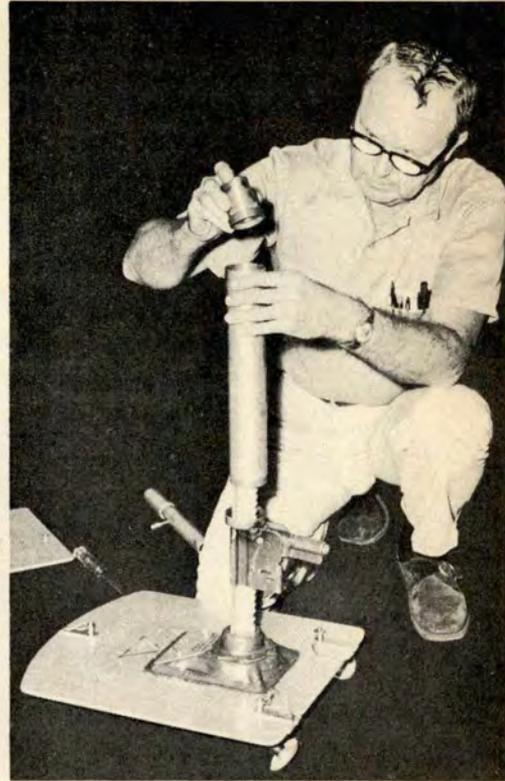
Jack Shaft Tube and Adapter.

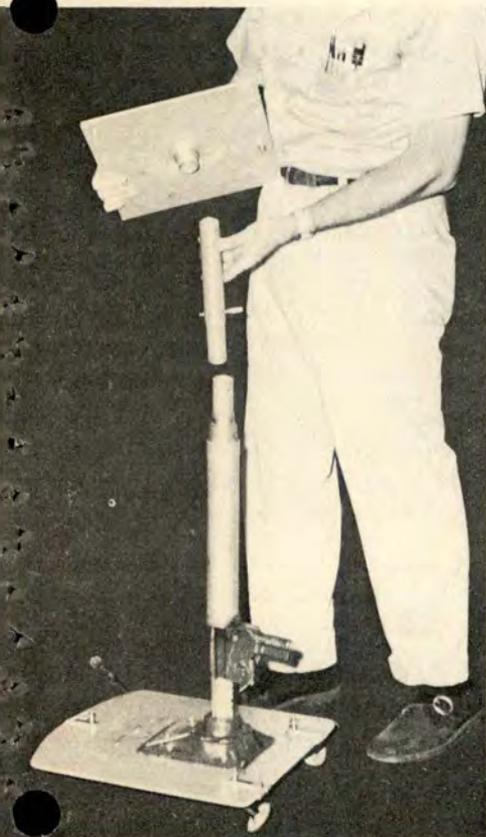
Extension and Upper Plate Assembly.

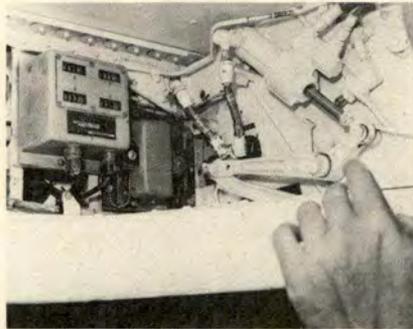
Photo Three

Photo Nr 3 shows the end result of bending the line. It will eventually come in contact with the inner door linkage, as was the case in this incident. Photo Nr 4 shows the normal undisturbed position of the line as the door closes.

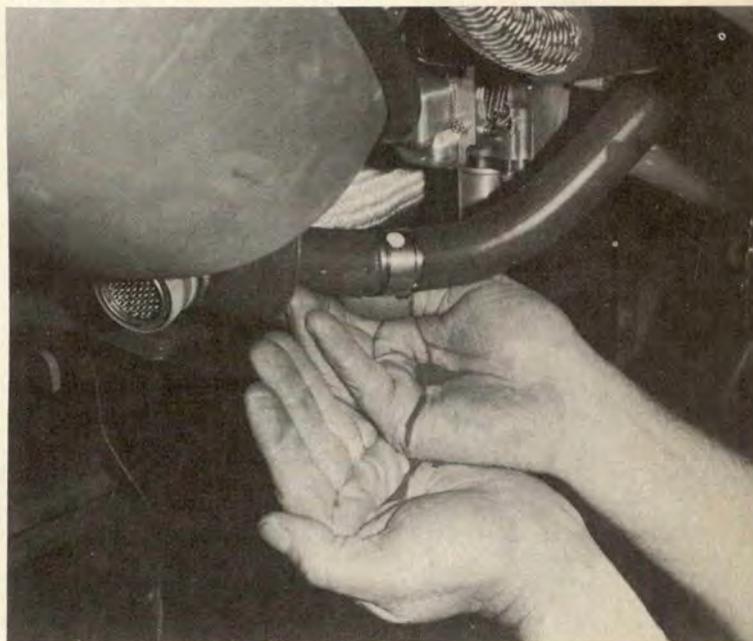
During initial inspection of a missile exposed to a leaking G&C cooling system, chromate is discovered at the base of the third stage. The coolant has seeped into the missile raceway and the cabling. Continuity checks will be performed on the cabling. Failure of the continuity check requires replacement of the entire cable.
