# *aerospace*

SAFETY JANUARY 1976

# aerospace SAFETY

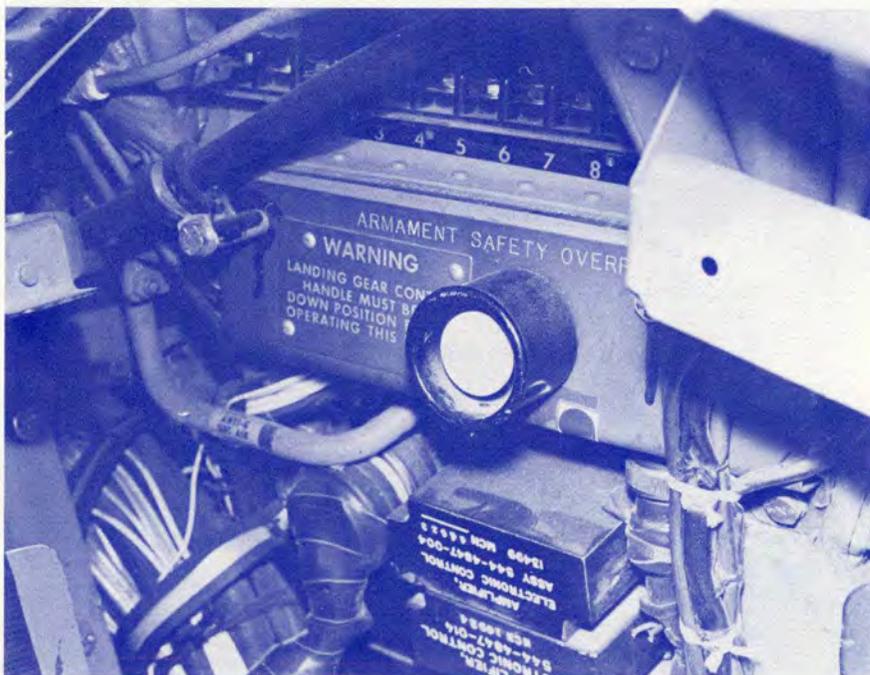
The armament safety override button has been the cause of at least one FOD incident.

“. . . The foreign object was the Armament Safety Override Button. It is probable that the button came loose in flight since the AC stated that he had engaged it during his before take-off checks. Investigation also revealed that the set screw on the button was loose. The linkage on the top of the FCP seat mounted canopy initiator probably extended as the seat was raised following the AC's engine shutdown check.

"The involved TFW performed a one time inspection of its F-4 aircraft. Seventeen Phantoms had loose Armament Safety Override Buttons, due to either missing or loose set screws. Recommend other F-4 units conduct similar inspections.

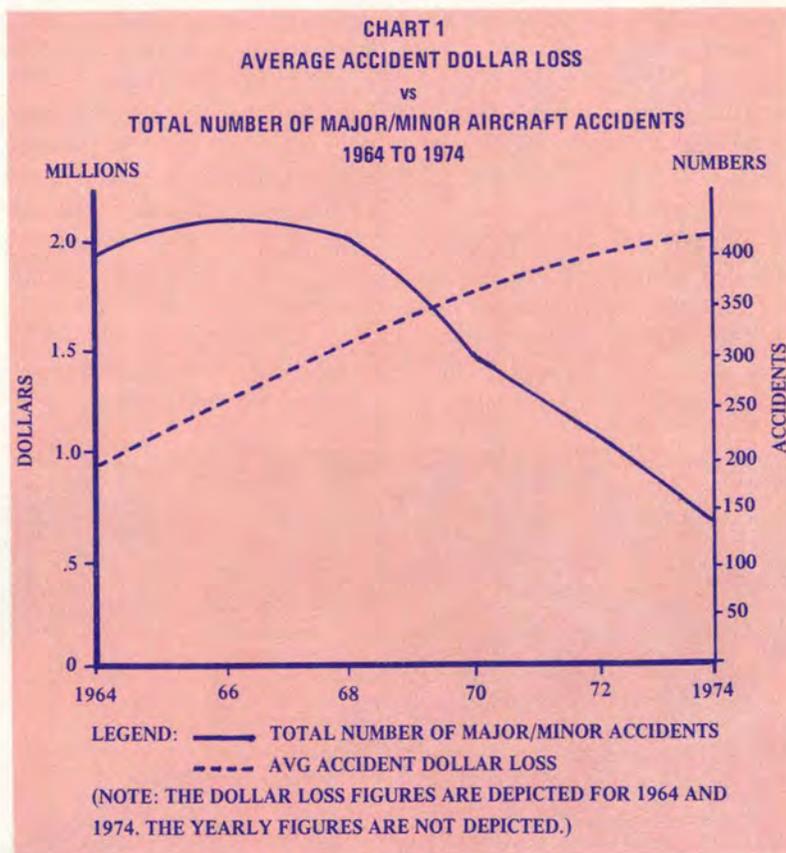
In 1974, 141 major and minor accidents occurred, resulting in a loss in excess of 312 million dollars—an average of \$2,200,000 per

accident. So while Air Force decreased the total number of accidents by 64 percent, the average dollar loss per accident increased by 144 percent.

A similar review of aircraft destroyed data reveals trends approximating those in Chart 1. In 1964, a total of 262 aircraft were destroyed, resulting in a dollar loss of 363 million dollars. In 1974,

The aircraft losses and mishaps which serve as the "data base" for the figures presented in Charts 1 and 2 do not, in large measure, include systems such as the C-5 and F-15. Rather these accident statistics include many aircraft now retired or "soon to be retired" from the active fleet. Many of these systems, such as the B-47, C-119, and F-84, were built at a fraction of the costs of their successors. It is, therefore, reasonable to assume that the "cost" trends indicated in Charts 1 and 2 will continue to be inversely related to USAF's safety statistics. The only acceptable answer to offsetting the effects of these trends is to continue to decrease our accident rates; but the slope of the "accident-rate" line must be steeper than that of "accident-cost" line.

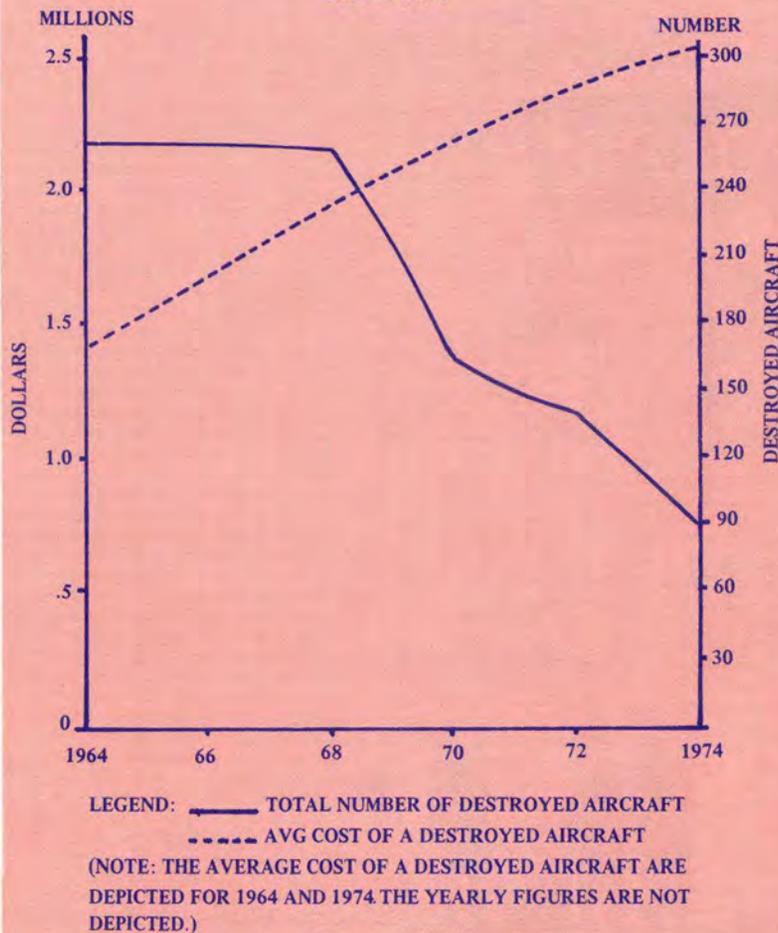
**CHART 2**  
**AVERAGE COST OF A DESTROYED AIRCRAFT**  
 vs  
**TOTAL NUMBER OF DESTROYED AIRCRAFT**  
**1964 TO 1974**

Chart 2 presents the contrast suggested by these statistics:

Once again a decrease of 66 percent in the number of aircraft destroyed was accompanied by a 107 percent increase in the average cost of a destroyed aircraft.

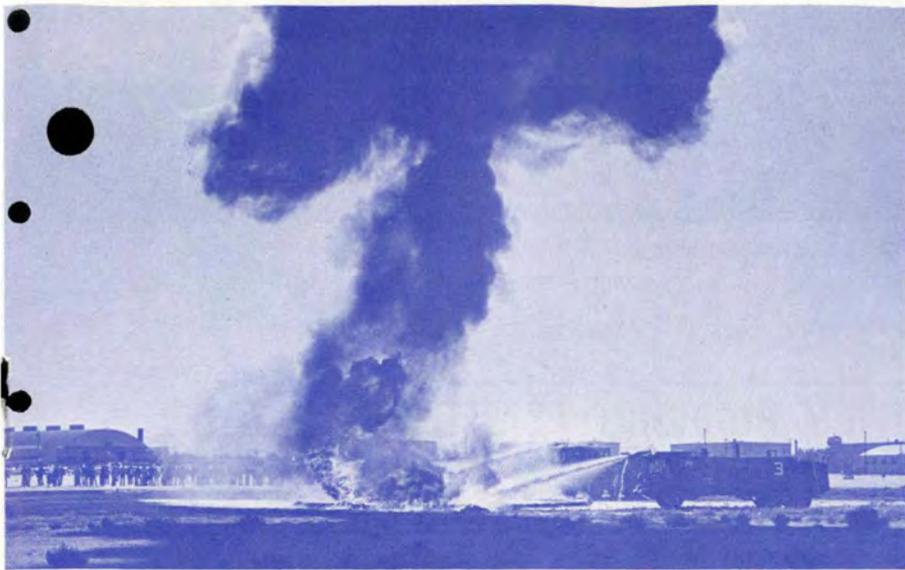
One of the most dramatic events was a demonstration of crash/rescue techniques by the George AFB Fire Department. The picture above shows the trucks moving in to fight a simulated aircraft fire.

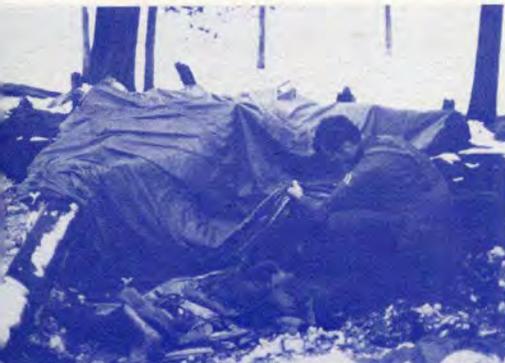
The "survivor" puts the finishing touches on his shelter, built between two fallen trees. The observers termed it "excellent."

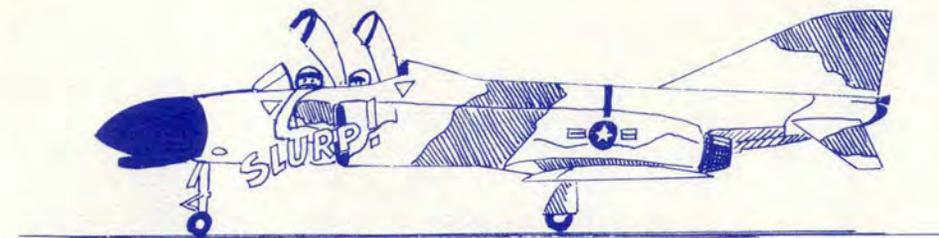
## who goofed

While the F-4 was parked in the de-arm area, the pilot pulled the face curtain safety pin out of the pin stowage bag and installed the pin in the ejection seat. The pin bag with the remainder of the pins was then put on top of the seat for taxiing to the parking area. As the aircraft was turned to the right

leaving the de-arming area, the pin bag fell off the seat. The pilot was able to catch the bag before all the pins had dropped out of the bag. He then briefed the ground crew at the parking area about a pin falling out. The ground crew installed the safety pins, and all the pins were accounted for but

one. The crew chief immediately checked the intake area and there it was—pieces of the red streamer in the left intake area. The engine was removed and inspection found minor FOD throughout the compressor and on the first and third stages of the turbine wheels.

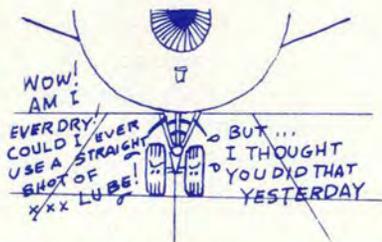
## no lube no gear

The KC-135 pilot was performing his descent checklist. When he tried to put the gear down the nose gear would only show an intermediate position. The crew had to lower the nose gear manually. During post flight inspection, the nose gear was found dry from improper lubrication. After 10 man-hours and proper lubrication, the nose gear retraction tests were completed without malfunction. By the way, the servicing records showed that the nose gear had been lubricated the day before the incident (?).

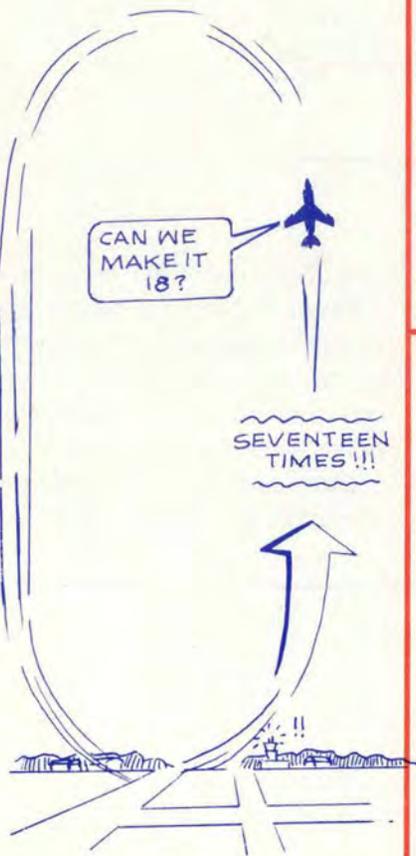
### dragging

The F-4 was on landing roll when the aircraft started veering to the right; however, the pilot was able to keep it centered on the runway with nose wheel steering. Troubleshooting revealed the lock plate for the adjusting ring had been left off when the right wheel was rebuilt. During the previous 17 takeoffs and landings, the bearing adjusting ring backed off allowing the right wheel and tire to come free from the bearing cone sleeve. This also allowed the wheel to move inboard and rotate on the disc drive keys causing severe gouging.

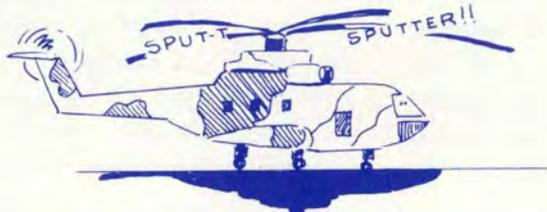
### no fuel

A CH-3 pilot was preparing for a training mission. The pre-flight was normal through engine start. When the rotors were engaged and fuel boost pumps were turned off, fuel flow for nr 1 engine dropped to zero and the engine flamed out.

Inspection found the drain cock in the fuel filter was cocked partially open by a small piece of O-ring in the drain cock. With the drain cock partially open, the engine driven fuel pump was able to draw air into the fuel system.

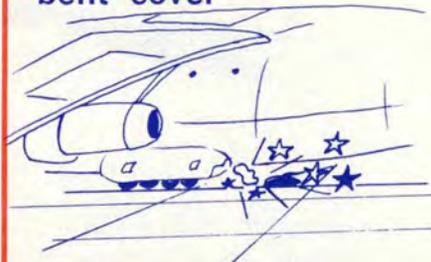
### bent cover

The C-5 was being marshalled into the parking spot. During taxi, the left main landing gear traveled over a fuel pit cover. A deficiency in the pit cover allowed it to raise causing damage to the aircraft brake hydraulic lines and the pit cover.

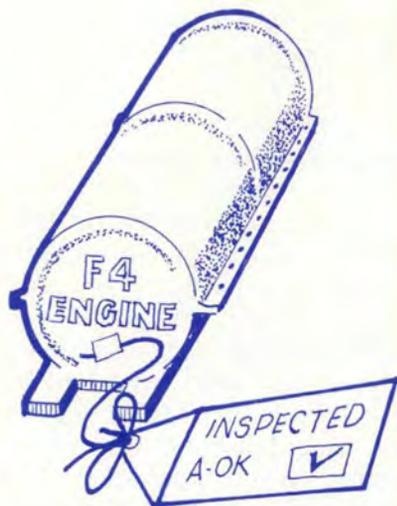
## loose pin

While on a single ship training sortie, the F-4 pilot encountered a fire warning light on the left engine. The engine had to be shut down to extinguish the light. There were no discrepancies in the fire warning loops or connectors. However, the engine technician found a hot air leak and removed the engine for detailed inspection. During the inspection, the technician found that the alignment pin for nr 9 combustion can was not properly installed. The threads on the pins were stripped; however, the boss wasn't damaged. There had been no work done on the engine in this area since the engine arrived from overhaul. Wonder where the inspectors were when it came time to check the can?
