aerospace

SAFETY APRIL 1976

RIDE THE FOAM	2
USAF SAFETY TROPHIES	5
THE RISE OF THE EJECTION SURVIVAL RATE	6
ATTITUDE	8
WHEN IT RAINS	12
B-25s OVER TOKYO	14
NIGHT FLIGHT	18
F-111 NACELLE FIRE ANALYSIS	20
UNWANTED LIFT	23
FIGHTER PILOTS EVEN "SIMULATE" IT	24
LASER TARGET SCORING SYSTEM	28

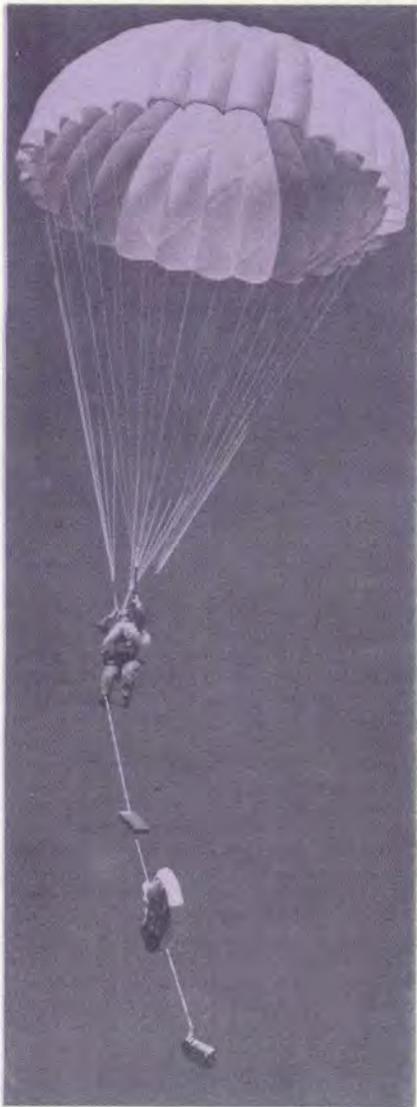
Ejection systems such as the Martin Baker H7 in the F-4, shown on page 6 and during inspection, below, are reliable and will save lives when used within their operational envelope. Initiation outside the envelope accounts for most ejection fatalities.

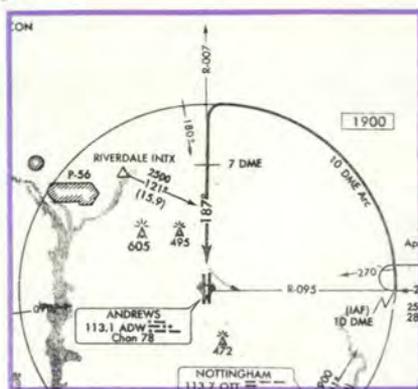
FIG. 1

Figure 1 is an example of an arc to radial approach. Pilots are expected to lead the turns, both onto the arc and onto the final approach course.

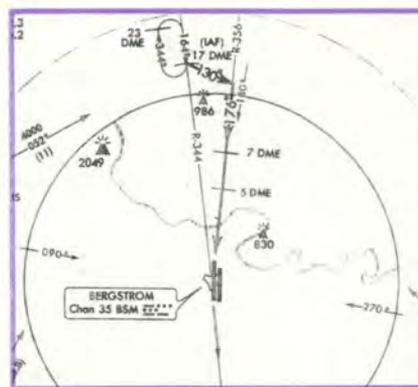
FIG. 2

Figure 2 depicts a DR leg that intercepts the final approach course. As you can see, the 130 degree leg has no course guidance. Apply any known wind to the DR leg heading so as to make good the ground track of 130 degrees.

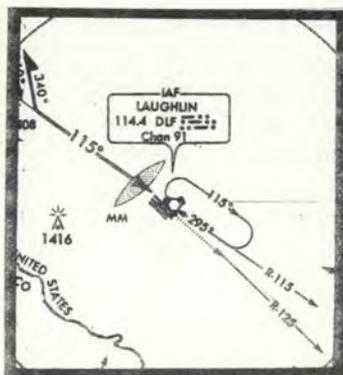
FIG. 5

In the low altitude structure, these procedures normally incorporate a procedure turn. Figure 5 is an example. The final, in this case, begins at the point where you intersect the final approach course inbound. When you are on course inbound, you are on final approach. A point to think about on approaches like this, is that you can reach the missed approach point more quickly than you think. Prior planning is necessary to ensure that you reach MDA and configure to land as soon as

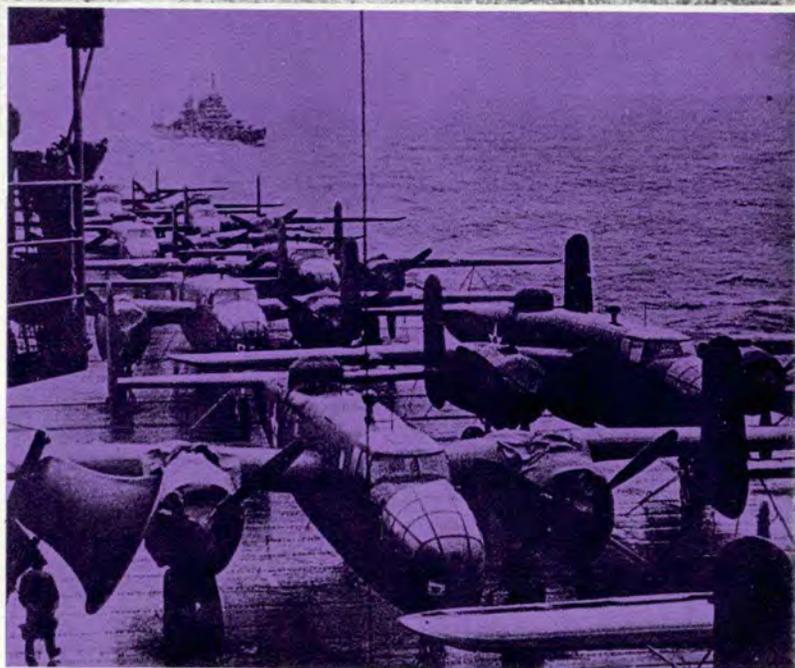
B-25 bombers on deck of the Hornet enroute to launch area. They had flown from Eglin Field, FL, where crews practiced very short takeoffs, to McClellan Field near Sacramento, CA, and loaded aboard at Alameda NAS on San Francisco Bay.

From McClelland, the planes flew to Alameda NAS where 16 of them were hoisted aboard the *USS Hornet*. The larger planes took every inch of available deck space. The crews were mixed in with the Navy people wherever berths were to be found.

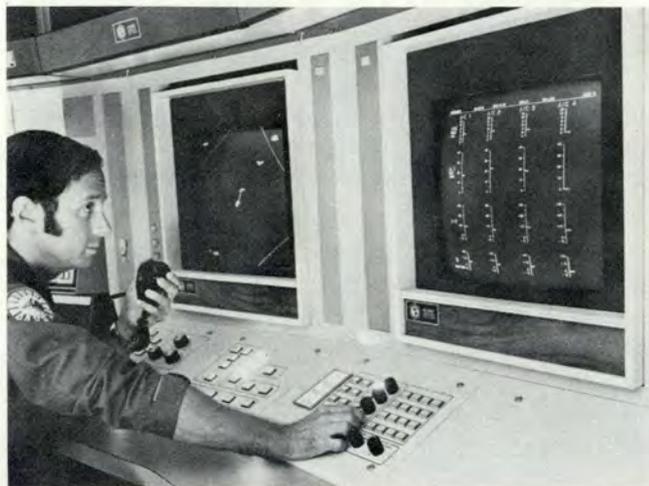
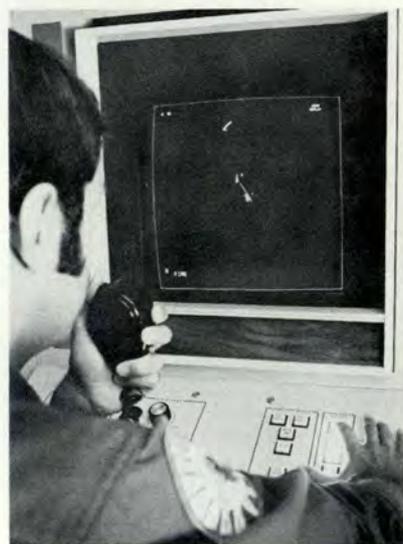
Lt Commander Kent Stauss, VF-1 Sqdn at Miramar NAS, CA, monitors a live dog-fight training exercise (top photo). Line between aircraft 1 and 3, lower photo, is trajectory of the fired missile weapon system.

debriefing. This is the second great advantage to this system. One of the most difficult things an ACM instructor must do is teach a student how to perform the basic air-to-air maneuvers, when the only tools are his hands or model airplanes on sticks. Now the ACMR display can show what successful and unsuccessful maneuvers look like not only in plain view, but actual cockpit view as well. The display gives the student total recall of the mission. Each maneuver can be reviewed and analyzed, greatly increasing the value of each training sortie. Finally, this training has the advantage of avoiding the use of costly live missiles and targets while actually providing a more realistic combat environment.
