# AEROSPACE

SAFETY • MAGAZINE FOR AIRCREWS

APRIL 1980

# Inflight Weather Avoidance Service

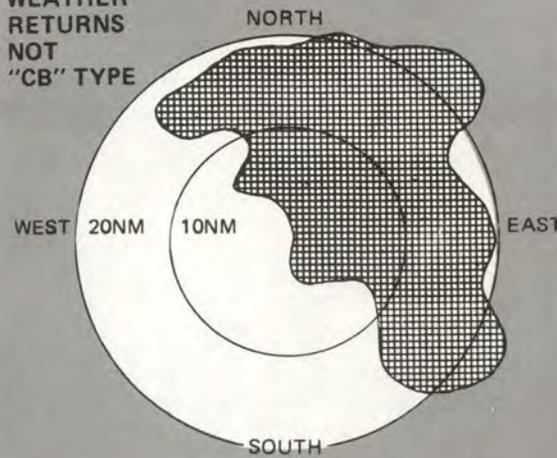
**FIGURE 1**  
RAW RADAR  
WEATHER  
RETURNS  
NOT  
"CB" TYPE

Figure 1 illustrates a radar scope that displays a large dark area of weather returns. The radar return probably not a thunderstorm but heavy stratus clouds containing precipitation. Obviously, this presentation is unacceptable since aircraft operating on the easterly quadrant of the radar scope could not be seen and are blocked.

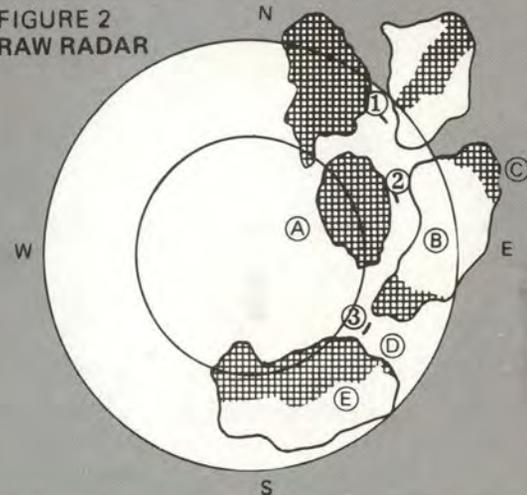
**FIGURE 2**  
RAW RADAR

Figure 2 illustrates a typical radar scope when thunderstorms are present. The figure has five weather cells that are probably "CB" type. The outline of each cell is the actual dimension of the build-up area. However, only the black areas are displayed on the scope. Aircraft targets that can be seen by the controller are indicated by the numbers 1, 2, and 3. There may be others within 20NM that the controller cannot see which are being blocked by the weather returns. This radar presentation is a raw display—no special features are used to reduce the effects of weather on radar.

There are some important limitations displayed on Figure 2 that should be noted. Weather cell "A"

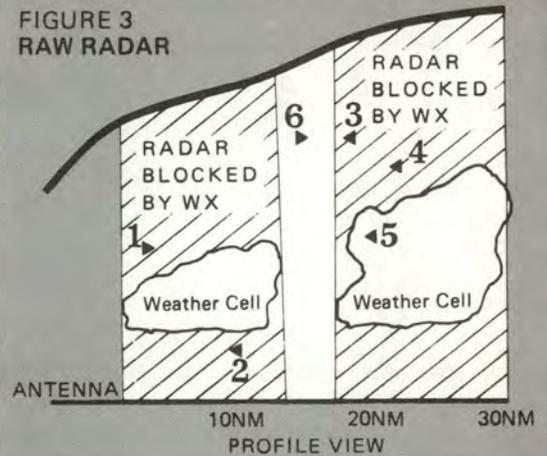
**FIGURE 3**  
RAW RADAR

Figure 3 is a side or profile view of the area within 30NM of the radar antenna. Only aircraft nr 6 would be displayed on an ATC radar scope. The other aircraft (one through five) would be blocked by weather cells even though some aircraft may be above or below the weather. In this instance a dangerous conflict exists between aircraft nr 6 and nr 3 which are flying directly at each other at the same altitude. Unfortunately, the controller would be unable to separate the two aircraft since nr 3 is not displayed on this scope.

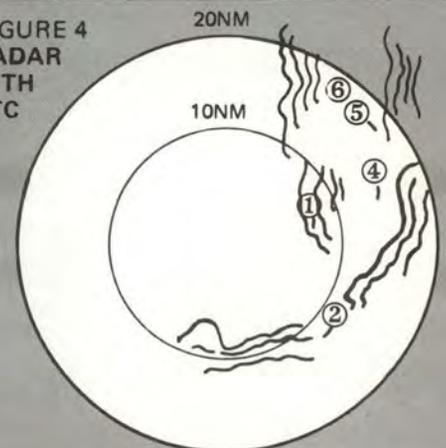
**FIGURE 4**  
RADAR  
WITH  
FTC

Figure 4 indicates the display seen when FTC is selected. As you can see, the "CB" return area has been reduced and only the edges closest to the antenna are now portrayed. Number 4 aircraft can now be seen by the controller since the blocked out area has been reduced. An inherent limitation of this feature is that the display of aircraft can easily "blend in" with the weather or ground returns. Tracking an aircraft can be difficult.

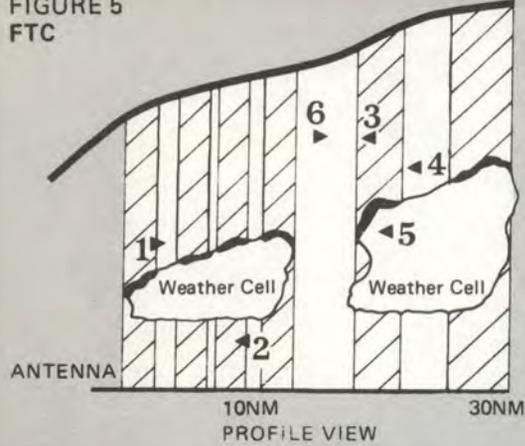
FIGURE 5  
FTC

Figure 5 is a profile or side view that shows how FTC can improve the scope presentation by reducing the area blocked by weather returns. Aircraft 6, 4, and 2 are now displayed and separation can be applied between those aircraft. Only the dark portion of the weather cell will be displayed on the scope.

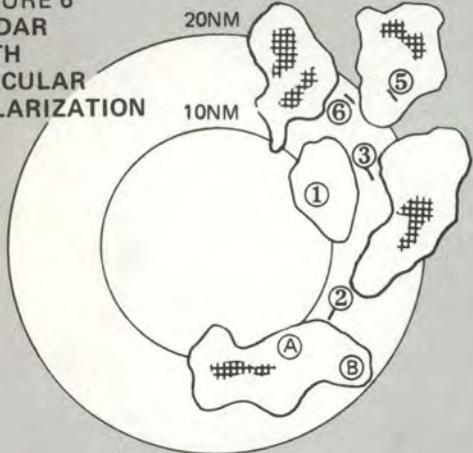
FIGURE 6  
RADAR WITH  
CIRCULAR  
POLARIZATION

later installed to offset and complement FTC (see Figure 6). CP is designed to reduce, as far as possible, precipitation clutter from the radar indicator. However, it does not completely remove intense clutter which is usually associated with thunderstorms. Only the heaviest portions of the weather cells appear on the scope. This is indicated by symbol A, Figure 6.

The outline surrounding the dark cell areas (symbol A) is the actual dimension (symbol B) of the thunderstorm, but is not seen by the controller when using CP. Therefore, an aircraft could be vectored through part of the thunderstorm (area B) unknowingly by the computer.

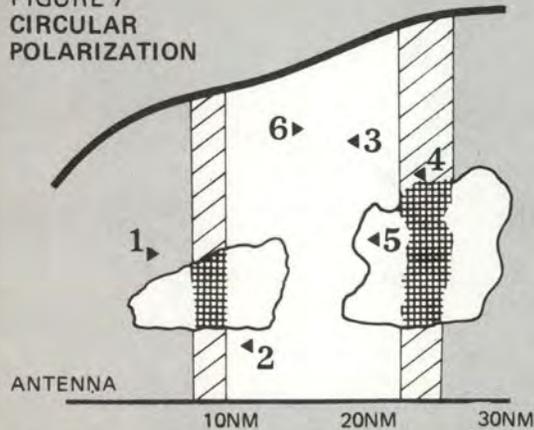
FIGURE 7  
CIRCULAR  
POLARIZATION

Figure 7 depicts the profile or side view of how CP works and enables the controller to eliminate weather returns which allows more aircraft to appear on the scope. By using CP, only aircraft nr 4 is blocked by the weather cell. Knowing that CP eliminates almost 70% of weather returns, controllers should use CP only if there is a possibility of losing an aircraft target in the precipitation clutter. CP can be cycled in approximately 7 seconds and supervisors can operate back and forth between raw (linear) and CP to track aircraft through thunderstorms.

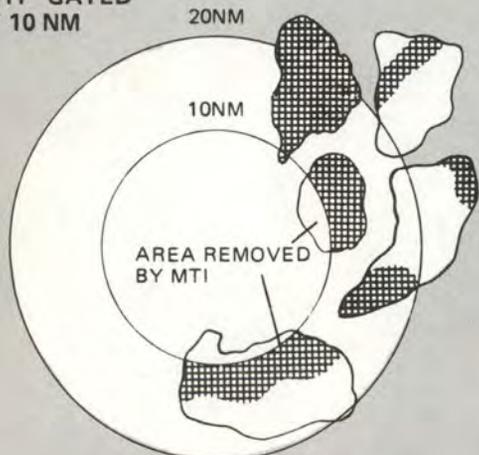
FIGURE 8  
"MTI" GATED  
AT 10 NM

*Moving Target Indicators (MTI)* is a special circuit that is able to distinguish between moving and stationary targets with limited efficiency (see Figure 8). If a target is moving at less than a specified speed, it will be eliminated from the scope. The main purpose of MTI is to eliminate ground returns such as buildings,

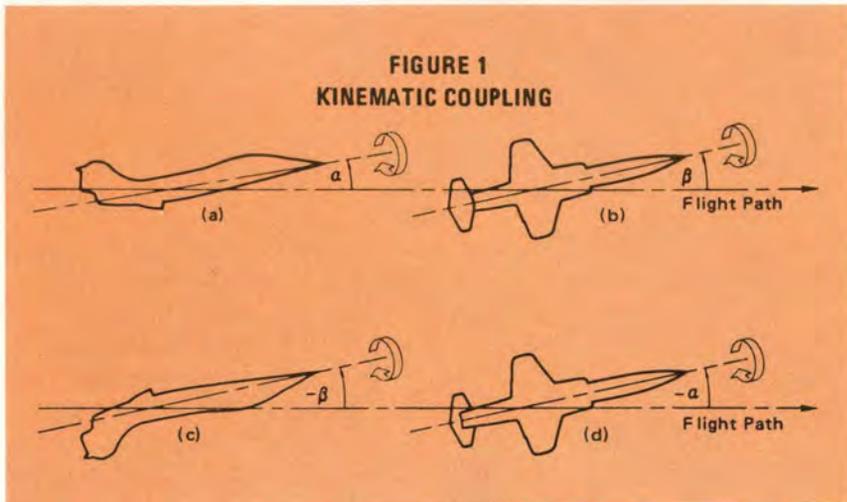
**FIGURE 1  
KINEMATIC COUPLING**

Kinematic coupling, as shown in Figure 1, is the simplest contributor to roll coupling.

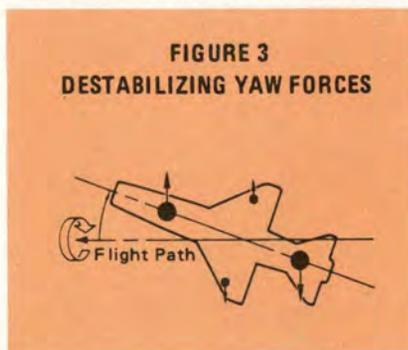
**FIGURE 3  
DESTABILIZING YAW FORCES**

For any given roll rate about the flight path, the fuselage masses are acted upon by centrifugal force and tend to pull away from the roll axis (flight path in this case). These forces are depicted in Figure 3.

The magnitude of this force couple increases with the square of the roll rate and is highly destabilizing.

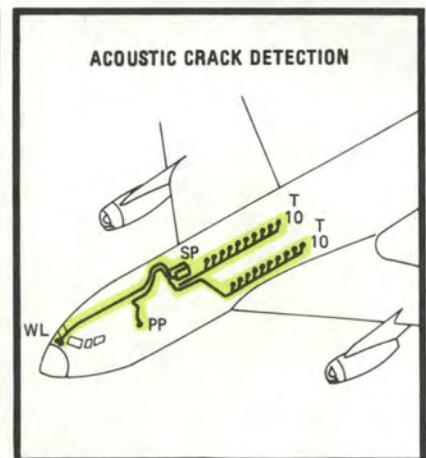
■ A unique nondestructive inspection system has been developed at Tinker AFB to detect unstable fracture of center wingskin panels in -135 series aircraft during flight. The system consists of twenty piezoelectric transducers bonded directly to the aircraft lower center wingskin and the Signal Processor module which monitors signals coming from the transducers. The Signal Processor module discriminates against non-crack signals and activates local and remote caution indicators when it detects the acoustic emission signature produced by unstable fracture in the wingskin.

WL - Warning Light      SP - Signal Processor  
PP - Power Panel      T - Transducers
