# fly<sup>ing</sup>

MAY 1983

PAPI, PLASI . . . A new generation of  
Aviation Lighting Systems

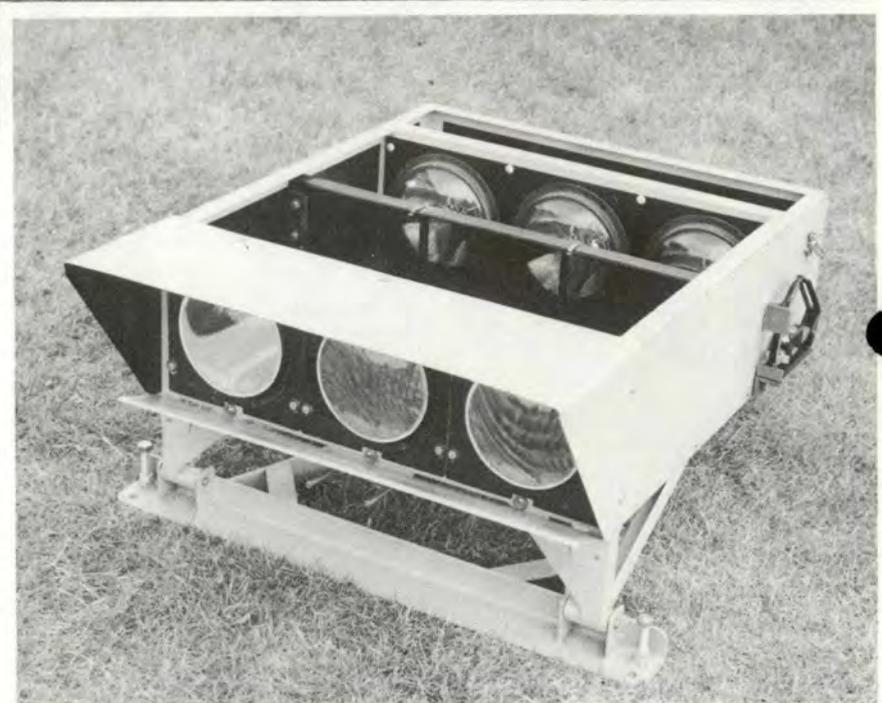
For the past 25 years the VASI has been the world's primary visual approach slope indicator. The VASI system has served well as an approach guidance aid for the pilot. Now, second-generation systems are being manufactured. Developed in England, the precision approach path indicator (PAPI) is designed to provide sharper and more specific indicators of glide slope position than VASI. It can be visualized as a

VASI with the near and far units arranged horizontally on each side of the runway. The PAPI display provides five different combinations of light to the pilot, each representing a specific indication of approach position. The accompanying pictorial depiction (Figure 1) relates the various combinations of light to position.

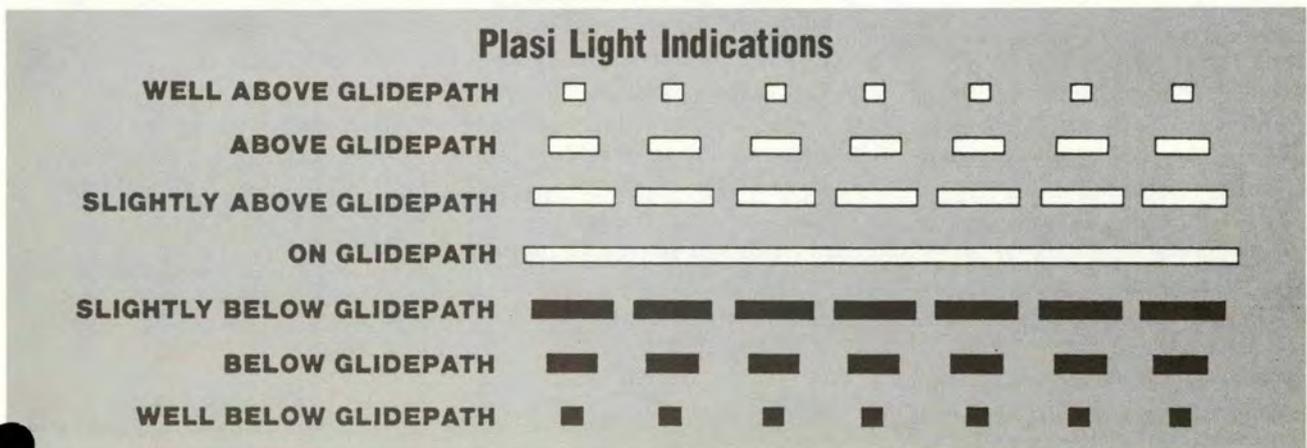
Another second generation approach aid is the pulse light approach slope indicator (PLASI). The PLASI is a single-source unit that uses a pulsing light to provide glide path information. Deviation below glide path results in the pilot seeing a pulsing red light — above glide path, a pulsing white light. When the correct approach path is flown, the pilot views a steady white light. PLASI is a relatively inexpensive system that has been certified by the FAA. Testing by the USAF will be accomplished in conjunction with testing of the PAPI system at Williams AFB. See Figure 2 for a depiction of the way PLASI works.

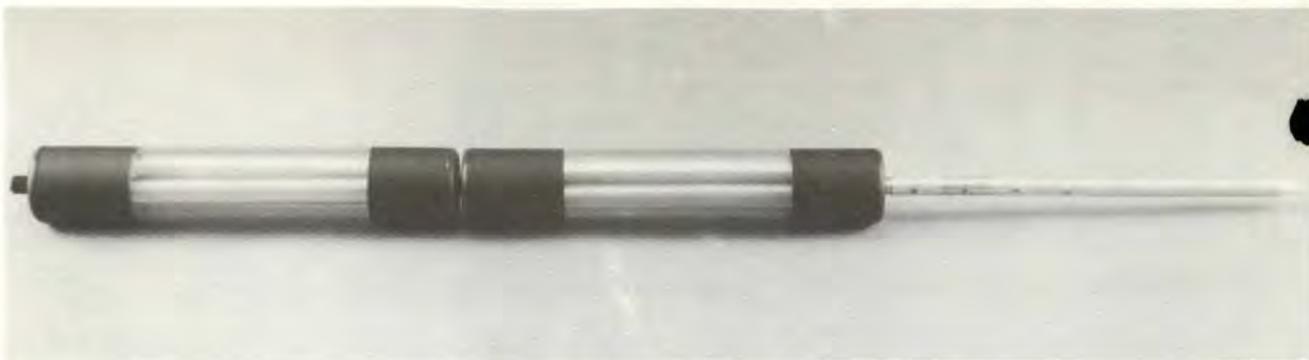
Radioluminescent Light Unit

The second of the new lighting technologies is radioluminescent lighting. Because existing airfield lighting systems are energy-intensive, it takes a great deal of energy to operate an airfield in addition to the expense of associated construction and maintenance costs. Radioluminescent lighting is totally self-sufficient, requiring no externally provided power source. Light is produced by phosphors

activated by radioisotopes. The Air Force Engineering and Services Center at Tyndall AFB, Florida, has been conducting tests in conjunction with the US Department of Energy for several years in order to refine this technology. Radioluminescent lights offer particular promise in portable lighting and cold weather applications where normal battery and generator electrical sources are unavailable or sensitive to extreme climate conditions. Prototype units have been manufactured and field tested, including recent cold weather testing in Alaska during Brim Frost. Equipment improvements are occurring steadily and technology development will continue in the future.

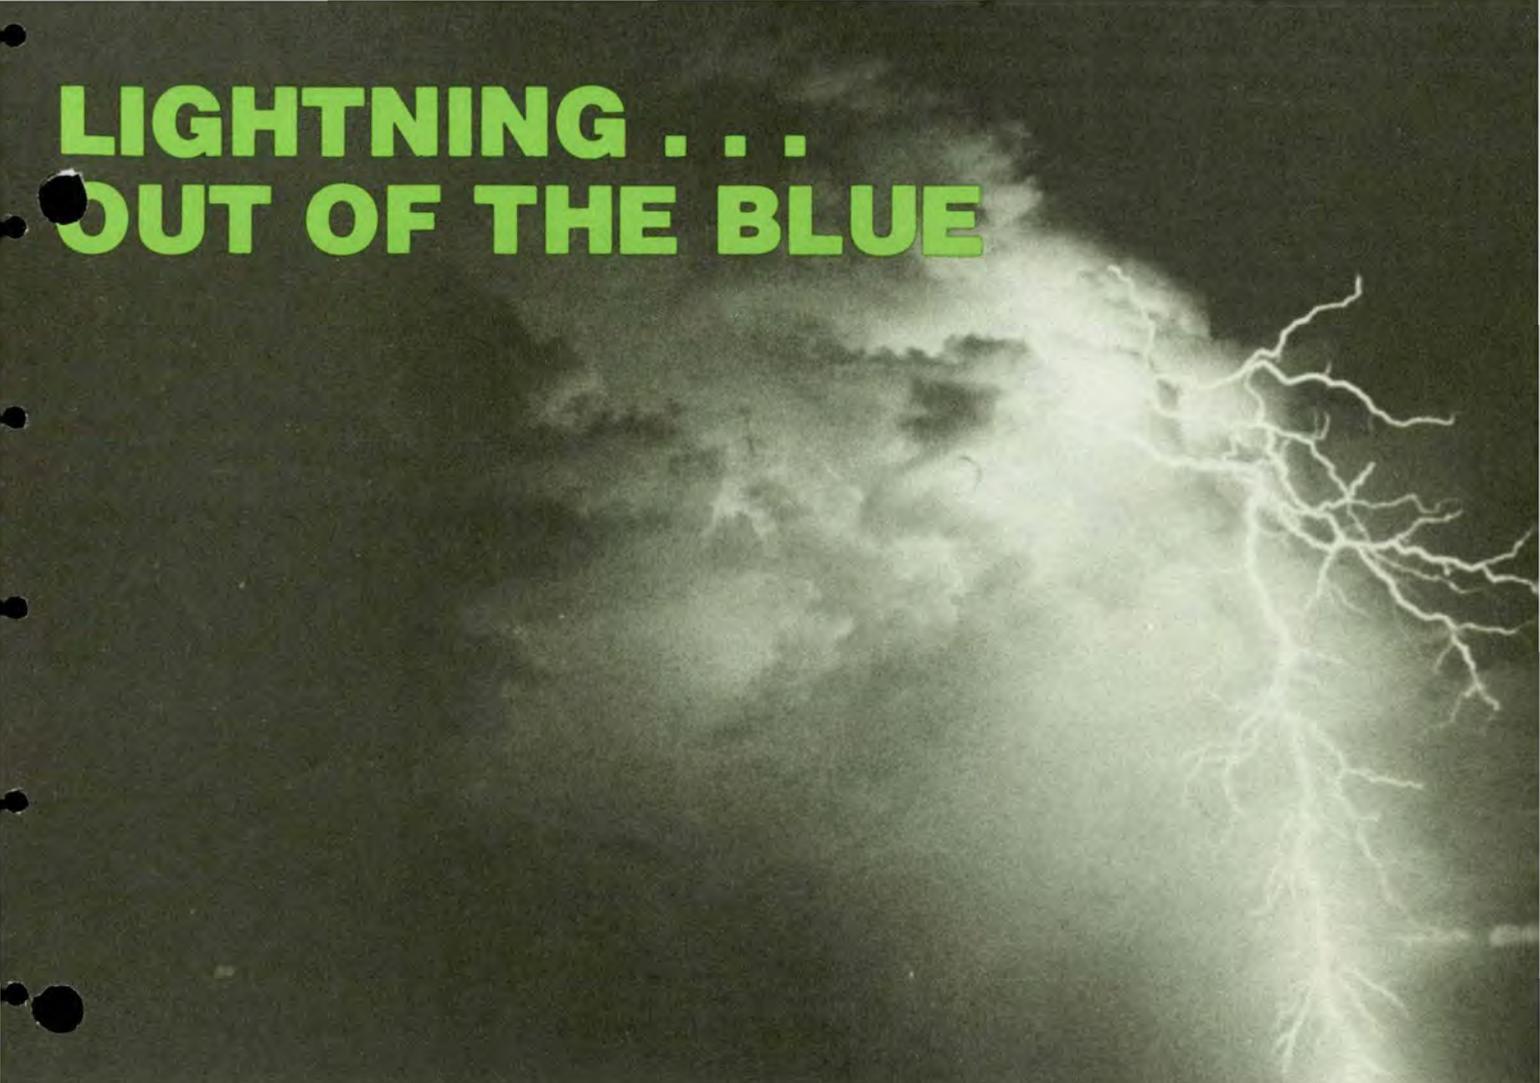
Photograph taken by Michael W. Maier, Lightning Location and Protection, Inc., Tucson, Arizona, demonstrating a lightning flash that angled outward from the leading edge of the thundercloud on an angle of approximately 125°, striking the earth some 5.6 miles from the vertical overhead origin of the flash.

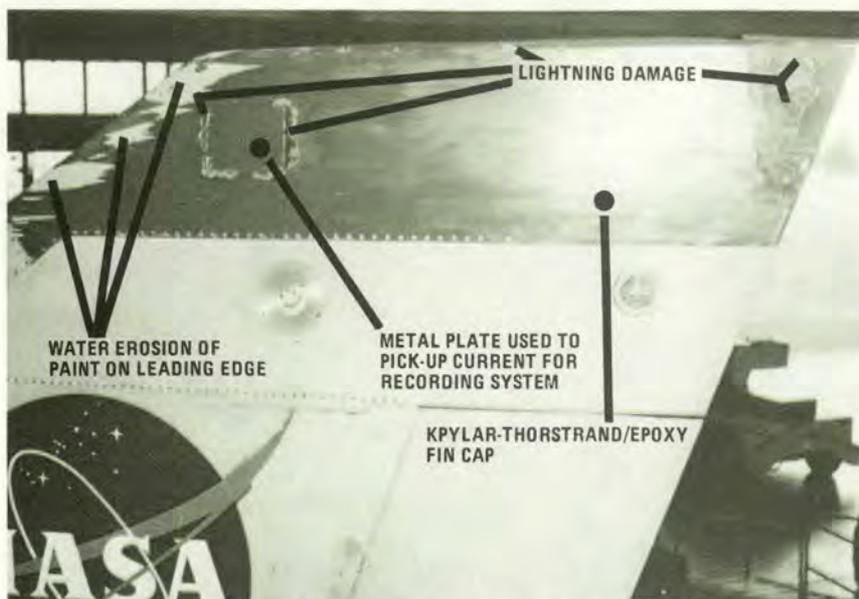
Lightning damage and water erosion damage to the Kevlar-Thorstrand/epoxy fin cap on the NASA F-106B storm hazards airplane following a flight in which nine direct lightning strikes were experienced at an altitude of 25,000 feet over Appomattox, VA (July 11, 1982).

measurement) F-106B was flown into some 150 thunderstorms in the past 3 years. This aircraft has been struck by lightning 176 times. In 1982 they increased their "success" (success means getting hit by lightning) by penetrating at higher altitudes using a ground-based lightning detection system.

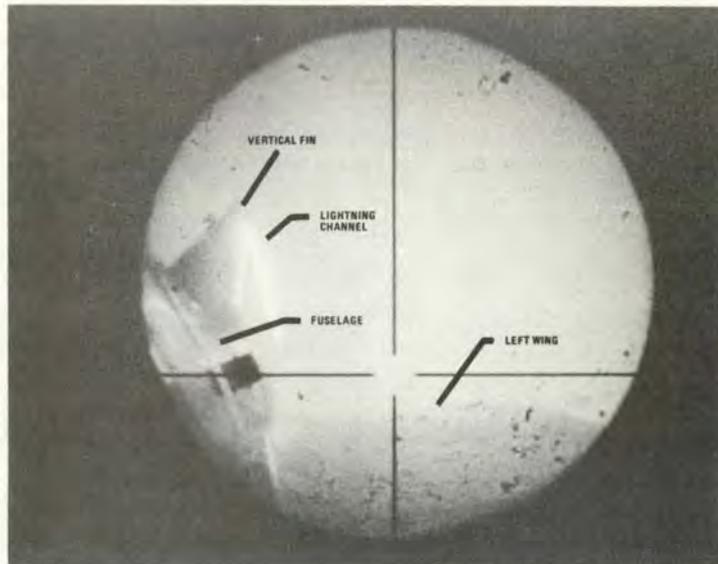
Photograph of a lightning strike to the vertical fin cap of the NASA-Langley F-106B storm hazards airplane. The strike occurred May 28, 1982 at an altitude of 24,800 feet (7.6 km) during a research flight through a thunderstorm at Annapolis, Maryland. The outside air temperature was  $-21^{\circ}\text{C}$ . (Photograph courtesy of F.L. Pitts and B.D. Fisher of NASA-Langley.)
